Poison Gas Leakage from Chemical Plant in Bhopal, India

【December 2nd, 1984 Bhopal, India.】

Mitsuo Kobayashi (Graduate School of New Frontier Sciences, University of Tokyo)
Masamitsu Tamura (Graduate School of New Frontier Sciences, University of Tokyo)

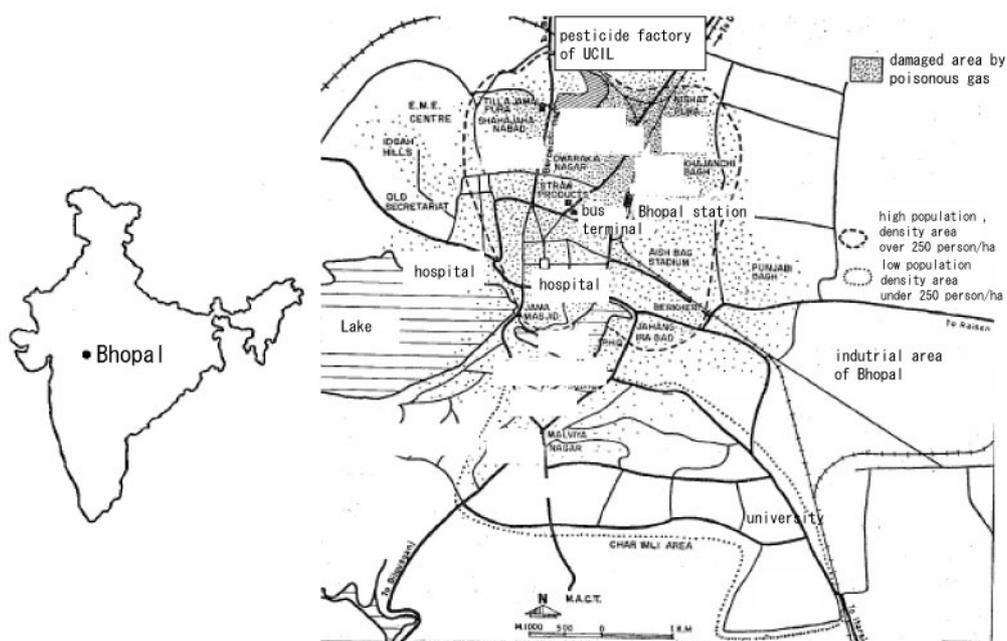
Fig.1 Spread of the damage

From midnight of December 2nd, 1984 to the dawn of the 3rd, the deadly poisonous MIC gas leaked from the storage tank. MIC, which was an intermediate in pesticide manufacture, was stored in three storage tanks of the pesticide factory in UCIL Co. at Bhopal in central India. MIC evaporated as a result of an abnormal reaction. The northwest wind was blowing on that night, and the temperature was low, so the leaked gas spread silently to the southeast over the ground to cover an area of about 40 km² in the city. Because the accident occurred at midnight, the citizens were not able to take refuge. The number of victims was at least 200,000 persons, which was over one quarter of Bhopal's population of 800,000, and according to other estimates, the number of victims was as much as 300,000 persons. The number of instant deaths exceeded 2000, and the final number of fatalities was 14,410 persons.

As the wind direction that night was from the northwest, the leaked gas spread towards the city zone where the population was most dense. A large amount of human damage was an inevitable result of high toxicity of MIC, of the large leakage quantity 35 tons in total, of the time of the leakage that was midnight, and of a lack of publicity activities and rescue operations.

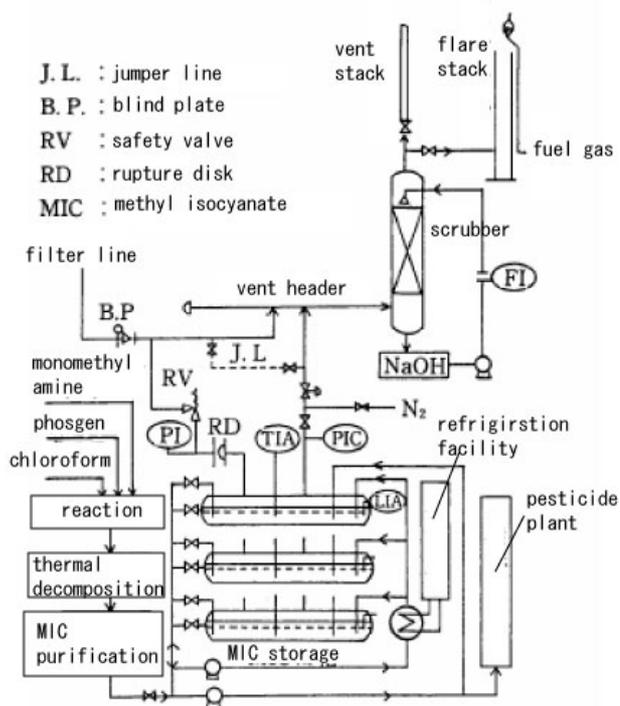
Fig.2 estimated process diagram and safety equipment

The causal chain of events leading to the leakage of MIC vapor is considered as follows. The off-specification product that contained much more chloroform than the specification was distilled into a storage tank for a few days before the plant started operation. A large amount of water was contaminated in the tank. Hydrochloric acid was generated from the high temperature reaction of chloroform and water. Hydrochloric acid corroded stainless steel of the tank material, dissolving iron. With the iron as a catalyst, a series of abnormal reactions were caused, which led to leakage of MIC vapor. The series of abnormal reactions is shown below. MIC vapor leaked from a safety valve, and a pressure relief valve due to a pressure rise caused by carbon dioxide formation and MIC vaporization.

MIC reacts with water to form carbon dioxide and methylamine with the generation of heat. In addition, due to the rise in temperature and the catalytic effect of iron, trimers of MIC were formed with a large heat generation of 325kcal/kg-MIC. The temperature became high due to the reaction, causing a runaway reaction to occur. The reactions from the generation of hydrochloric acid to trimerization of MIC had been known.

In addition, all three kinds of safety devices failed completely, and MIC gas spread to the city. Three kinds of safety facilities had been prepared, as is described in the “Course” section above. However, the refrigeration unit had been stopped since July, and the scrubber had also been stopped on October 22nd when the manufacturing plant was stopped, possibly because it was judged to be unnecessary since it treated the process off-gas. Finally, the flare stack was stopped for piping work. Because of these reasons, the leaked gas was discharged out of the facilities without any

treatment. Although not directly related to the accident, there were some problems in the processing capacity. The maximum processing capacity of the scrubber was equal to eight tons of MIC. However, there was 40 tons of MIC in the tank at the time of the accident. The scrubber could not handle that much MIC. Furthermore, there were some questions regarding whether or not the processing rate was sufficient. Although the scrubber's processing rate should be designed for the total flow rate from the pressure relief valve and safety valve, the actual processing rate might not be sufficient. These issues indicate there were problems not only in the operation control but also in the safety design of the plant itself. It was regulated that the tank temperature must be lower than 0 because the MIC boiling point is just 39.1 and MIC is easily vaporized, but the refrigeration unit had been stopped over six months before the accident to cut down electrical charges by a certain opinion. Although it is not known whether or not the operation of the refrigeration unit could have prevented the runaway reaction directly, there is no doubt that refrigeration would have lengthened the time to the leakage.

- d) Safety equipment, including monitors and alarms for storage facilities, must not be stopped even if the manufacturing plant is shut down. Substitute measures

- e) Safety equipment such as scrubbers should have a sufficient processing rate and a capacity for treating the estimated discharge rate and quantity from safety valves and so on. Some buffer facilities are necessary to handle the situations where the rate is extremely large and a scrubber of sufficient size cannot be constructed.
- f) It is important to carry out safety education, especially that of managers. The water washing of the piping, which might be unnecessary and was executed on the instruction of a site manager who had been transferred just before, triggered the accident. Education regarding safety and basic knowledge for management supervisors and operators working at the chemical plant was also important, considering that they did not insert the blind plate to the place where a leak may occur and they did not think that a valve may leak sometimes.
