Criticality Accident at JCO Uranium Processing Plant

【September 30th, 1999 Tokai, Ibaraki, Japan】

Mitsuo Kobayashi (Graduate School of Frontier Sciences, University of Tokyo)

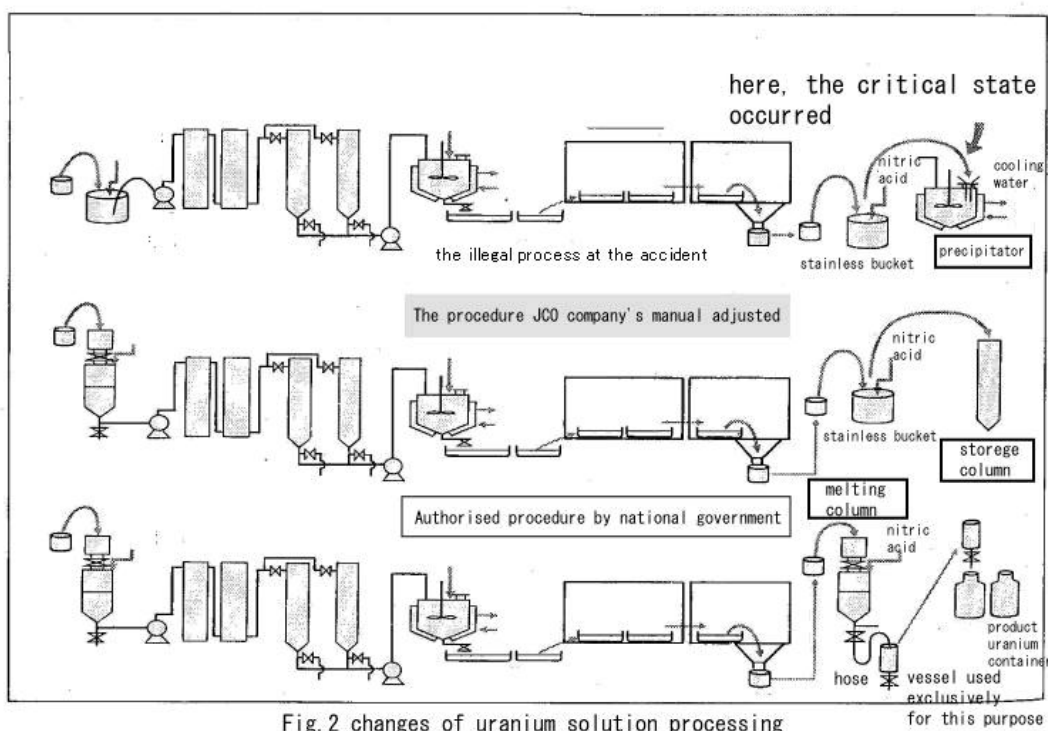
Fig.2 changes of uranium solution processing

The final process is labeled as the “illegal process at the accident” in the figure. In the official manual, re-melting work is required to be done in the dissolution tower, and the subdivision is required to be done using a specially designed container. In the JCO company manual, the re-melting work was done using stainless steel buckets and the subdivision was done using a normal storage tower. The storage tower was 3.5m height and 17.8 cm in radius, and the bottom valve used for supplying the liquid to the stainless steel bucket was mounted only 10 cm above the ground. The operation using the storage tower was very difficult. Therefore, in the operation that led to the accident, another change was made to use the stainless steel buckets and the precipitation drum. Even worse, the precipitation drum was attached to a water jacket. The image of the

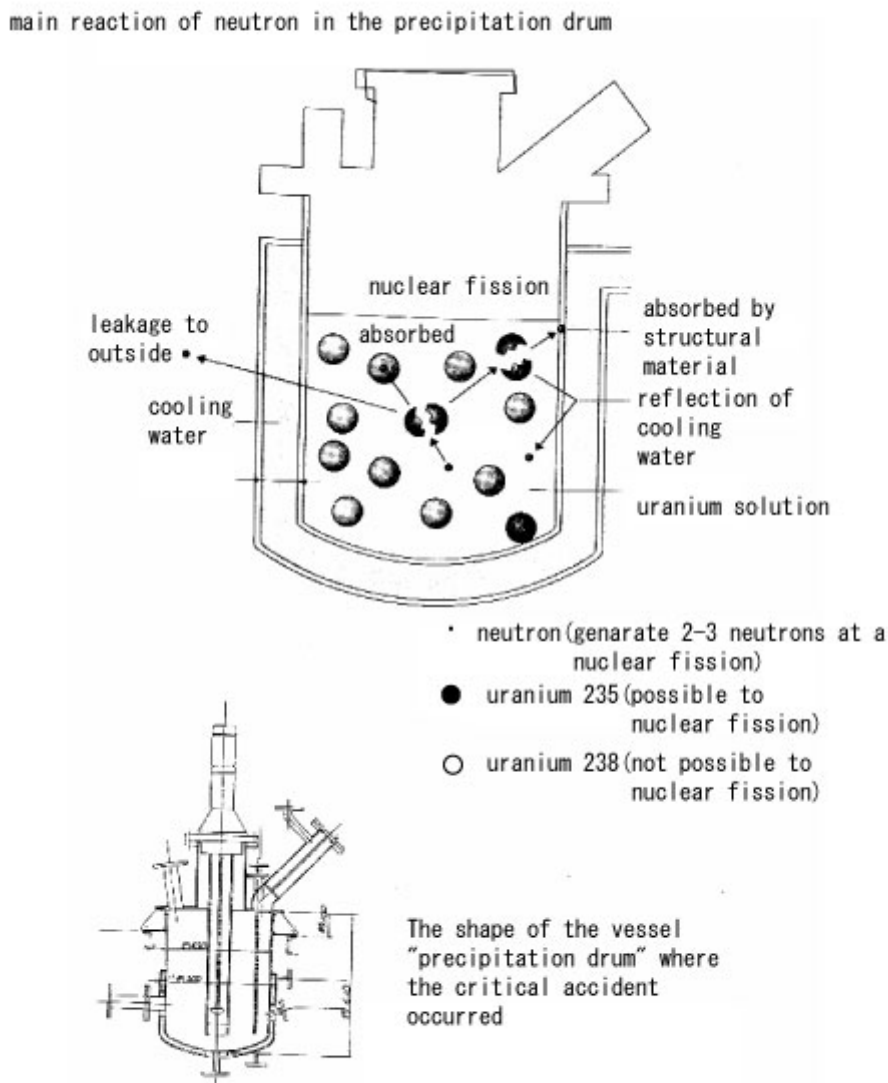
Fig. 3 image figure of the precipitation drum

In order to reach the critical state, two conditions are needed. First the number of U^{235} atoms must exceed a certain limit. Second, the probability of a collision of generated neutrons with an atom of U^{235} must be high. Considering that neutrons escape from the surface of the fuel canister, a critical state is hardly generated with a container with a big surface area, in other words a slender container.

Even though it was at the request of the working operators, the accident was triggered by the decision of the manager to change from a slender container to a stumpy container with a small surface area, and to conduct equalizing work with uranyl oxide with critical mass without any confirmation, or calculation, based on the wrong conviction that the concentration of the material was 5%, though actually it was 18%.

draw off the water in the precipitation drum jacket. At 02:35, according to the decision, two persons of JCO started the draw-off work as the first suicide squad. At 06:04 in the following morning, the critical state ceased due to the successful drawing-off of the drum jacket water by the tenth JCO suicide squad, and the criticality stopped.

At 08:39, the injection of a boric acid solution into the precipitation drum finished and the critical state ended at last.
