Bridge girder fell in Hiroshima "New Transportation System" construction site

[On March 14th,1991, Hiroshima, Hiroshima]

Masahiko Kunishima • Kazutaka Matsumaru (Note)

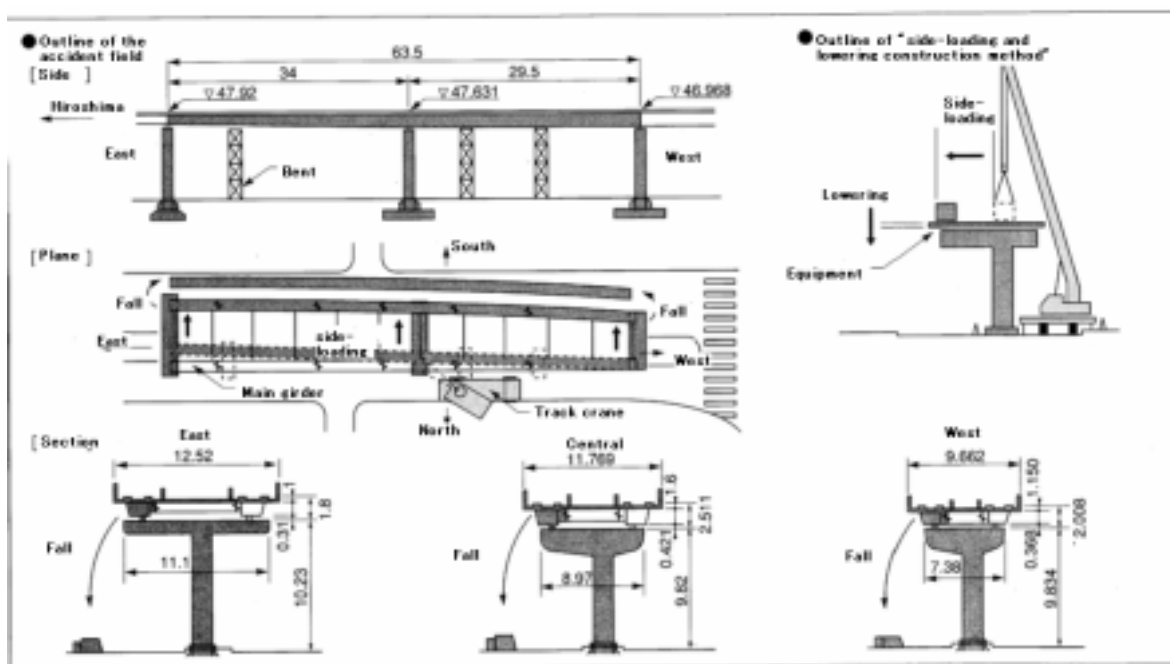
Figure 1 shows the outline of the accident field and the "side-loading and lowering construction method"

Figure 1: The outline of the accident field and the "side-loading and lowering construction method" (source: "Construction Accident" (Nikkei Construction) p16)

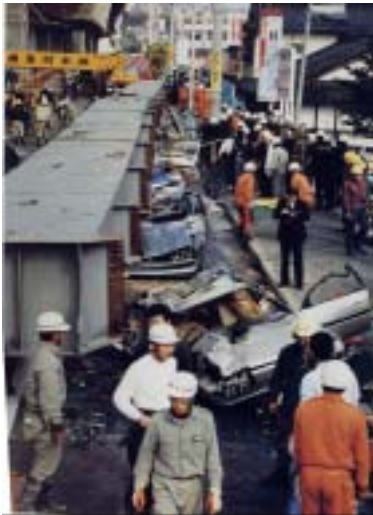
Picture 1: The field 1

At around 14:05 on March 14, 1991, at the Hiroshima City elevated rail track "New transportation System" construction site, a steel box girder 63.4 meters long and weighing 60 tons fell to the prefectural roadway below. Eleven motor vehicles waiting for the traffic signal to change were

crushed and ten citizens died. Five workers also died. In total fifteen people died and eight people received serious or slight injuries. It was a big disaster. Picture 1 is taken from the near side and picture 2 is from the sky.

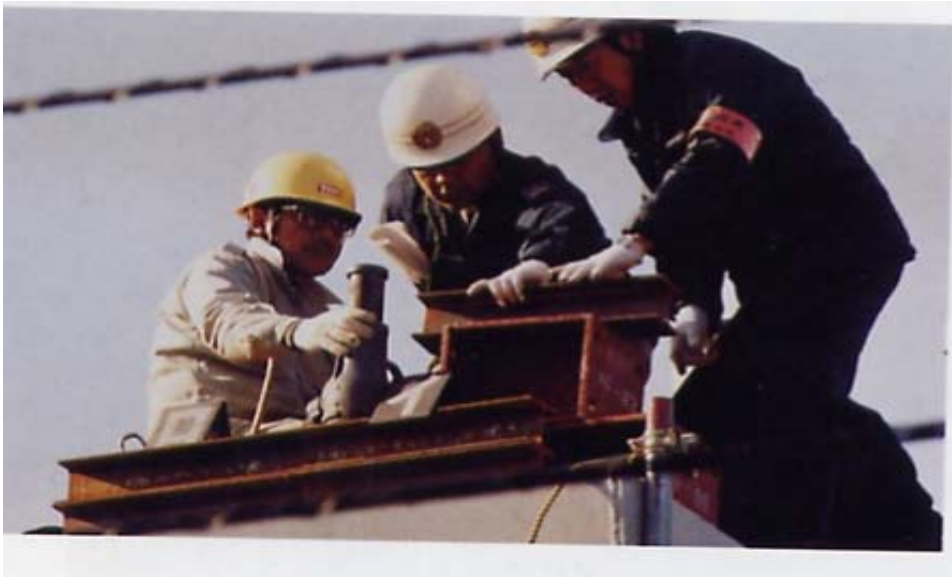
The jack mount had a triple tier of steel H-beams stacked in the same direction (normally each tier would cross the previous one at a right angle). The H-beams also lacked reinforced ribs. As the result, the girder deformed since a non-reinforced section was in direct contact with the jacks. Two of the three jacks supporting the main girder experienced a change of fulcrum force, and at that instant, one of those two was loaded beyond its ability to withstand. As the result, the remaining jack could not support the reaction, so that two jacks collapsed at virtually the same instant. While executing a half turn around the bridge axis, the girder fell to the prefectural road below, crushing eleven motor vehicles that were waiting for the traffic signal to change. Picture 3 shows the H-beams which lack reinforced ribs. Figure 2 shows the situation of how the jacks fell. Figure 3 shows the process of the falling girder.

Picture 3: the H-beams which lack reinforced ribs (source : "Construction Accident" (Nikkei Construction) p16)

- (1) Three tiers of steel H-beams stacked in the same direction were used as temporary jack mounts.(Fatal cause)
- (2) Materials where load force was concentrated were not reinforced with shear reinforcement ribs, and jacks abutted sections that were not reinforced with shear reinforcement ribs.
- (3) Wires were attached to prevent the girder from falling during side-loading; however, this countermeasure was not in place during the lowering operation.

- (1) Do not stack steel H-beams in the same direction for supporting loads.
- (2) Install shear reinforcement ribs on components bearing concentrated loads.
- (3) Attach wires to prevent girders from falling during the lowering operation

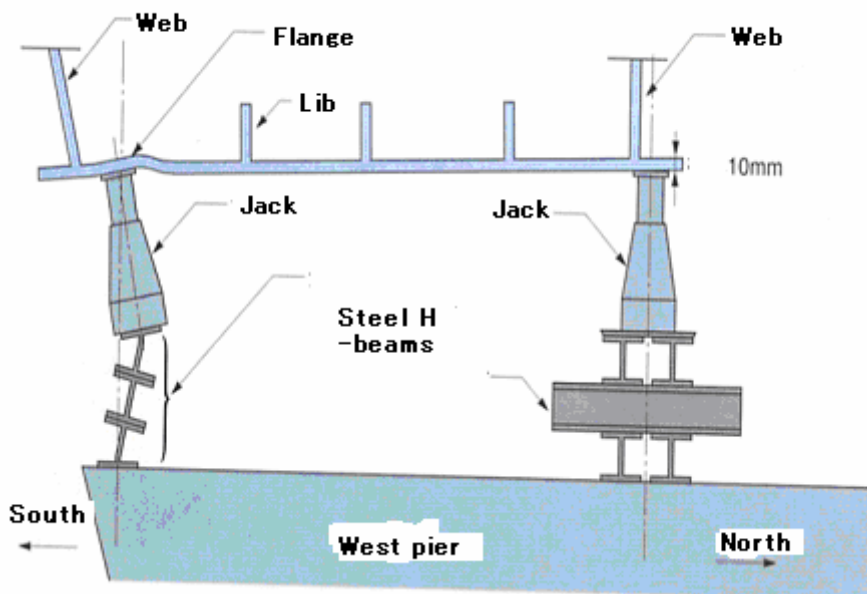
● The situation of how the jack fell on the west pier

Figure 2 : The situation of how the jacks fell (source : "Construction Accident" (Nikkei Construction) p16)

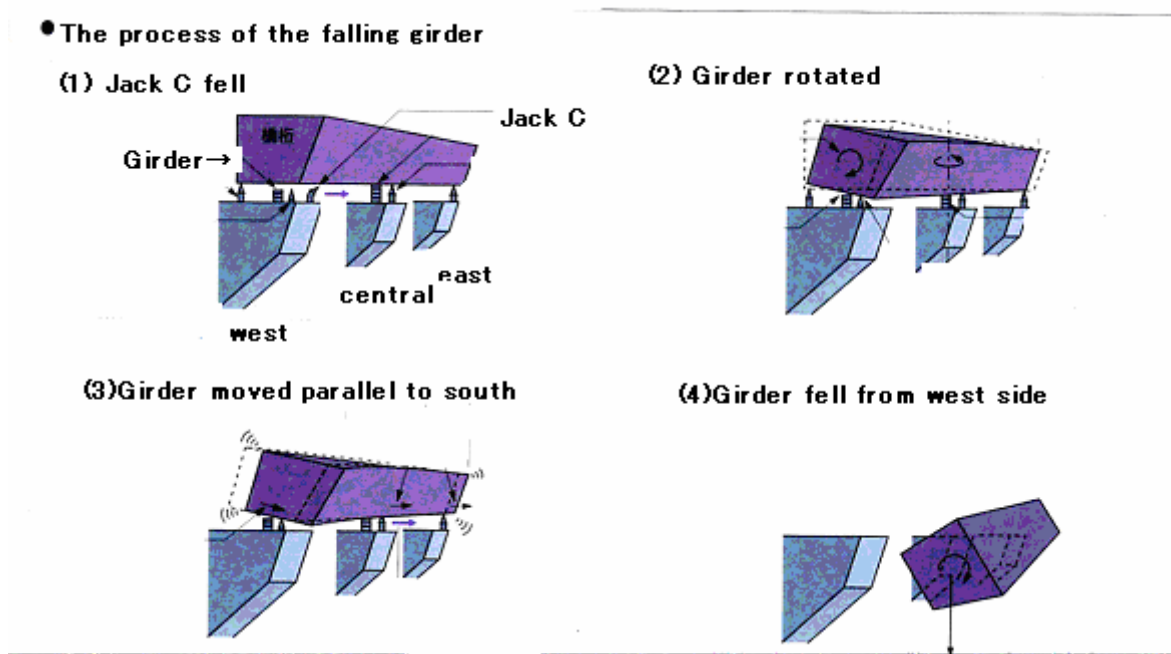
Figure 3: The process of the falling girder (source : "Construction Accident" (Nikkei Construction) p17)

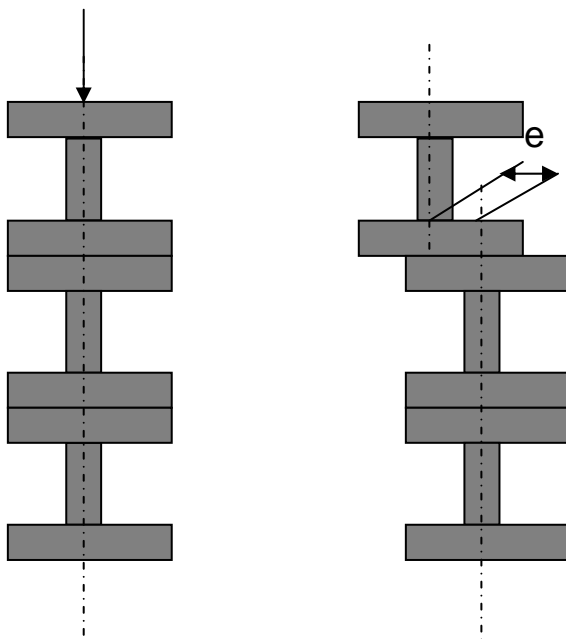
- (1) The "flow of the force" of hypothesis structure which supports heavy goods such as timber support and frame, or the insight which perceives whether it smoothly transmits the force is necessary for the practicing engineer in respect of the estimation method.
Figure 4 shows how the very slight slippage ((e) in the figure) causes the deformation of the estimation outside, and how tipping over and collapse are brought about.
- (2) Safety is "culture". Safety is the result of daily attention to details.
- (3) Not to repeat the same mistakes, the construction field should seriously consider this failure, hand it down as a fact of the common awareness, and educate about it.

Figure 4: slippage of the H-beam (Source: Author made)
