The submergence accident at the tunnel of Kokubugawa River diversion channel [Matsudo City, Chiba Prefecture, on September 19th, 1991.]

Masahiko Kunishima, Sachiko Tsukahara (Note1)

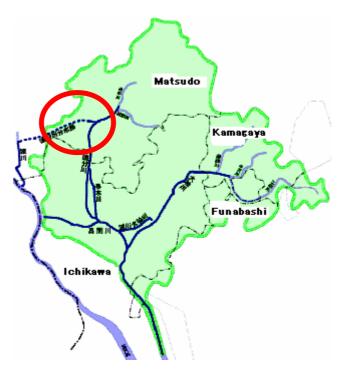
Figure 1: The place of Kokubugawa River diversion channel

On Sep tember 19 th in 1991, because of the heavy rain with the typhoon No.18, the muddy stream flowed to the diversion channel tunnel under construction which had been constructed for discharging the part of the water in Kokubugawa River (Matsudo City, Chiba Prefecture) to Edo River (via Saka River), and all seven workers in it died. The figure 1 shows the details of the site on the day after the accident.

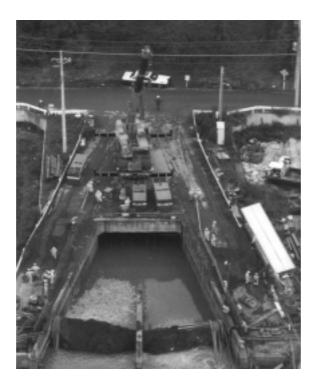
Figure 2 the aspect of the site on the day after the accident (September 20th, 1991)

On this day, Chiba Prefecture had heavy rain, and the water which overflowed from Kokubugawa River and Wanagaya Irrigation Canal, flowed into the entrance of the tunnel. The temporary cofferdam at pit mouth collapsed, and the muddy stream flowed in. The water attacked the site under excavation, which was about 1600 meters away from the pit mouth, and seven workers in the tunnel were confined. 7 workers were found drowned to death consequently.

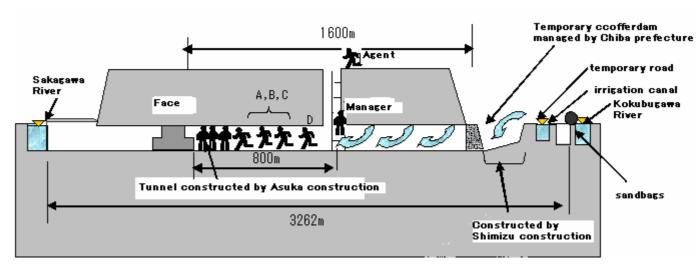
Figure 3 the brief diagram of the temporary cofferdam of the pit mouth

The temporary cofferdam collapsed because of the hydraulic pressure of the muddy stream just after the worker D ran to the back of the tunnel. The flash flood surged ahead with the muffled thump, and the tunnel was submerged. The total of 7 persons consisted of the 3 persons in the back and the 4 workers (A, B, C and D) were drowned. The construction chief was escaped by clinging to the stair and by climbing up it, in spite of the fact that he had been soaked up to the neck in the muddy stream.

The temporary cofferdam which collapsed in this accident was constructed by putting up the H-shaped steel frame and horizontal sheathing and by piling the sandbags in front of it. (Ref. Figure 3) The lack of intensity of the fixing part at the bottom of the H-shaped steel frame caused the washout. Actually, there

was a difference between the original design of this temporary cofferdam and the result of construction. Because the staff of the consultant did not understand the situation of the field sufficiently and the design condition did not match the situation, Shimizu Construction as the owner changed the design by itself. However, the strength of the bolt became lower than that of the original design. Also, even though the contractor asked the chief of Kukubugawa River construction section of Chiba Prefecture to show the calculation book of the intensity in the design change, this request was rejected.

- Though bolts are often used in the design of temporary structures, there are many cases that the structures built temporarily collapse since the actual conditions in the field does not always meet the design intent (to make it re sist by shear stress) and the bending moment might be applied, if it is designed to resist by shear stress. The design of temporary structure such as this cofferdam requires not only accuracy of calculation process, but prudent consideration for safety on the basis of the site situation. And, information such as the calculation process of designing and conditions for calculation should be showed all the time.

- The unusual situation which might occur should be a ssumed in a dvance and design with safety margin should be examined.
- In the case of changing the design condition, when there is a drastic change in the design conditions and loading conditions in the process of the change should be confirmed.
