Fire in Oshimizu tunnel

[20th March 1979, Minakami Town, Tone District, Gunma Prefecture]

Masayoshi Kitajima (Maeda Construction Company, Headquarter of Safe Environment, Safe Environment Bureau, Safe Labor Group, Fulltime Chief Director)

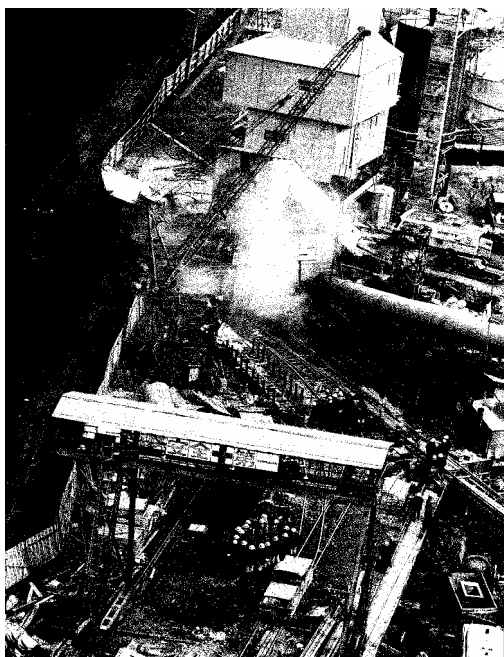
Smoke from the entrance of Hotozawa mine (photograph: Kyodo News Service)

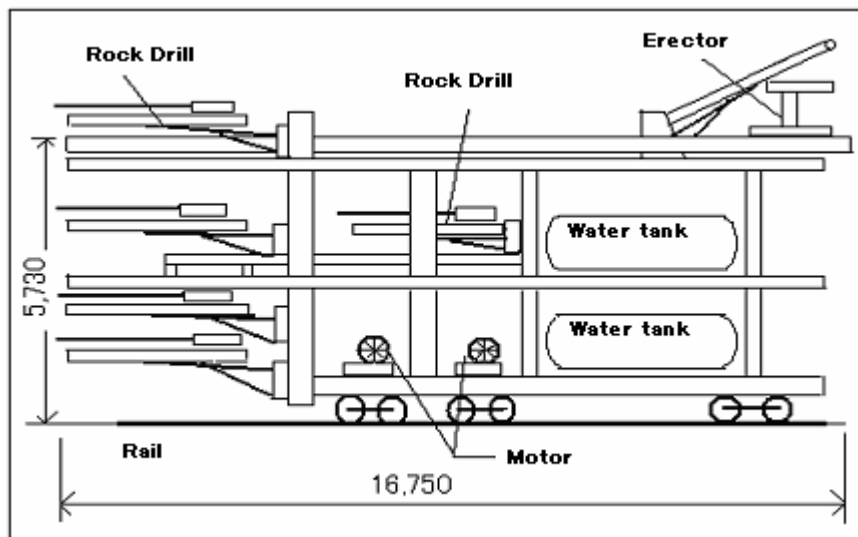
21 boom-jumbo drill stand (Source: Author made)

On the deck of the jumbo drill stand, wood chips etc. generated when cutting off the wood for the tunnel support piled up and adhered. In addition, they were easy to be burned because they sponged the oil leaking from hydraulic hose which was detached at the time when the disassembly operation.

(2) There was no monitoring person in the middle deck in which fusion cutting spark, etc. fell.

Although the watchdog was appointed, there was nobody on the middle deck when fire broke out; as a result, it was too late to notice the fire.

- (1) Combustibles should be removed around the fire. If impossible, they should be covered by the incombustible material.
- (2) The watchdog must be stationed in the fire work.
 - Fire can be easily extinguished in most of the case, if it is found when it is small.
 - The watchdog must not do the any work except for the monitoring.
- (3) Effective extinguishment facility should be prepared in the fire place.
 - Using the hemp cloth to put out the fire is the last means to adopt for fire extinguishing.
 - Accumulator fire extinguisher which is strong to the moisture in the tunnel construction should be arranged.
 - **The fireplug which utilized water supply pipe** should be used at the same time with fire extinguishers in the tunnel construction.
 - Maintenance and inspection of extinguishment facility should be done the

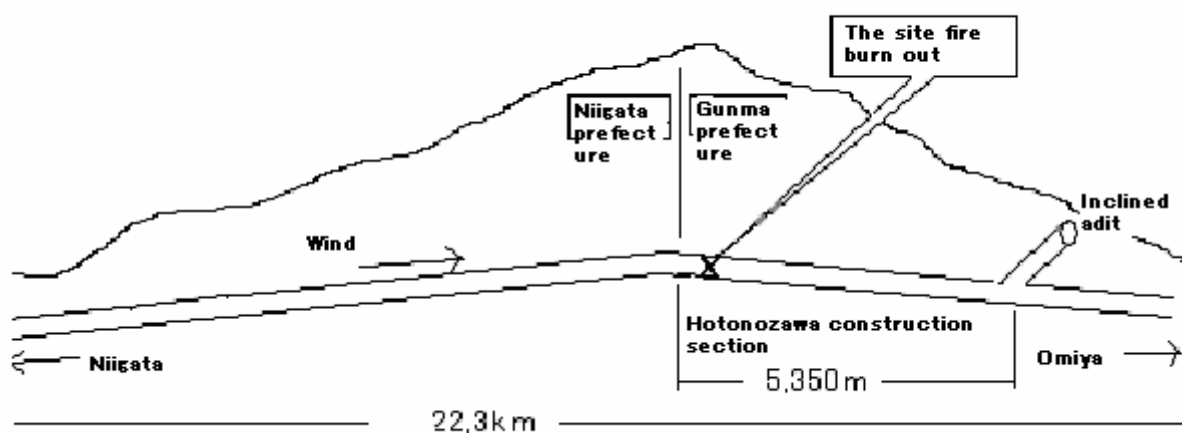
8 out of 11 workers in the group of demolition of jumbo drill stand succeeded to escape, since they ran to Niigata. But 3 workers who moved toward Omiya failed to escape and died winding by the smoke; this direction was windward. Also, although 3 out of 14 workers, who were doing lining concrete installation work (this work is; assembling the tunnel-shape mould, and pouring the concrete there) in the field which

was 254m-windward from the fire, succeeded in the escape to Omiya, 11 workers failed to escape and died winding by smoke. All the other workers who worked on the way managed to escape.

Cross-section figure of Oshimizu tunnel (Source: Author made)
