**Concrete mould timber support collapse accident in the gymnasium construction work  
in Maritime Self-Defense Force Atsugi air base.**

**[February 14th, 1992 (Fri). The Kanagawa Prefect. Ayase City.]**

During the concrete installation work of the beam and the slab of the second floor of the gymnasium, installed concrete and slab's reinforcing steel fell and 7 people died, and 14 people got injured.

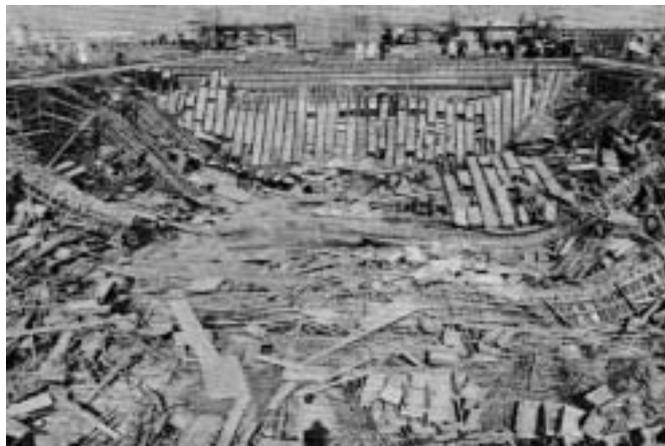
After about 25 minutes, a chain reaction collapse of the moulds and the mould timber supports spread from this falling point, and 2/3rds of concrete and reinforcing slabs of the second floor fell down. And the workers who were working on the inspection at the 2nd and the 1st floor were pinned under these fallen materials, and 7 died, and 14 got injured.

Fig-1. Situation of the whole (Source: the Ministry of Labor survey report)

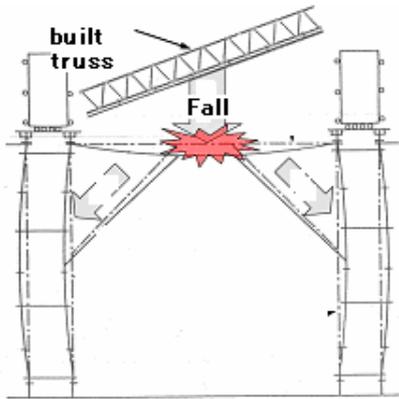
By the previous day of the accident, concrete was placed in the first floor column and the external wall under the girder mould. And during concrete installation of the slab on the day of the accident, a beamed member of the built truss with coffer forms ( the mould boards ) on its both sides with placed concrete in it fell on the shelf scaffold just below that ( figure 2 references ). The installation work was immediately stopped, and some persons descended to the first floor to grasp the situation. There is a testimony that the inflow of the concrete was resumed after a while at another section of the second floor.

Fig-2. The bend of the pillar by the built truss falling (Source: the Ministry of Labor report)

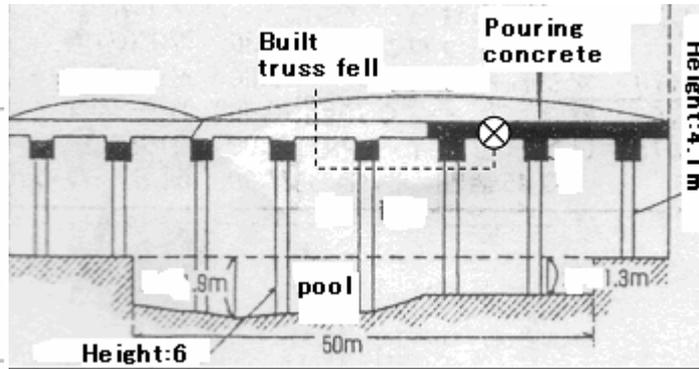
Fig-3. Outline drawing of the timber support collapse (Source: Asahi Shim bun article).

After about 25 minutes, a collapse of the mould timber supports began from the part of this built truss, and it spread rapidly, and it lead to the whole collapse (figure 3 references).

The mechanisms of the whole collapse are as follows. The scaffolds (the shelf scaffolds) of the workers were installed in the way that braces were fixed on the pillar, and the stage planks were installed on them horizontally. When the built truss and concrete fell on the shelf scaffold, the impact transmitted through the braces to the pillar, and the load in an oblique direction affected it, then the pillar reached the proof stress, and it bent as figure 2. The structure of the mould timber support and the scaffold should have been independent from each other in order to ensure strength, but on this site, the scaffolds had been installed on the pillars through braces, and moreover, since they were fixed near the joint (the link part) which is a structural weak point of the pillar, the strength of the pillar has been considerably lowered. Therefore, the pillar finally lost the retention capacity force and collapsed, and this developed into a chain reaction, and it led to the collapse of the whole mould timber support.

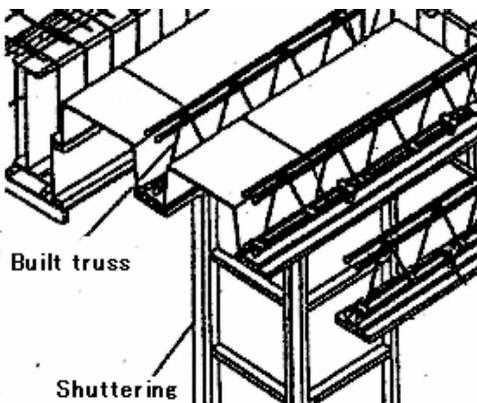
Fig-4. The built slab method (Source: the Ministry of Labor report)

In this construction, the built slab method was applied. A feature of this method is to omit the process by prefabricating the moulds. The members used in the mould are the built trusses. The built trusses are the truss reinforcing steels of about 6m in length, and they become finally a part of the floor, but in the concrete construction, they also play a role as supports of the mould boards from the inside. Therefore, the traditional timber supports from the outside are unnecessary.

In the investigation of the part which didn't collapse, results which show support blocks of the built trusses were not established right under the loading point and results which show there were the gaps between the support blocks and centers of the built

trusses were found, and the support blocks can break or buckle in such cases. The similar assembly seemed to have been carried out in the accident scene. As the result, the falling of the built truss which became the origin of the accident occurred.
