## A concrete wall collapsed under drainage channel improvement work in Tottori

【The accident date : Afternoon in December 20th, 1972

The accident place: Yurayado Daieicho Tohaku District Tottori Prefecture】

Writer : Masahiko Kunishima • Keita Sugihara ( note 1 )

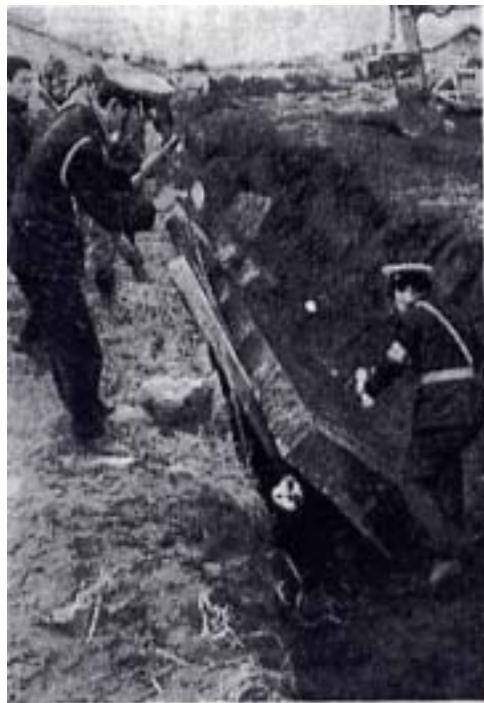
Picture1-Situation of accident  
(Source: Mainichi Newspaper)

In December 20th around 13:20 in 1972, the side wall (1.1m height, 22m length, 25cm width, made from concrete) collapsed onto construction workers during the excavation phase of drainage channel improvement work in a Hojosakyu prefecture-run agricultural field at the north-side of the Yura elementary school in the Tohaku District Tottori Prefecture.

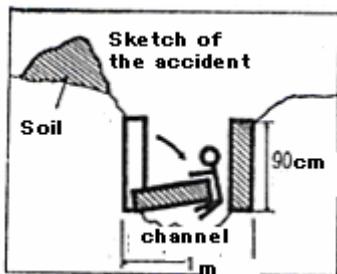
Figure2- Simple figure of the accident

1. The concrete wall gradually moved and suddenly collapsed because of the soft ground of the drainage channel due to an accumulated 15 cm- depth of water, and the weight of the soil heaped up on the side of drainage channel.

2. The workers failed to escape, because they worked with their heads bent down and were late to notice the collapse of the concrete wall.
3. The concrete wall was very unstable, because they had dug down 15cm one week before that day, even though the wall was embedded only 10cm in the drainage channel bottom.

4. Since the soil had been heaped up on the side of the drainage channel, it was difficult for the victims to escape from the collapsing wall, even if they had noticed the collapse of the concrete wall.
