External wall collapse accident in the building demolition work in Fuji City

【On March 13th, 2003. Yoshihara Fuji-city Shizuoka-prefecture】

Masahiko KUNISHIMA, Koichiro TOYODA (Note1)

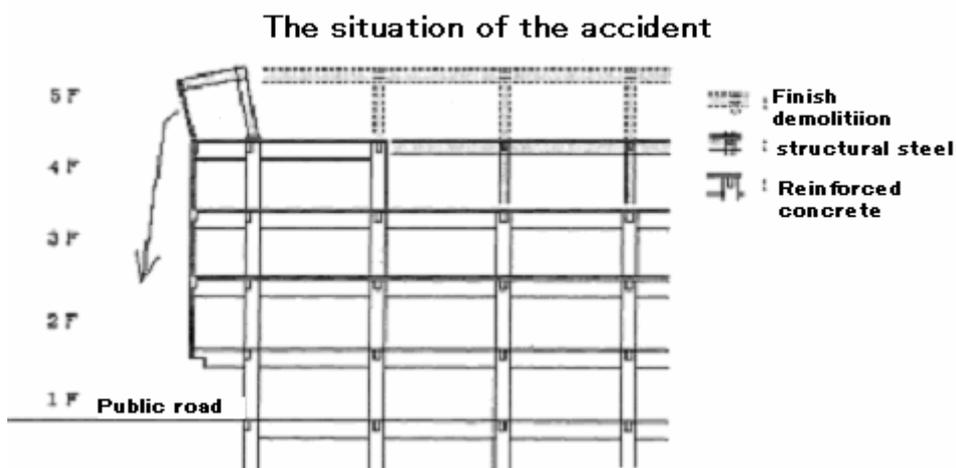
steel frames was made a cut by gas burner and overthrown inside, but suddenly strange sound occurred and the wall fell in the roadside. The sound seemed that the bolt which was fixing the steel frame in the plate of bed sill was broken. The fell in part was a external wall of the building and pillars, the 6th floor's floorboard and girders which supported by the pillars, they were about 3m heights, about 15m width, about 37 ton weight. The 5th floor's wall fell in was made of reinforced concrete, and the upper part of it jetted about 1.5m like eaves.

Figure 1. Situations of 2 of the accident (Source : Work safety information center home page)

Two passenger cars waiting a signal at that time on the prefectures road were trapped under the rubble. Two passengers in the inside the automobile died, and two were injured. Two construction workers fell and died.

That in spite of taking collapse prevention measures for the building outside, the building was unstable structure because its center of gravity over external wall, but the construction manager also omitted the removing work to upper floor face so that construction terms become shorter.

This building was completed as a 4-floor building in 1969. An additional fifth floor was extended afterwards, and it became a 7-floor building in 1974. Therefore, over reinforced concrete, over the fifth floor was reinforced concrete, and the method differed different to the fourth floor in the steel build, and it was the structure that the steel column was fixed by the bolt, when the basic plate was embedded, junction. Because of becoming superannuated the building, a lot of volts connected original part and extension part had come out, so the strength of the junction part was weakened .

In the demolition work of junction between different structure, a steel frame construction and a reinforced concrete construction and precast concrete structure, etc. or junction between a part of extension or reconstruction and an original part, should be pay attention to strength for the junction, make a plan for construction and carried out.
