Tachikawa City, the falling accident of the pile driver

【16th March 1991、 Tokyo, Tachikawa City, Akebono town】

Masahiko Kunisima · Koichiro Toyoda (note¹)

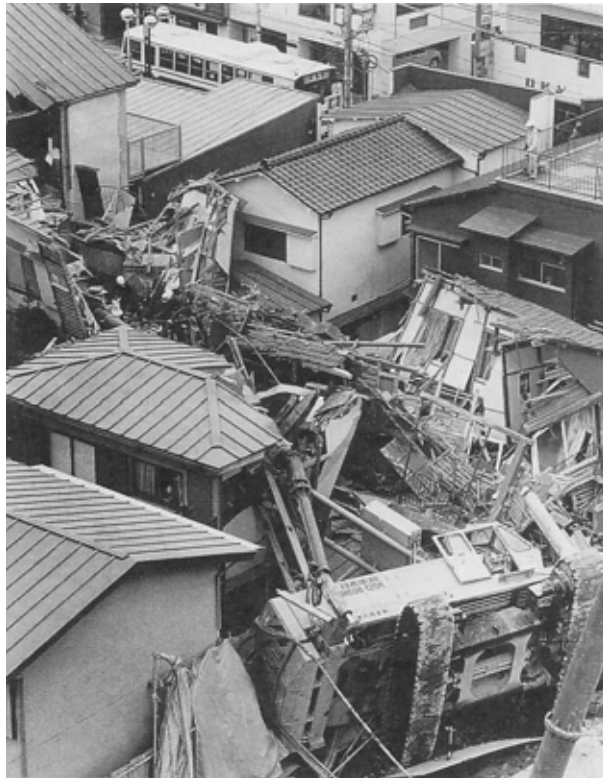
Fig. 1 The Situation of the accident
(Source : “The construction accident”)

On 16th, March, 1991, the accident occurred at just after 9:30a.m. In Akebono town, Tachikawa city, Tokyo, at construction site of Tachikawa JF building which was operated by a joint venture of Taisei Kensetsu and Goyo Kensetsu, the large pile driver (weight: about 100ton, height: about 30m) fell down to the east side with a big noise. Some private houses and apartments were buried under the machine. "Apartments were crushed completely, 2 buildings were partially destroyed, and the parts of 3 buildings were broken. In this accident, three people were killed. They were university students. The workers in this site were not injured. (Fig. 1)

After the same operation of the pile driver on the east side of steel sheets, it moved back and the driver descended. Just after that, the head of the machine shank with the steel sheets started to lean. The driver noticed this and tried to drive and move the machine falling down and hoping one of the eastside steel sheets little up, making a big noise.

However, the soil of the site was weak, "the Kanto- loam-layer", and considerable groundwater gushed on from the boring trace. Therefore, the loose ground seemed to be unable to resist the dead weight of the pile driver of 100 tons.

Though the pile driver was fixed with three arms in the excavation, but it was not fixed because the work hadn't started in the accident day. For that reason, the weight of the pile driver leaned to the other side because of losing balance, and it came to tipping over.

The alarm buzzer of the crane truck informed about the danger from tipping over just before the accident. When the buzzer rang, the safety equipment which stopped the work automatically should have worked. But, on the day, the safety equipment was not put into motion because the switch of the safety equipment was switched off.

As a safety countermeasure in the case of the construction using heavy machine in the place with the soft ground, the tipping over prevention, and the ground made to be reliable by injection of coagulating agent, etc.; are necessary before the construction is carried out. After they should put materials such as the outrigger outside in the circumference of heavy machine, it is a considerable countermeasure to prevent falling.
