Collapse of the Korea Seoul Seongsu Bridge [October 21st (Fri), 1994 Korea] Masahiko KUNISHIMA (note of 1)

The central section of Seongsu Bridge, totaling over 48m in length which was constructed across the Han River in Seoul, the capital city of Korea, suddenly, collapsed during service. A bus and passenger cars, both in use, fell in Han River under about 20m below, since it was the commuting time in the early morning, and 32 people died, and 17 people were injured on the bridge. Following the investigation after the accident, the actual condition of many "omissions" became clear.

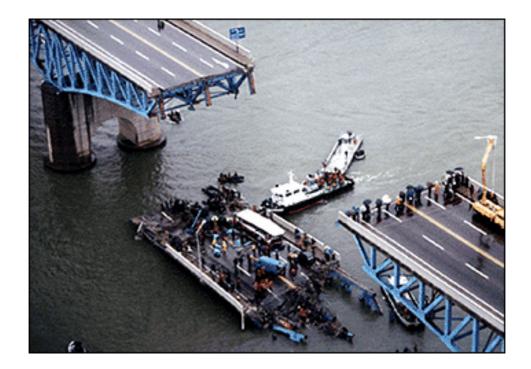
Photo.-1. the situation right after the decay falling accident of Seongsu Bridge. (Donation: Prof.Yozo Fujino, University of Tokyo)

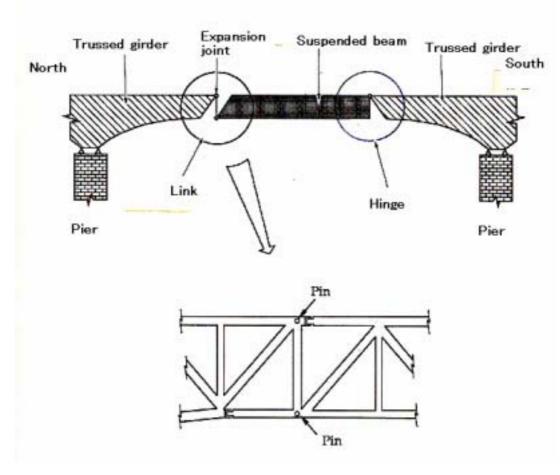
Seongsu Bridge has four lane (two lanes each way) roads of 1160.8m length and 19.4m width. Construction was started in April 1977, and it was completed in October 1979. In Dong Ah Construction Ind. Co., it was Orderer Seoul City consultant (designer) big consultant builder construction cost about 116 hundred million Won (about 14 hundred million yen). It consists of steel truss digit of the seven spans and simple steel and concrete synthetic column of 16 spans of the before and behind. It is the 672m overall length in the steel truss digit division where the accident occurred. Five spans of the center are also one span 120m on anyway, and the fixing support digit of the steel truss, which issued bridge pier dry pitching of both sides, becomes the Gerber-structure that hangs and supports suspension digit of the center of the 48m length in the vertical member. Collapsing and fallen part was one of the suspension digits of the center.

Figure -2: Schematic drawings of structural type of Seongsu Bridge. (Source: Author made)

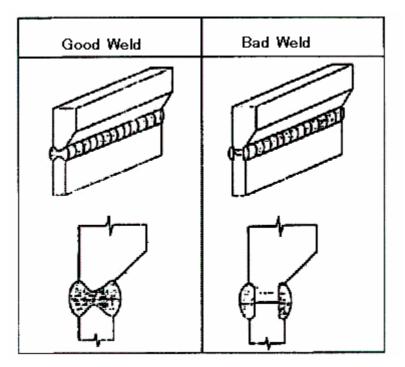
(1) Bad welding of the suspension seems to be a main cause which member of the I-type cross section, which was hanging the suspension digit of the center from the steel truss.

That is to say, it was insufficient to carry out the edge preparation of the mate welding, and the except for surface part was the un- welding. Therefore, the fatigue crack developed there, and it seemed to come to the rupture. That is to say, the cause of the accident is not corrode of the member but poor of weld. Then, this is not proven in the visual inspection. Generally, there might be a fault that was important for production and construction management system that it should do the x-ray inspection and could not discover the welding bad why on such weld zone minute.

Figure -3: Weld zone minute of the suspension material. (Source: Author made)

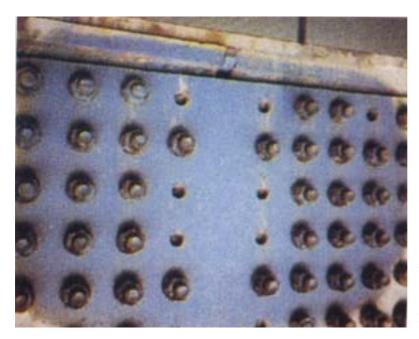
(2) Joint part an example showed in figure -3 and photograph -2 (the bolted joint). The surface shape of fillet welding of photograph -2 is spot welding like warty projection, and there is poor welding which is proven in the visual observation that welding rod sufficiently does not dissolve. The splice plate of photograph -2 there is a position where the volt has not been installed in the volt hole of high-tensile bolt in which the position deviated; there was omission construction which was proven in the visual inspection. Construction management and inspection method in the construction of Seongsu Bridge seemed to be remarkably slipshod, it was surveyed.

Photograph-2: Bolted joint minute of the splice plate (there is a position where the volt has not been installed. (Source: Nikkei construction)

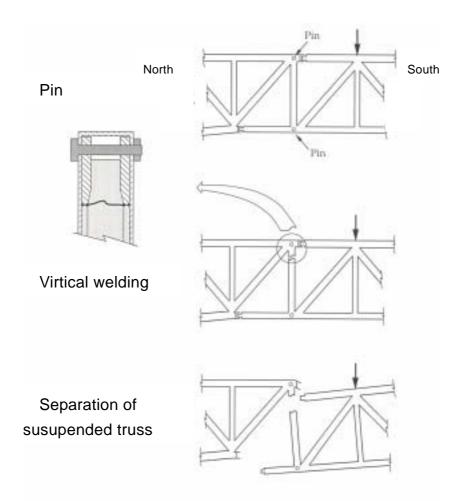
Seoul City was not the last to presume cause of accident was that traffic volume on the bridge increased, passage load became superfluous and the structure was damaged in the storage of the fatigue. On October 22nd, 1994, Seoul City released an interim report about cause of the accident that 1 inside of connection pin of 9 which connected collapsed suspension digit of the center with the fixing support digit of the steel truss broke, and other pins broke in a chain reaction by overload, and the suspension digit part in the center was separated and felt (mechanism reference of collapse and figure -4). The corrosion of this pin and the weld zone was also confirmed. And, investigation headquarters concerned police and prosecutor had grasped the abnormality of the weld zone of the bridge, since the August, 3 times, from the description of "the repair inspection diary" done the confiscation from Seoul east construction office.

Figure -4: The mechanism of a collapse (Source: Nikkei construction)
