Fire in the subway station in Teagu-city, Korea [February 18th,2003 Korea, Teagu-city]

Masahiko Kunisima · Erika Asami (note1)

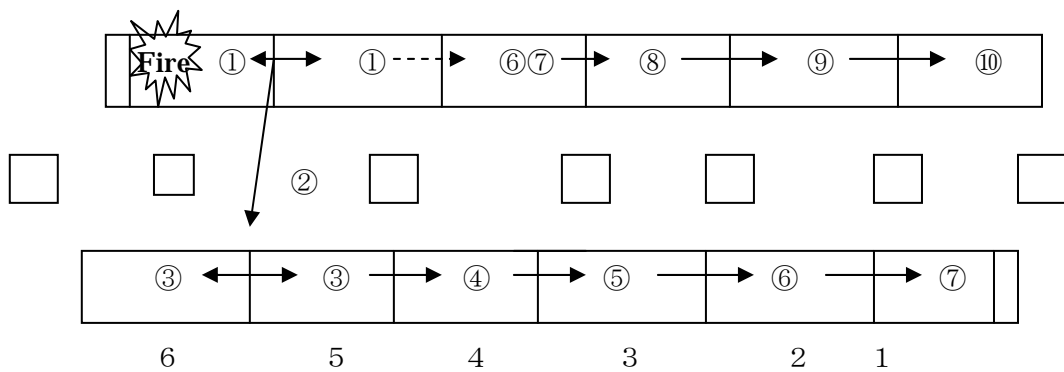
- ※ The circled numbers indicate the order of the spread of the fire
- ※ Figure 2 The situation of the fire (Source Fire and Disaster Management Agency)

The driver of the oncoming train shut the doors and tried to start the train in order to escape from the fire. However, at 9:57a.m., the fire sensing system operated and stopped the electricity in the station automatically. Then, the fire leaped across to the oncoming train (Figure.2) . The electric power operator tried to start the electric power to the train no.1080 so that the train could pass through the station, but it failed. The wireless telephone to the commanding officer was cut off, the emergency lights did not work, and the station became completely dark. These factors contributed to the confusion of the passengers.

While the doors connecting the cars of the train were closed in the train where the fire started, in the oncoming train, there were no doors in the connections between the cars. The oncoming train was moving fast. When the third rolling stock caught fire, the fire spread rapidly to all six rolling stocks. It is because the connecting part was open, so it was easy to spread and the cornice of the connecting part was made from synthetic resin which is not resistant to flames.

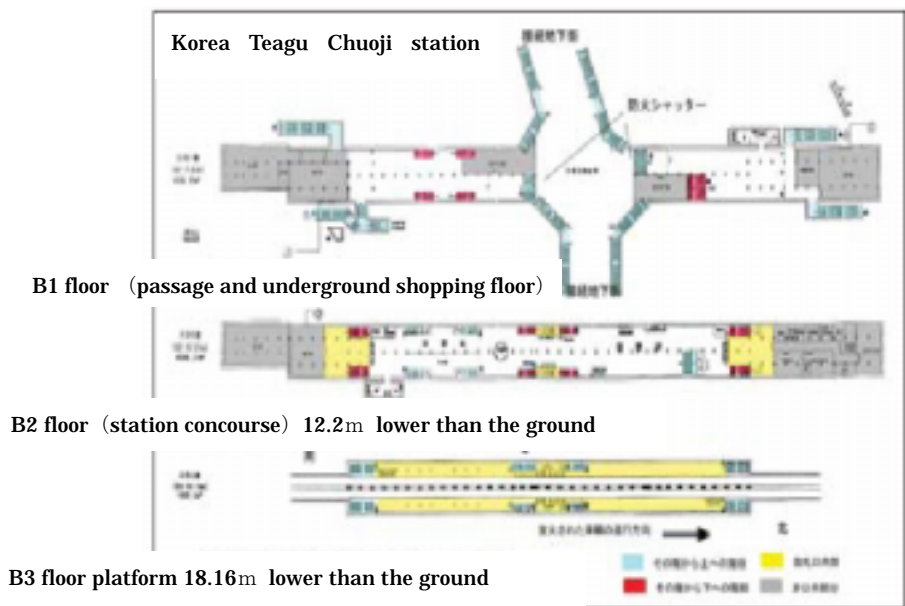
Figure 3, the structure of Chuoji station (Source Fire and Disaster Management Agency)

The fire spread quickly from the lowest floor to the upper floors. The passengers in the station had to escape by using the stairs; so many people could not escape in time (Figure.3).

The platform was on the B3 floor, the ticket gates on the B2 floor, and the underground shopping center on the B1 floor, although when the fire broke out, the shutter to the shopping center was closed. Furthermore, the layout of the stairs was very complicated, and it was difficult for the passengers to find the evacuation route. The safety design of the space had not taken into account the possibility of this kind of large fire. For example, the fire extinguishing facilities, the evacuation route, and the shelters were inadequate. The structure of the subway station was a closed space, and there were many air inflows throughout the tunnel. When the fire broke out, the structure of the subway station turned into an oven and chimney. (note3)

note3) In the case of fire occurring in an underground floor, an oblong space has the danger of becoming a flow route for the smoke like a chimney. This flow is generated by the buoyancy of the hot smoke, and it is called the chimney effect.
