**Collapse accident under New Haengju Bridge construction work**  
**[Seoul City, Korea. July 31st, 1992]**

**Masahiko Kunishima** (note of 1)

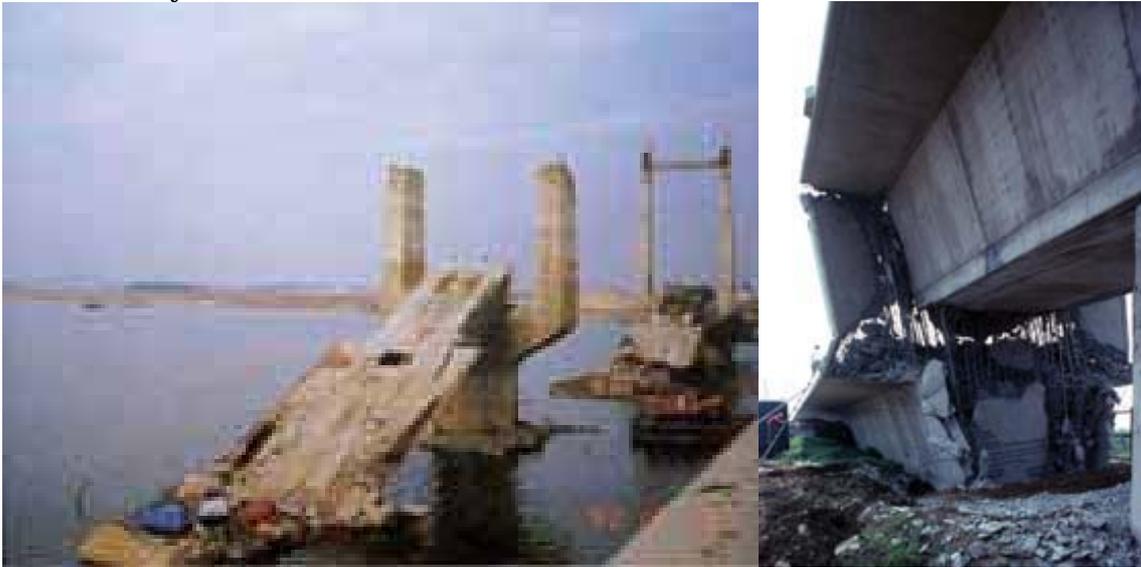
Photograph 1 the situation right after the collapse accident of New Haengju Bridge.  
(Donation: Prof.Yozo Fujino, University of Tokyo)

At around 6:55 p.m, July 31st, 1992, New Haengju Bridge over the Han-gang River which connects the Jiangxi Ward in capital Seoul City with the Goyang city, Gyeonggi-do in Korea collapsed suddenly (see photograph 1, figure 1).

The features of the collapse situation was that the whole parts collapsed all at once since the entire part of 800m was a PC connected box girder structure and it was a unified structure, and that a form of destruction which is the breakage of the whole cross section occurred at various parts of the girders.

The destroyed part of the bridge was removed and newly constructed.

The whole part of the PC connected box girders of 102m length, 1 damaged main tower, and 12 piers were removed. In the demolition, breakers (large rock drill), the dropping steel sphere strike method, nonvibratile high temperature and the pressure jet method, and wires-saw method, etc. were applied. The removal of the main tower was determined by horizontal load safety test.

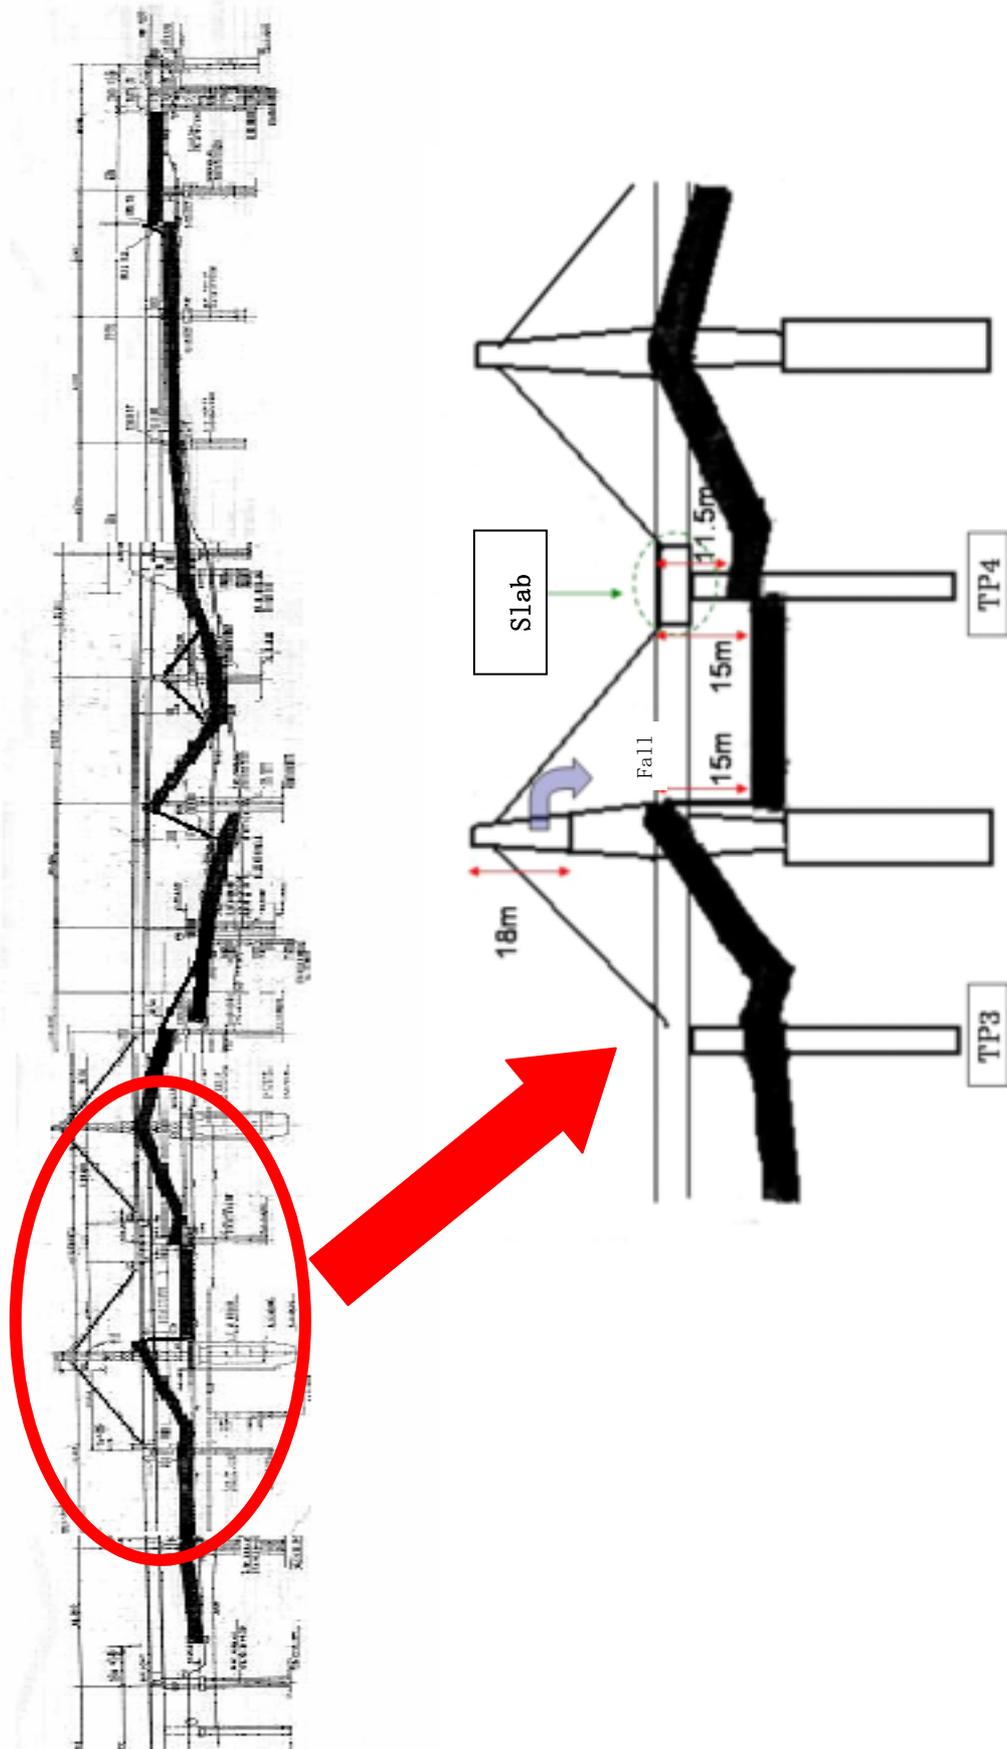
Then the collapse accident occurred, and the PC connected box girder part of about 800m length which was pushed out for the south from the northern abutment was completely destroyed, and the main tower of one side broke. The temporary pillars and 10 piers were damaged heavily or destroyed (see Figure 2).

Figure 2: Outline of the structure of New Haengju Bridge and the collapsed part

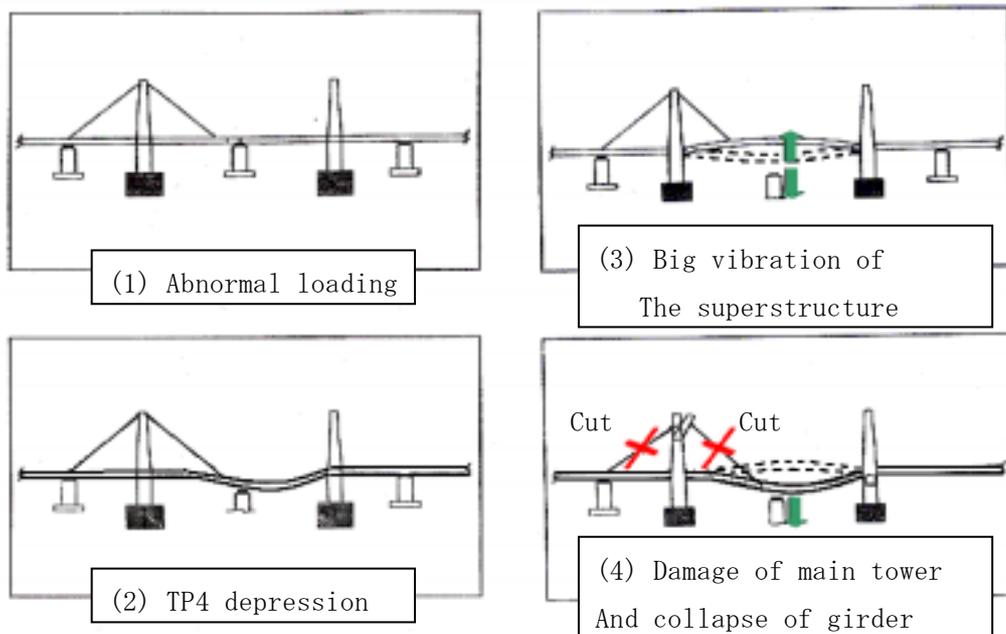
The collapse originated in the center span between 2 main towers of the cable-stayed bridge, and the collapse of the temporary pillars which were set there was supposed to be the direct cause (see Figure 3).

The connection performance of the PC connected box girders which were constructed by the extrusion method was considerably lowered (shear slip) by the installation work of the cable and the plain concrete. Therefore, the vertical load that acted on the temporary pillars increased considerably. As the result, the load supporting capability of the temporary pillars was markedly weakened, and the unexpected force and deformation acted on the PC connected box girders near the main towers and the cable, and it led to the collapse of the main towers and the bridge girder. Since the whole PC box girder section of 800m length was a connected digit structure, it is supposed that the big change of the load action condition by a collapse of one place triggered the collapse of one after another place where the cross sectional power surpassed the yield capability of the member.

Figure 3: Collapse mechanism of the cable-stayed bridge part

There might have been a failure in design and construction concerning the load supporting performance of the temporary pillars. However, since the construction was carried out without any prior examination about the effect of the load which arises during erection on the temporary pillars, the cable, superstructure, and substructure, it is evident that an excessive load acted and destroyed the members.

(1) The cable of PC member whose rigidity was big was changed into flexible steel one in order to improve the workability and reduce the dead load.

(2) They reduced the load on the main towers by changing the cable-stayed bridge part (300m) to steel and concrete synthetic girder from PC connected box girder, and the length constructed by the continuous extrusion method was changed to 420m.

(3) The foundations of the removed 12 piers were changed to the circular concrete piles and their number and length was increased. The piers were strengthened by adding partitions to inside the hollow sections. Two of the three temporary pillars of the cable-stayed bridge part were changed to permanent structures, and the other was changed to steel from concrete.
