## TECHNICAL REPORT: FUKUSHIMA ACCIDENT SUMMARY (AUG. 19, 2011)

**Ritsuo Yoshioka**  
Japan Functional Safety Laboratory  
Yokohama, Japan  
ritsuo.yoshioka@nifty.ne.jp

**Kenji Iino**  
SYDROSE LP  
San Jose, California, USA  
kiino@sydrose.com

The earthquake and tsunami caused unprecedented accidents in six units of Boiling Water Reactors (BWR) in Fukushima Nuclear Power Station 1, operated by The Tokyo Electric Power Company, Incorporated (TEPCO). This report, based on published information, summarizes the causes and processes of these accidents.

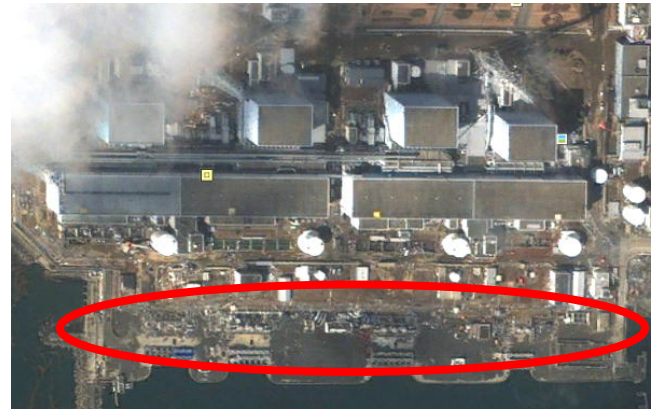
Figure 4 Sea-water cooling systems were destroyed [4]

Since the tsunami had destroyed most of the sea-water cooling systems as Figure 4 shows, it was clear that the core cooling function would completely be lost sooner or later.

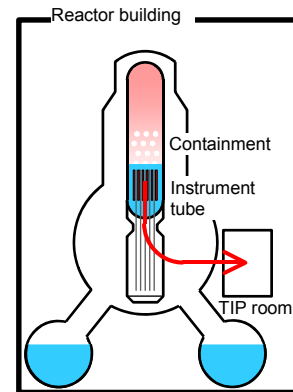
**Figure 7 Fuel melt-down path**

Very high radiation was observed in the TIP (Traversing In-core Probe) room of F1 (Figure 7). Oak Ridge National Laboratory (ORNL) reported that the instrument guide tube is the weakest point at the bottom of RPV [6]. So, we estimate that

several instrument guide tubes were broken, and some portions of fuel pellets fell down to the bottom of PCV through these holes. Small portions of fuel pellets reached the 1st floor of the reactor building. That is, PCV was also broken.

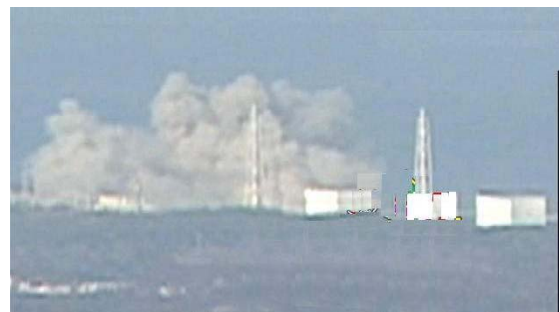
**Figure 11 Hydrogen explosion of F1 [4]**  
(The stacks are 120 meters tall)

**March 12, 15:36:** There was an explosion at the top of F1 reactor building. Concrete panels on the sidewalls of the top floor and top-roof are intentionally made thin. They are designed to rupture in case of pressure buildup in the building after an accident. The rupture keeps integrity of the whole building. If these walls were thick, an explosion with a large energy could destroy both the building and PCV. We tried to find veteran GE designers to hear why they adopted this design, but no luck here so far.

The hydrogen explosion gave a big impact to the public throughout the world because it looked like an explosion of the reactor itself. Of course, it was not.

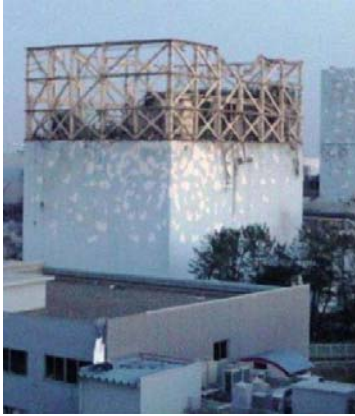
**Figure 12 F1 Top floor was destroyed**  
(March 12th, released by TEPCO)

As we explained above, the walls and roof of the top floor were designed thin. The left-side illustration in Figure 13 was shown in a Government web site, where it said that the reactor building wall is 2 meter thick, and acts as the 5th barrier. This explanation was misleading and the page was deleted from the website after the accident. The illustration should have been like the one on the right side in Figure 13.

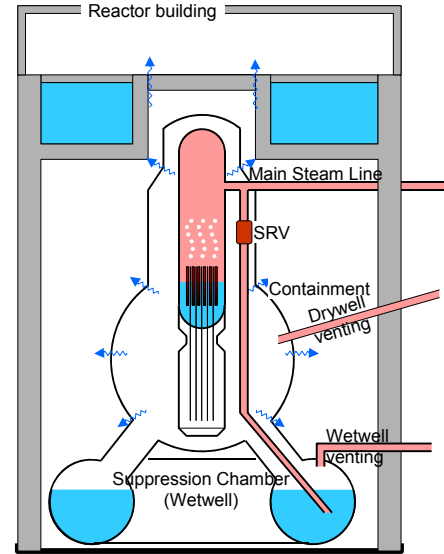
**Figure 14 Hydrogen escape route**

One cause of the hydrogen escape is that the PCV is not tightly sealed, and there are always some small leaks at pipes or flanges (Figure 14). Overpressure might accelerate this phenomena.

Another cause is the small size of hydrogen gas molecules. They can easily penetrate PCV walls.

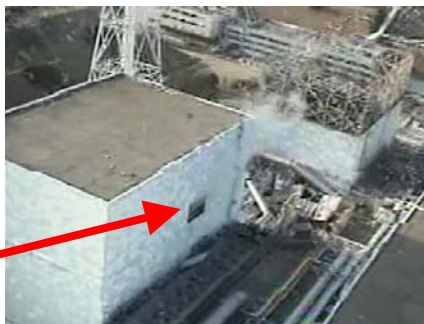
Figure 18 Opened F2 Blow-out Panel  
(April, 11th, by TEPCO)

**March 14, 11:00:** Blow-out panel dropped. This panel is installed to release overpressure, in case it happens in the top floor area of the reactor building (Figure 18). This panel occasionally drops just by earthquakes or some shocks. So, the hydrogen explosion at the top floor of F3, which occurred at the identical time, may have caused it.

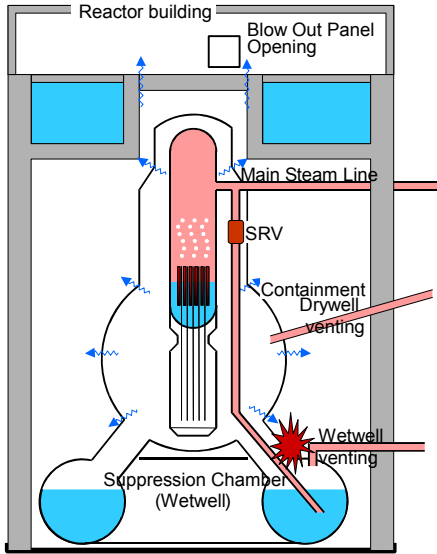
**Figure 20 F2 hydrogen explosion**

**March 15, 06:10:** There was a hydrogen explosion at the suppression chamber, and the PCV integrity was lost. This caused a large amount of radio-active water to leak into the turbine building (This is explained later).

Since PCV of BWR is filled with inert gas, it is probable that hydrogen explosion occurred outside the suppression chamber. The place had the highest concentration of hydrogen from the reactor core. There are always some small leaks at pipes or flanges. Overpressure might have accelerated this phenomenon.

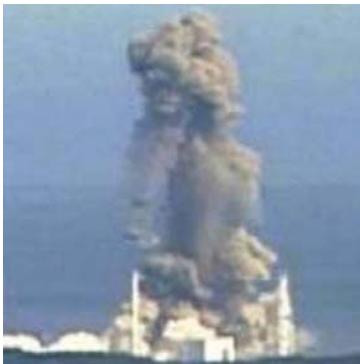
**Figure 24 Hydrogen explosion at F3 [4]**  
(Stacks are 120 meters tall)

**11:01:** There was an explosion at the top of the F3 reactor building (Figure 24). Panels of concrete and steel on the sidewall and roof of the top floor are designed to rupture, in case of overpressure such as steam line breakage within the reactor building. So, they ruptured as designed (Figure 25), although hydrogen explosion had probably not been predicted before.

Smoke reached 300-meters high, and the explosion was bigger than that with F1. Actually, F3 steel frameworks were destroyed, and this did not happen on F1. This cause might have been more hydrogen generation than F1, due to the larger fuel inventory at F3. When this explosion occurred, one of the authors, Yoshioka was in a TV studio, and was surprised by this news.

PCV venting was done 26-hours before the hydrogen explosion but it was not effective enough to remove the hydrogen gas before it exploded. The probable cause is wetwell venting that removes mostly steam, while hydrogen gas rises up in the drywell. Then, the hydrogen gas escaped from the drywell to the reactor building through seals or other penetrations. The paths were the same with those of F1 shown in Figure 14.

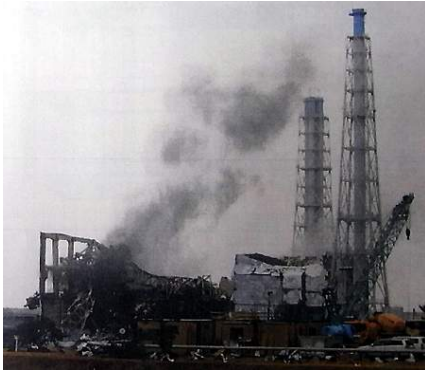
**Figure 32 F3 Smoke on March 21st (TEPCO)**

On March 21st, black smoke rose from the spent fuel pool area of F3 from 16:00 to 18:00 (Figure 32). Also, radiation level at 1km west of F3 was 494-micro-Sv/h at 17:40, but increased to 1,932 at 18:30, and decreased to 442 at 20:30.

We presume that radio-active material went out at this time with the smoke. Black smoke is an indication of carbon from organic material such as cable insulators. There are many cables under the bottom of RPV for the control rod drive mechanisms and neutron detectors (Figure 33). As we explained in 3.1.1, hot fuel broke the instrument tubes and fell down to the RPV bottom. They probably burned the cables at this time.

The French national laboratory suggested that “core-concrete chemical reaction” was responsible for the black smoke. Of course, hot fuel fell down on the concrete floor of the PCV, as Figure 34 shows, however, a Japanese national laboratory says that Japanese plants do not use concrete with carbon, and this reaction will not occur. So, it is more probable that this black smoke was caused by fire of the cables when hot fuel fell on them.

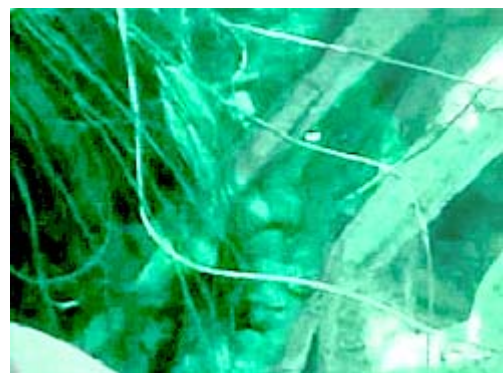
**Figure 35 F3 spent fuel pool (5/8 TEPCO)**

The hydrogen explosion on March 14th dropped concrete panels and steel re-bars in the spent fuel pool, and we cannot see if the fuel bundles are intact or not (Figure 35). The spent fuel lost its cooling function on March 11th, but sea water was injected after the 13th. Decay heat in F3 spent fuel pool is not large and we believe its cooling function has been maintained.

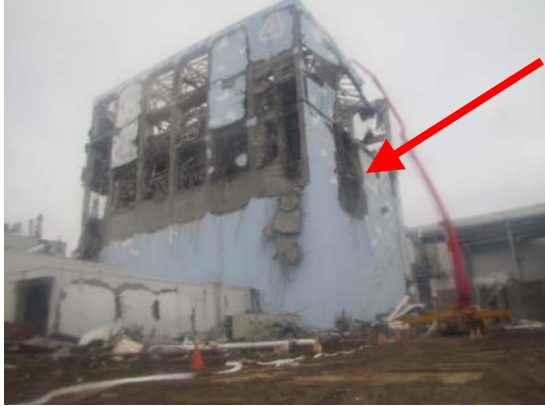
**Figure 39 F4 Reactor building (3/22, TEPCO)**

A fire means that some organic material burned. The March 22nd photo below shows a square opening on the 4th floor (Figure 39). The layout drawing shows 2 MG(Motor-Generator) sets inside where the 4th floor broke. These MG sets control the reactor cooling pumps, and transfer torque using fluid oil. We presume that when the hydrogen exploded, leaked oil caught on fire due to the high temperature in the spent fuel pool.

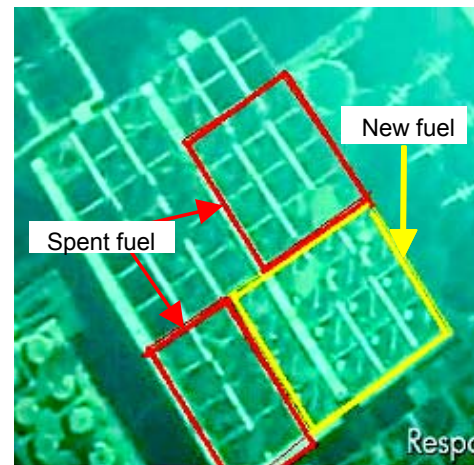
**Figure 42 F4 spent fuel pool (4/29, TEPCO)**

On April 29th, TEPCO showed a photo of the F4 spent fuel pool (Figure 42). It shows that the fuel racks, which separately hold each fuel bundle, were intact. But, we cannot see the upper tie-plates and handles of the spent fuels (marked in red). On the other hand, we can see handles clearly for new fuels (marked in yellow). This photo alone cannot tell if the spent fuel bundles are intact or not, due to fragments of concrete panels atop the spent fuel.

On April 14th, TEPCO reported radio-activity measurements of the F4 spent fuel pool water, and they were quite low. Iodine-131 was 220Bq/cc, Cesium-134 was 88Bq/cc and Cesium-137 was 93Bq/cc. If these measurements are correct, there have almost been no fuel failure with the F4 spent fuel.
