Chernobyl Accident

April 26, 1986 at the Chernobyl nuclear power plant, Pripyat, Ukraine (then part of the Soviet Union)

Masayuki Nakao (Institute of Engineering Innovation, School of Engineering, The University of Tokyo)

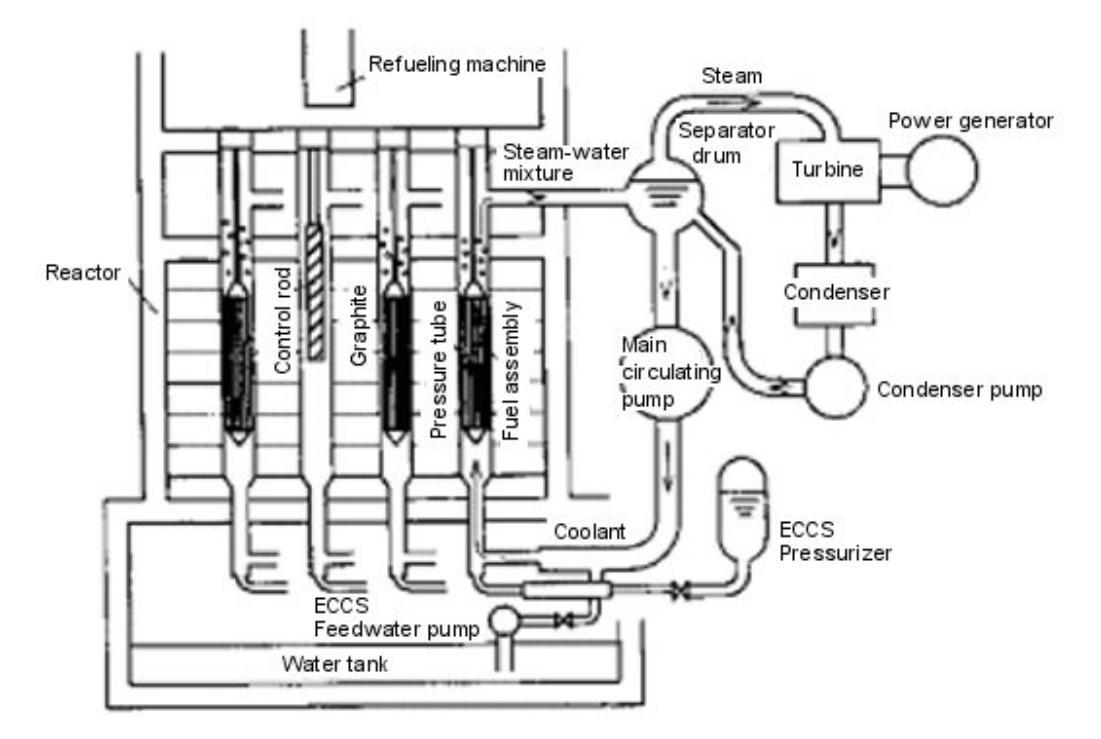
Figure 2. The RBMK Graphite-Moderated Reactor and Heat Cycle [1]

The r eactor at Cher nobyl is a RB MK (*reaktor bolshoy moshchnosti kanalniy*, which means in En glish "reactor of large power of the channel type") r eactor that uses light water for cooling and graphite for moderation. As Figure 2 shows, an RBMK employs long (7 meter) vertical pressure tubes running through graphite moderator. The se 1,693 pressure tubes (80 mm ca liber, 88 mm outside diameter) are made of zirconium alloy and called channels. Fuel is low-enriched uranium oxide made up into fuel assemblies 3.5 meters long. The water pumps inject coolant water (270 degrees C, 70 millibars) into the t ube from its bottom at a r ate of 1.2 m/ sec. The c oolant water, e vaporating partially, r emoves he at from the f uel assemblies as it passes t hrough the core. The steam-water mixture then continues to the large separator drums in which the water settles. The steam proceeds to t he turbines, generating power. Temperature of graphite reaches 600 decrees C during normal operation.

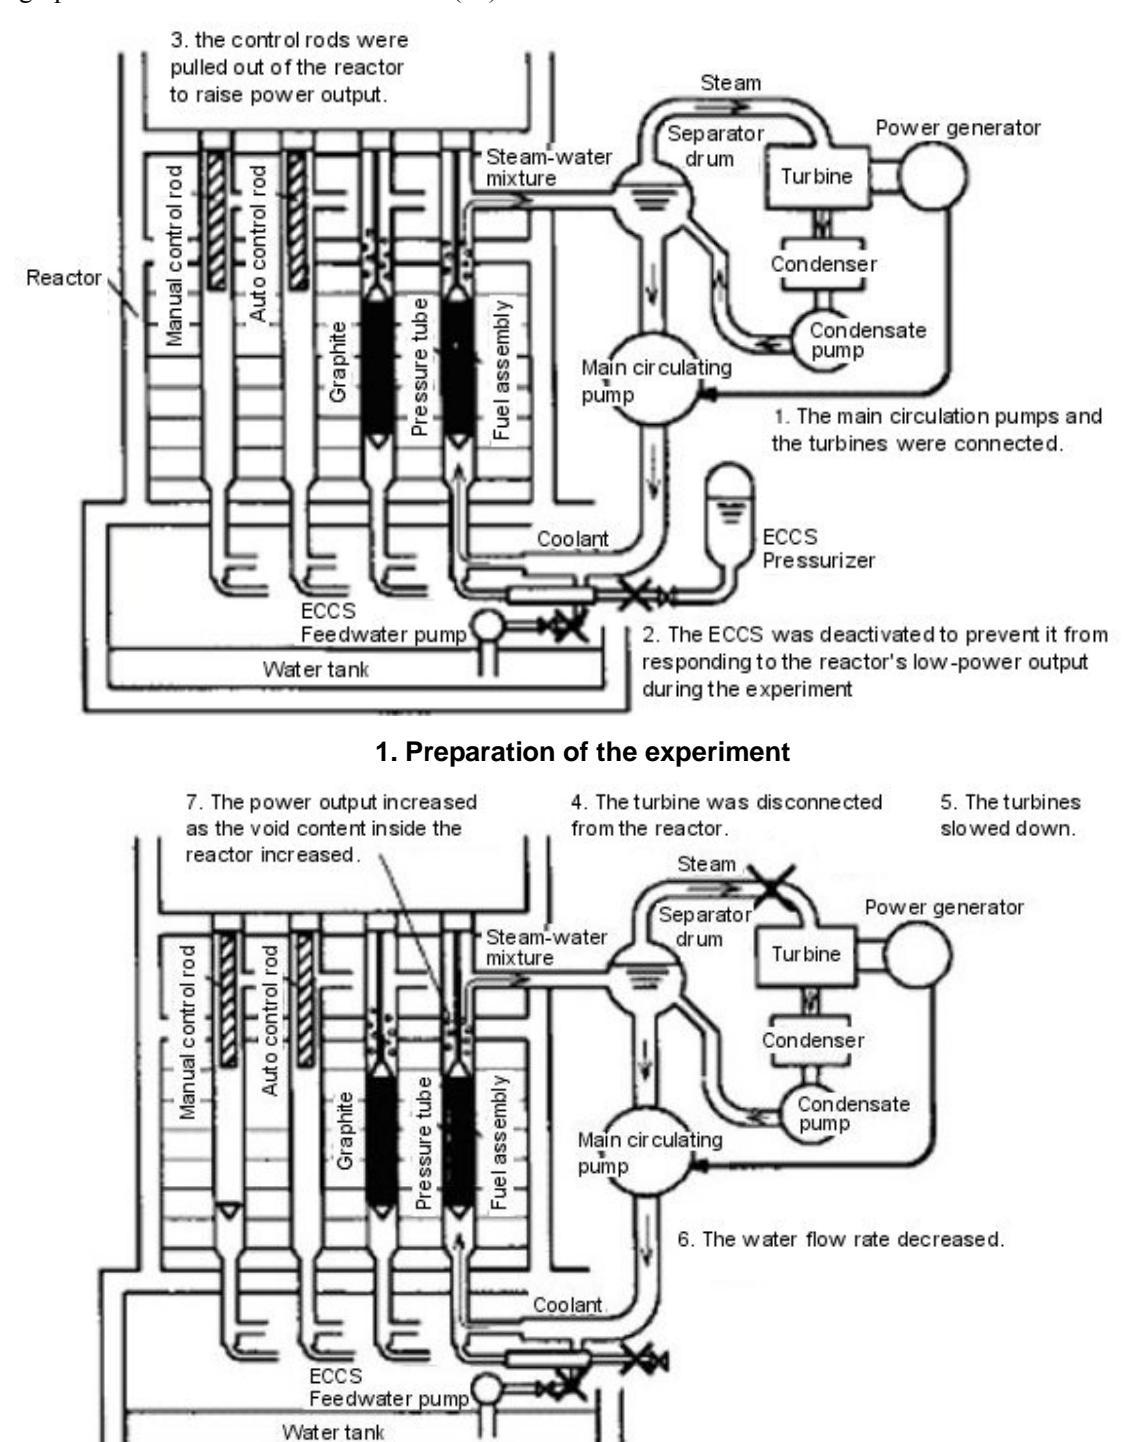
Figure 3. Chernobyl Accident: Sequence of Events 1 [1]

The experiment started after connecting the main circulation pumps and the turbines (1) and dea ctivating ECCS so that it would not respond to the reactor's low-power output during the experiment (2). The reactor operators reduced the power level too rapidly, close to the maximum scale of the power drop allowed by safety regulations. Then, the control rods were pulled out of the reactor somewhat farther than normally allowed by safety regulations to raise the power output (3). Then there was hardly any margin left to safely control the reaction in the reactor. Nevertheless, the operators shutdown the steam supply to the turbine to continue the test(4), and the turbines s lowed down to coast (5). The r ecirculation pu mps that w ere receiving power from the generator then slowed down and the cooling water flow dropped (6). The reactor then gained reactivity and the power started to rise (7). Automatic control rods were inserted in an attempt to lower the power, however, their slow speed failed to suppress the reactivity rise (8). The operat ors further ordered full insertion of emergency control rods (9), however, inserting these rods chased out the cooling water and the first 6 seconds rather boosted the reactivity. Soon a nuclear burst started further raising the fuel temperature and an they ruptured (10). It was only 40 seconds after the experiment had started. Sudden steam generation stopped the coolant water circulation and the fuel temperature reached 3,000 - 4,000 degrees C. By that time the entire core coolant was boiling and the steam pressure rapidly increased (11). The pressure tubes ruptured to let the coolant water to gush out (12) which then came in contact with the graphite moderators and a s team explosion occurred. The explosive force blew off the reactor lid and the upper part of the reactor and the reactor building was destroyed (13). A second explosion threw out fragments of burning fuel and graphite from the core and all owed air to rush in, caus ing the

graphite moderator to burst into flames (14).

2. Experiment started

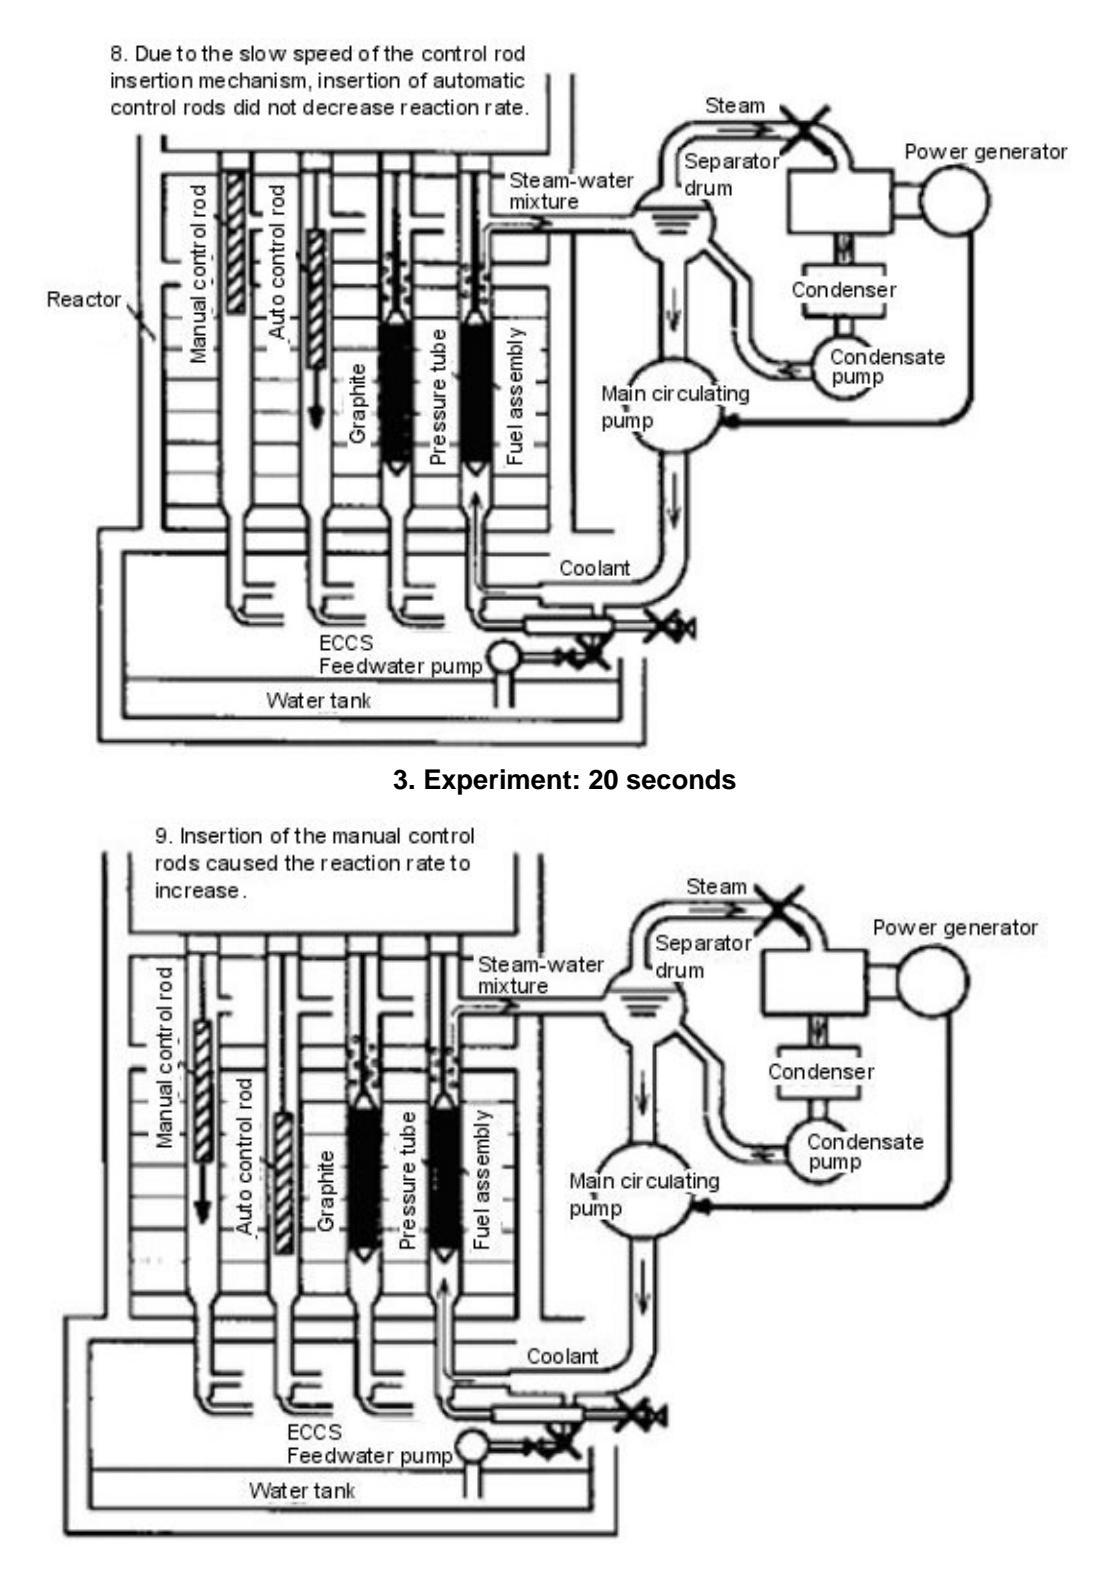
Figure 4. Chernobyl Accident: Sequence of Events 2 [1]

4. Experiment: 36 seconds

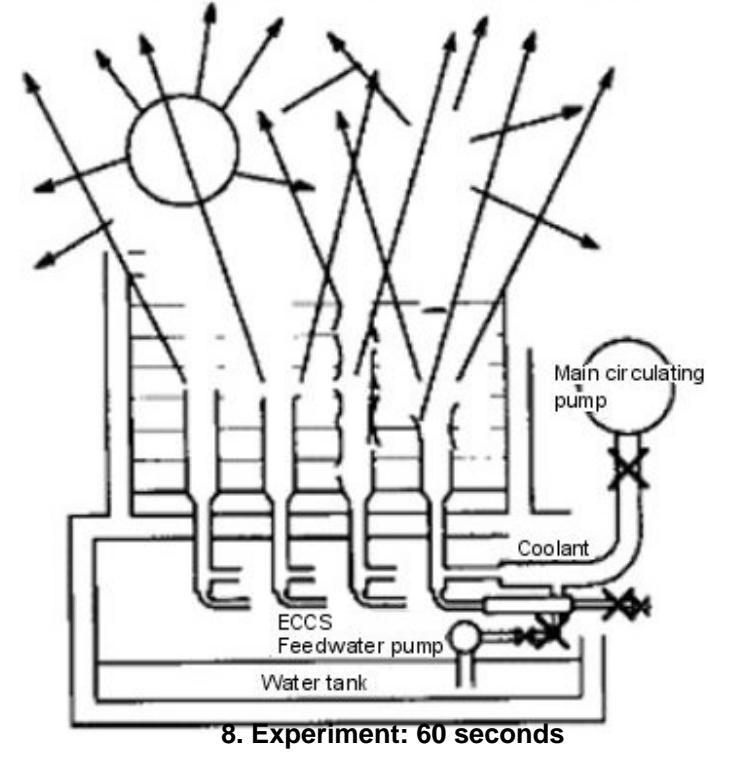
Figure 6. Chernobyl Accident: Sequence of Events 4 [1]

7. Experiment: 44 seconds

14. The second explosion threw out fragments of burning fuel and graphite from the core and sparked a graphite fire.
