## Okushiri Tsunami Generated by Southwest-off Hokkaido Earthquake July 12, 1993 at Okushiri Island off the Hokkaido southwest coast

Masayuki Nakao (Institute of Engineering Innovation, School of Engineering, The University of Tokyo)

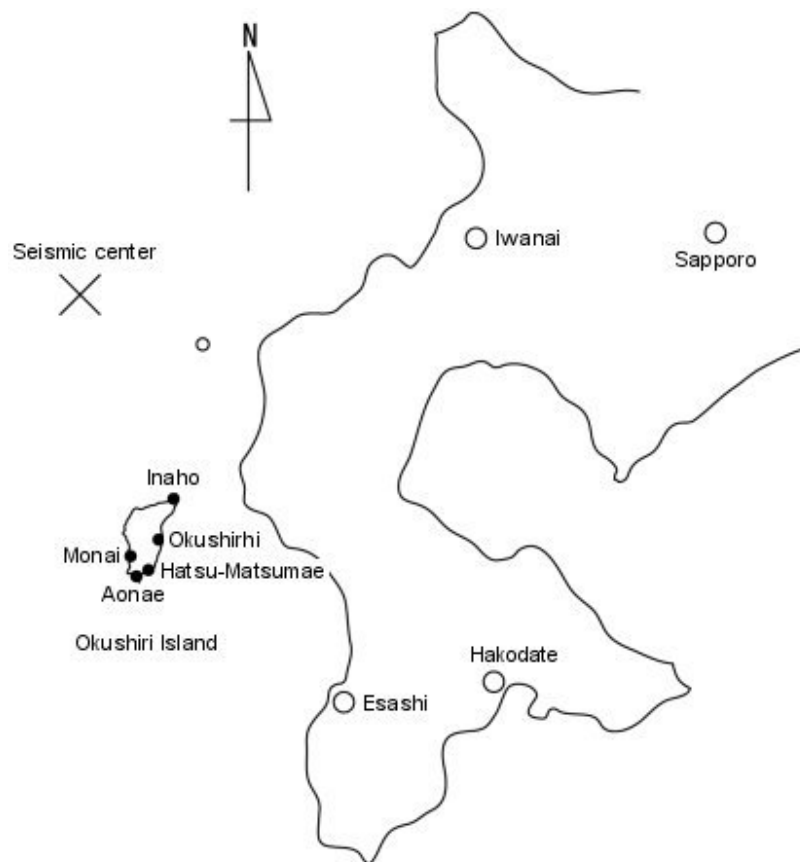
Figure 1. Seismic Center of Southwest-off Hokkaido Earthquake

At 22:17 on July 12, 1993, an earthquake occurred southwest (at latitude 42.47 north and longitude 139.12 east) of Hokkaido in the Sea of Japan. The powerful 7.8 magnitude quake had its epicenter at a depth of about 34 km on the sea floor very close to the Okushiri Island (Figure 1). The island was hit by a tremor measuring 6 on the Richter scale (estimated because the island did not have a seismograph).

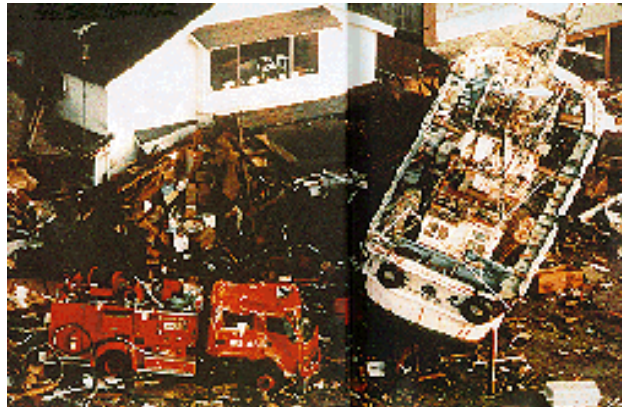
Photo 1. Devastated Aonae Port [1]

Photo 1 shows the devastated fishing port of Aonae, and Photo 2 the landslide in the Okushiri district.

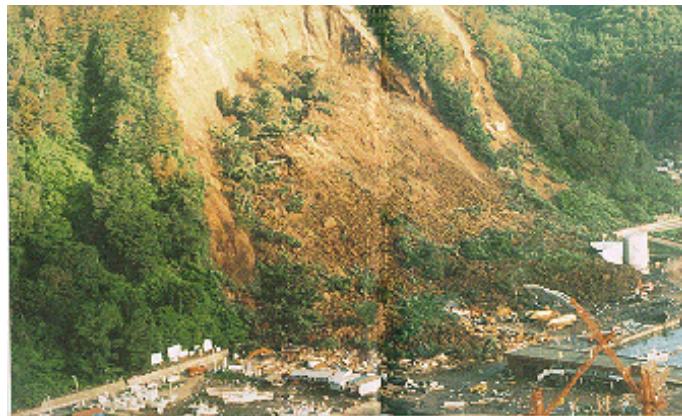
Photo 2. Landslide in Okushiri [1]

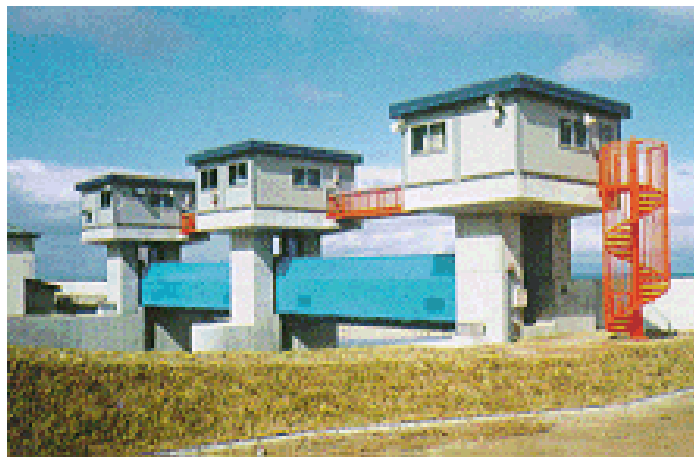
Photo 3. Tsunami Sluice [1]

As the disaster prevention measures, the local government constructed tide embankments, installed two tsunami sluices on a river (the sluice gates shown in Photo 3 automatically close after one-minute emergency broadcasting when a quake of magnitude 5 is detected), and reinforced slopes. For measures that help emergency evacuation, the local government created artificial ground facilities as evacuation and communication routes, distributed a disaster prevention handbook to residents, and supported individual household for purchasing emergency broadcast receiver.
