Explosion of Liquefied Nitrogen Storage Tank by Closing Shutoff Valve for Safety Valve

Aug. 28th, 1992: Ishikari-county, Hokkaido

KOBAYASHI, Hideo (Tokyo Institute of Technology)

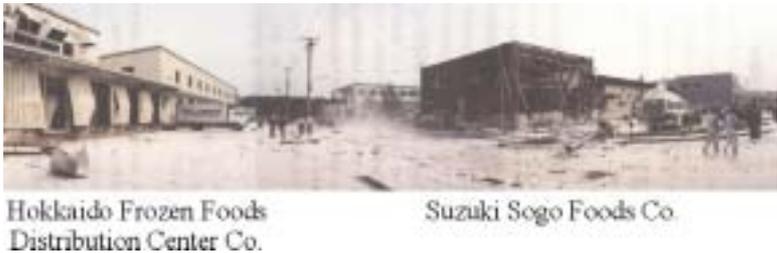
Fig. 2 Appearance of damage (Part 1).

In a food factory located along a national road, a liquefied nitrogen storage tank exploded and dispersed at mid-night, causing the destruction of the upper half of the factory as well as damaging other factories and structures partially, including the outer walls, window glass, and shutters of 25 buildings, 39 parked vehicles consisting of busses, trucks and cars, and electric poles in a circle with radius of 400m (Figure 2~4). The tank was a vertical type, double shell, vacuum insulating vessel (model CE-7500), and it is shown in Figure 1, with its attachments. Exploded circumstances of the inner and outer vessels are shown in Figure 5 and 6, respectively. The piece of the vessel that flew the furthest was the top dish plate of the outer vessel, 1.5m in diameter and 8mm in thickness that reached a distance of 350m. The insulator composed of pearlite scattered over circular area with a radius of 100 m. The appearance of the top dish plate is shown in Figure 7. The direct cost of the damage was estimated to be about 440 million yen.

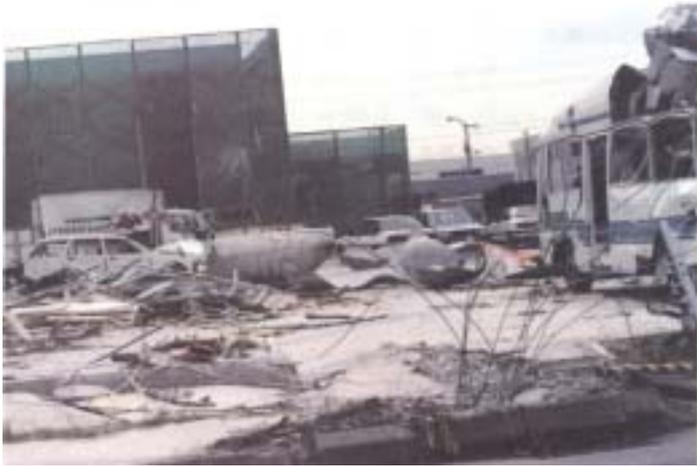
Fig. 4 Appearance of damage (Part 3).
