Capsize of torpedo boat Tomozuru

March 12nd, 1934, Seas near Sasebo port, Nagasaki prefecture

KOBAYASHI, Hideo (Tokyo Institute of Technology)

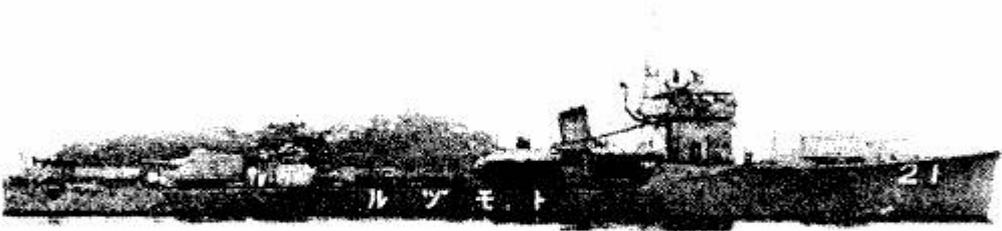
Fig.1 Torpedo Boat Tomozuru.

Tomozuru was the third vessel of the Chidori Class torpedo boats, and she was not yield to the London Naval Treaty. She had three 12.7cm main guns and four torpedo tubes while her total displacement was less than 600 tons and her maximum speed was approximately 30 knots. Her performance was no less than that of a Second Class Destroyer (Fig. 1). Tomozuru was completed on February 24th, 1934 at Maizuru, towed to Sasebo at the end of the month, and joined the 21st torpedo fleet that was organized with her and two other boats of the same type, Chidori and Manazuru. The fleet belonged to the Sasebo Guard squadron whose flagship was light cruiser Tatsuta.

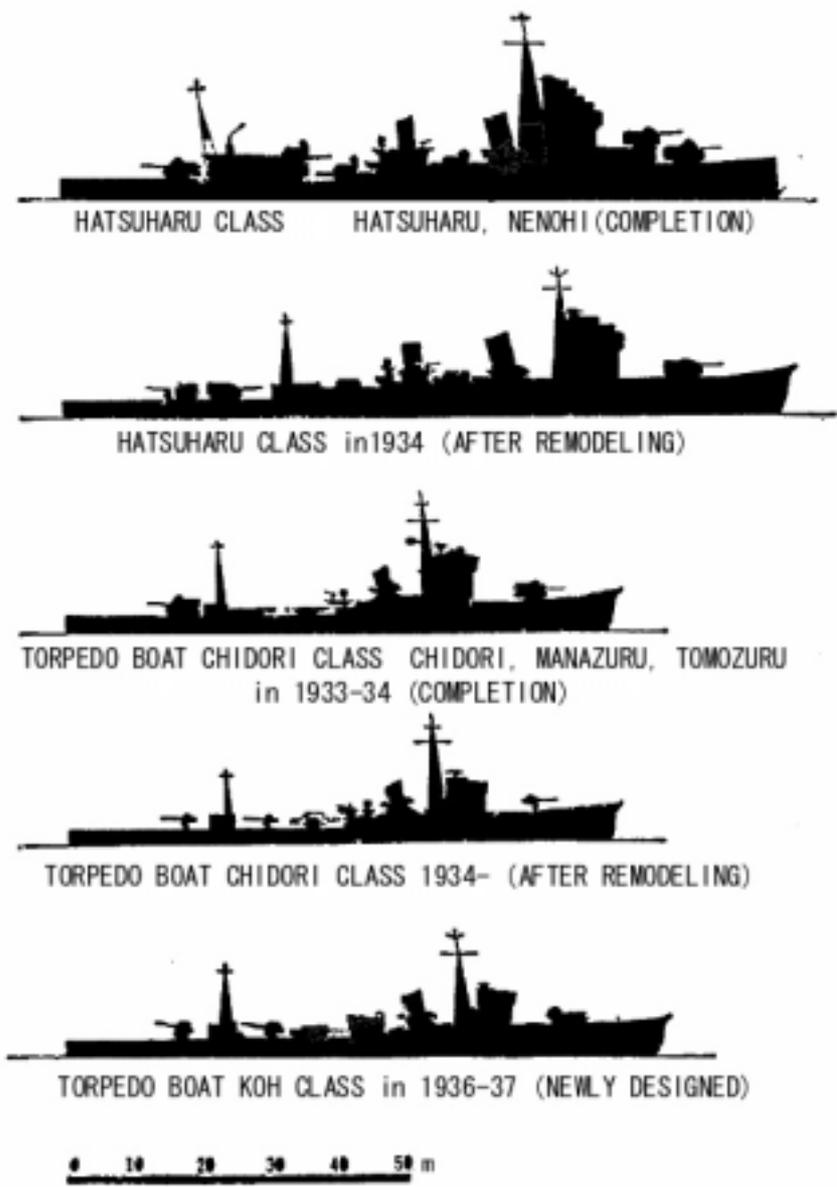
Tomozuru's capsizing forced the Japanese Navy to fundamentally rethink the stability of their vessels. A remodeling plan was made individually for every vessel, and shipbuilders carried out all of the remodeling plans during 1934~35 (Fig. 4). The designs of all of the vessels under construction at that time were reconsidered from scratch.

Fig.4 Change of the Destroyers and Torpedo Boats' shape.
(Before and After Remodeling)

- (1) Unnecessary armaments and equipment were removed. The main armaments in some vessels were removed or downsized.
- (2) Ballast or a ballast keel was put at the bottom of some vessels.
- (3) The width of some vessels was changed, and some vessels were equipped with bulges.
- (4) A seawater ballast tank was equipped on some vessels.

Moreover, bridges or funnels were shortened or downsized.
