Concrete flaking in a Shinkansen tunnel of West Japan Railway Co.

[June 27th, 1999 · October 9th, 1999, Fukuoka Prefecture]

Masahiko KUNISHIMA · Yukihiro ISHIHARA (*Note 1*)

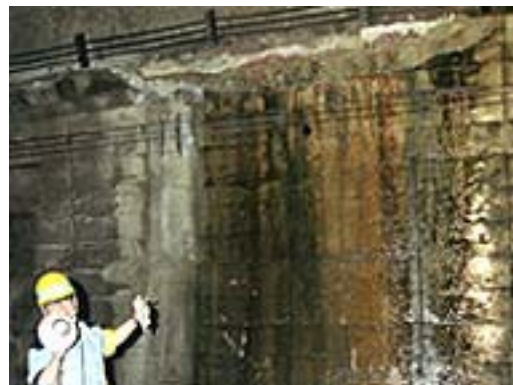
Figure 1. Kitakyushu tunnel flaking site

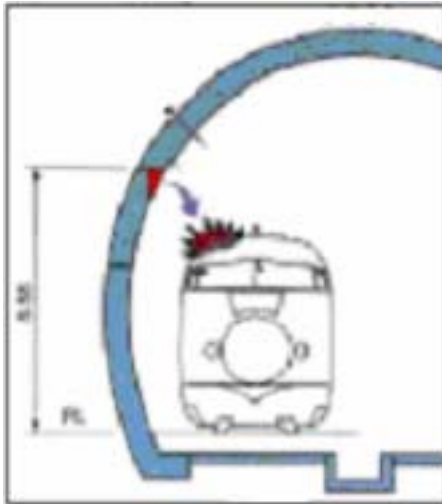
The cause of the Fukuoka tunnel accident was the inconsecutive plane of the concrete, which is called cold joint (CJ). (The figure which shows the outline of the accident is shown in Figure 2.) It is necessary to pour concrete into a form divided into divisions with the restrictions such as lateral pressure of mold, assembly of reinforced steel, temperature rise of mass concrete, technical constraint, and the quantity of the concrete which can be poured in one day, etc.. In this case, the condensation of the concrete poured in advance advances, and a plane of discontinuity occurs between old concrete and new concrete. Throughout construction, curing, and use, the crack was generated in the inside of the CJ, and it developed, and it seemed to cause the flaking.

Figure 2. The outline of Fukuoka tunnel accident
(Source: Nikkei construction)

when the material shortage happened, in addition to a manpower shortage because of the construction rush. It was not strange even if the work accuracy was made little of. This brought about execution defect like CJ, which became a cause of the Fukuoka tunnel accident.

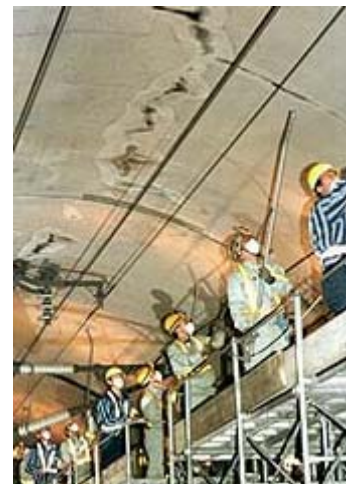
Figure 4. Hammering test
(Source: Chugoku newspaper)

were canceled or partly canceled, the last train was run at an earlier time, and the work time of the same section was extended by about one hour. Since the whole line opening (March, 1975), there was a complete inspection involving a suspension of operations for the first time. The photograph of Figure 4. shows the aspect

of the hammering test which was opened on November 13th to public by West Japan Railway Co. which did the whole inspection because of the accident of the Kitakyushu tunnel.

The accident on June 27th resulted from a cold joint (CJ), which West Japan Railway Co. did not make to be one of check items then. West Japan Railway Co. checked CJ of all 142 tunnels of Sanyo Shinkansen line (they extended for about 280km.) by carrying out a hammering test. CJ was found at no less than 2049 places in 93 tunnels. It carried out temporary measures such as removal of the bad part by hitting, and the safety announcement was made in August after the check.

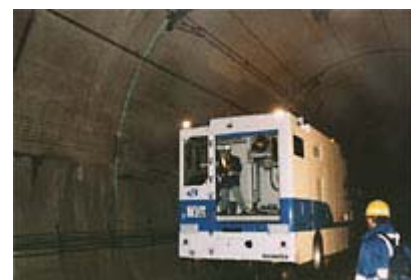
By irradiating lining surface with laser and detecting intensity of the reflected light, the system can measure the crack. This is a system which is a remarkable improvement of speed and precision of measurement over those currently in use, and it aims at automated inspection in the future, and possesses the function of automatic detection of the crack (Figure 5.).

Figure 5. Inspection by SATUZO
(Source: West Japan Railway Co)
