The Hanshin Awaji Great Earthquake (Hyogo Prefecture Southward Earthquake)
[On 17th January in 1995, Hanshin and Awaji district]

Masahiko Kunishima, Mariko Abe (Note¹)

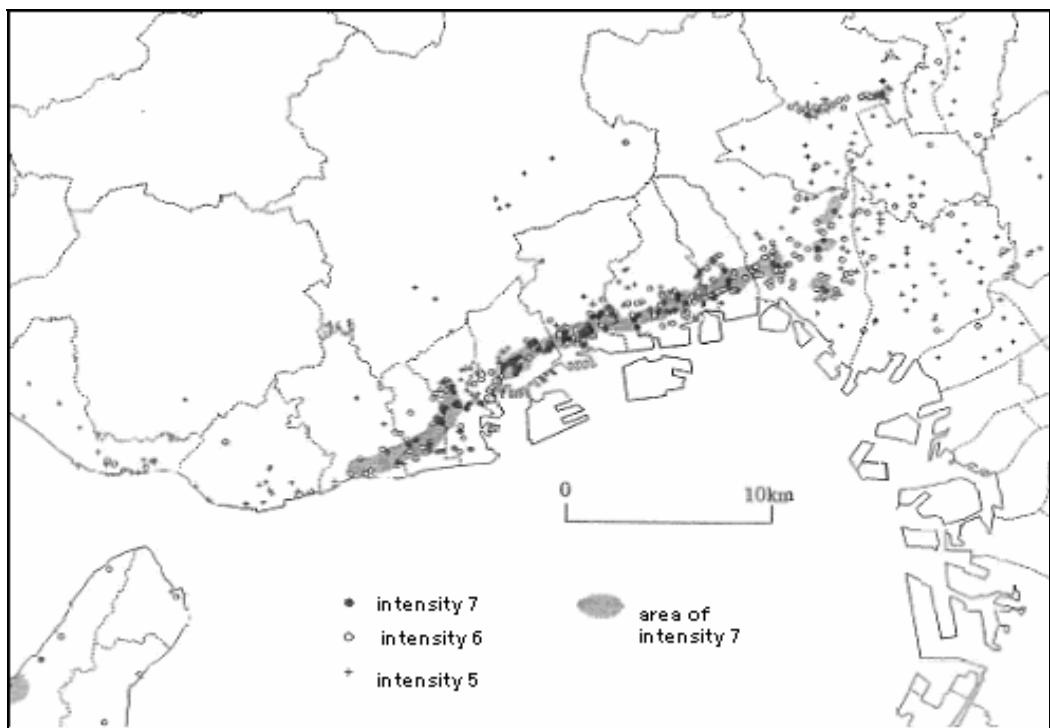
Figure 1 "The band of the earthquake disaster" in Hanshin district
(From the field study of Meteorological Agency) (Source: Architectural Institute of Japan)

At 5:46 on 17th January 1995, the M7.3 earthquake whose hypocenter was below Akashi Channel occurred. The quaking motion due to this earthquake was observed from the southern Tohoku area in the north to southern Kyushu in the south, and the seismic intensity of 7 was applied for the first time near the hypocenter. A region of seismic intensity 7, which was 1km in width and 20km in length and called the "band of the earthquake disaster", appeared from Kobe City to Nishinomiya City.

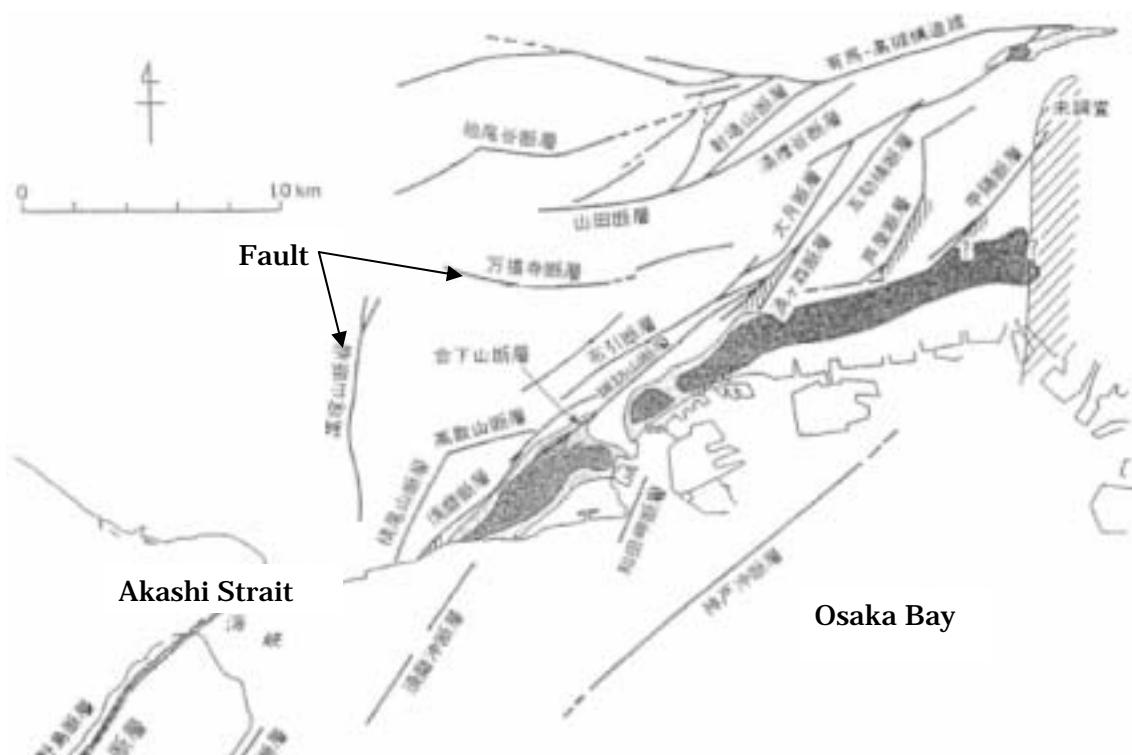
Figure 2 Fault distribution chart of Hanshin district (Source: Architectural Institute of Japan)

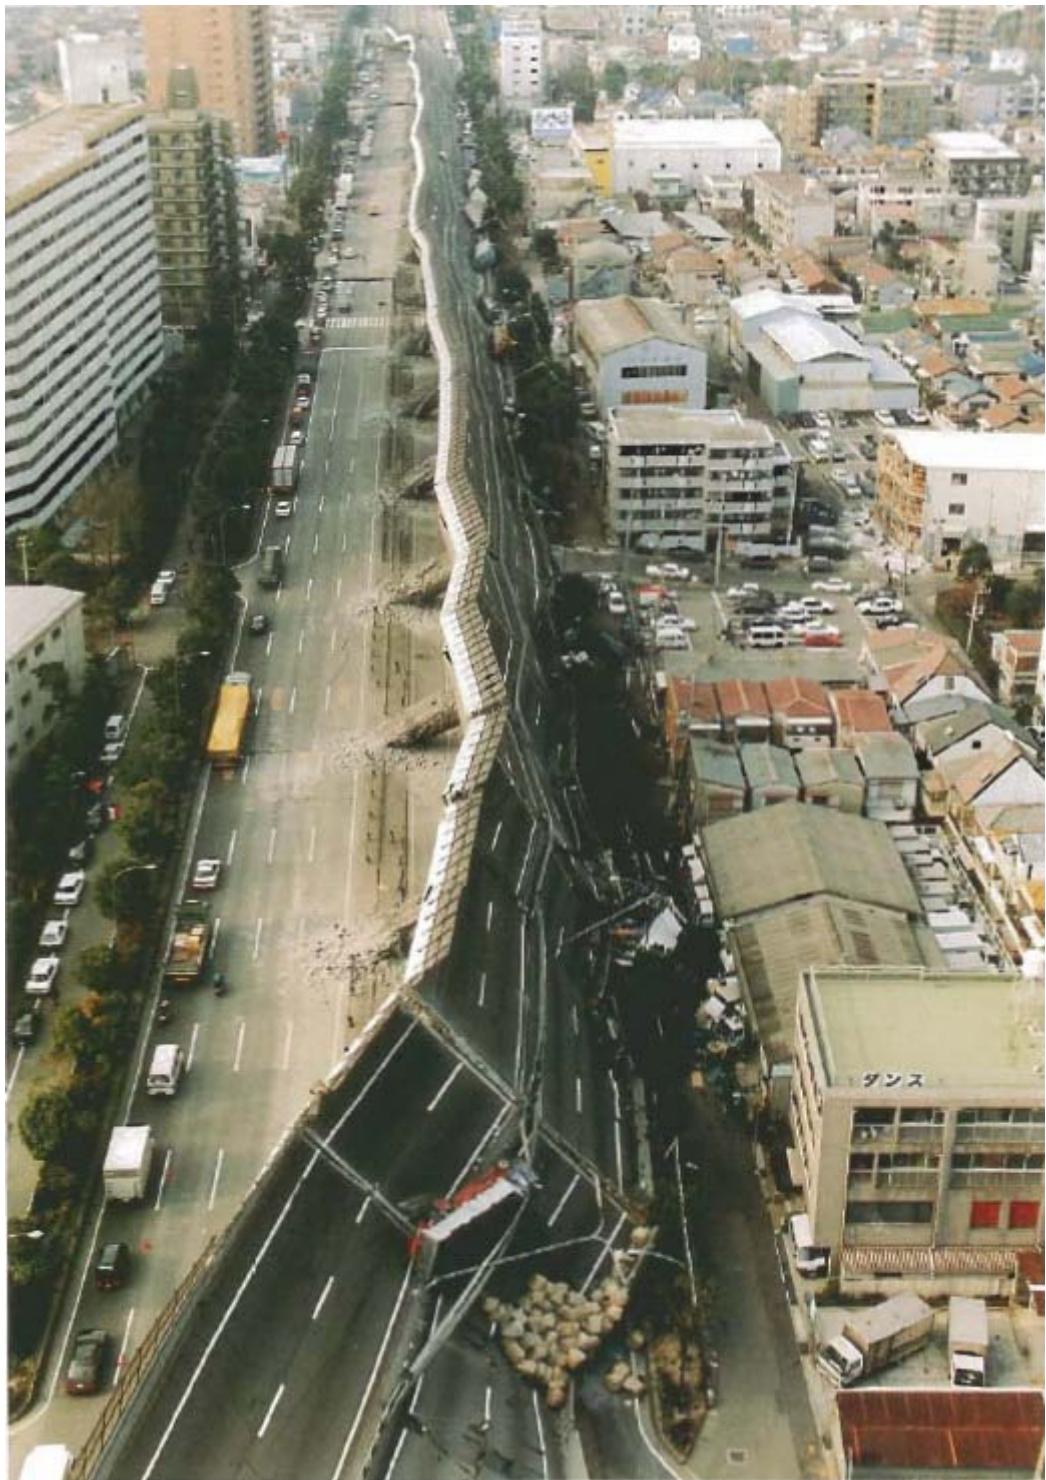
Figure 3 Collapse of the Pilz elevated bridge of Hanshin Expressway Kobe Line

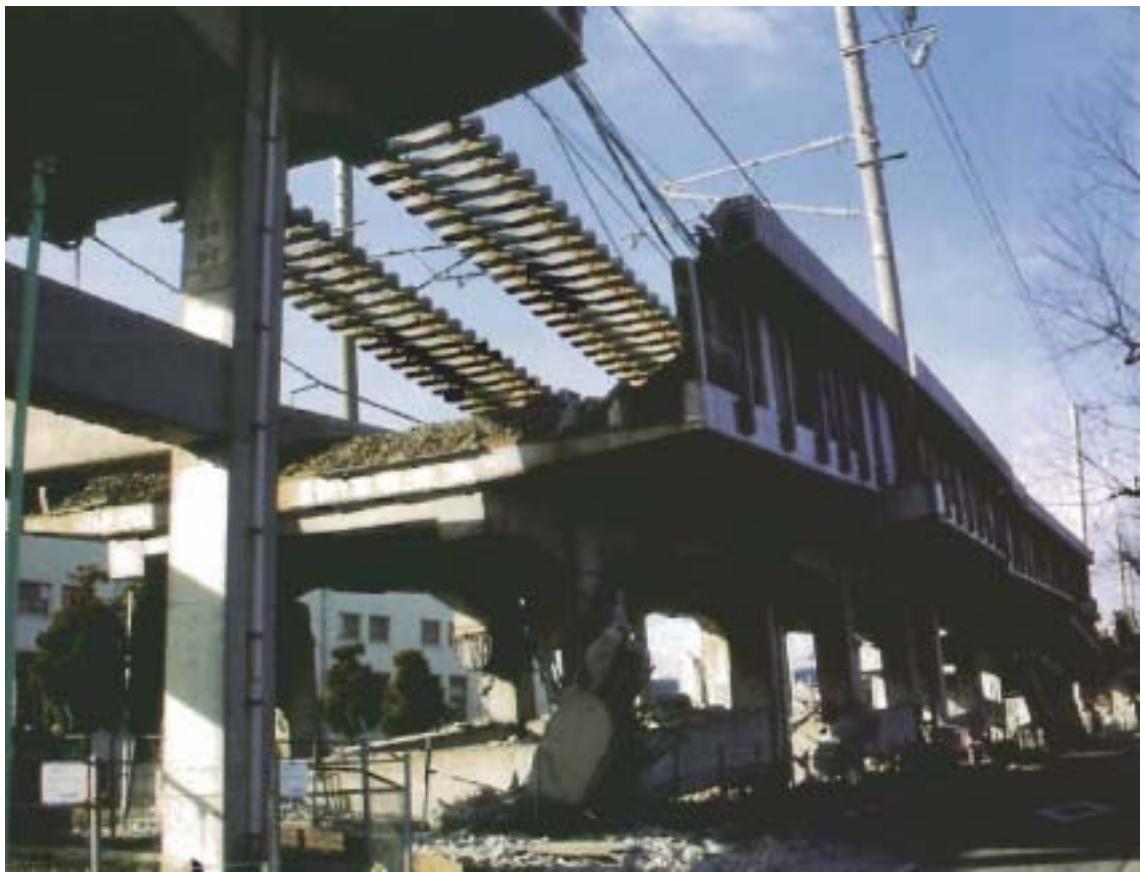
Figure 4 Collapse of the Hansui elevated bridge of the Sanyo Shinkansen

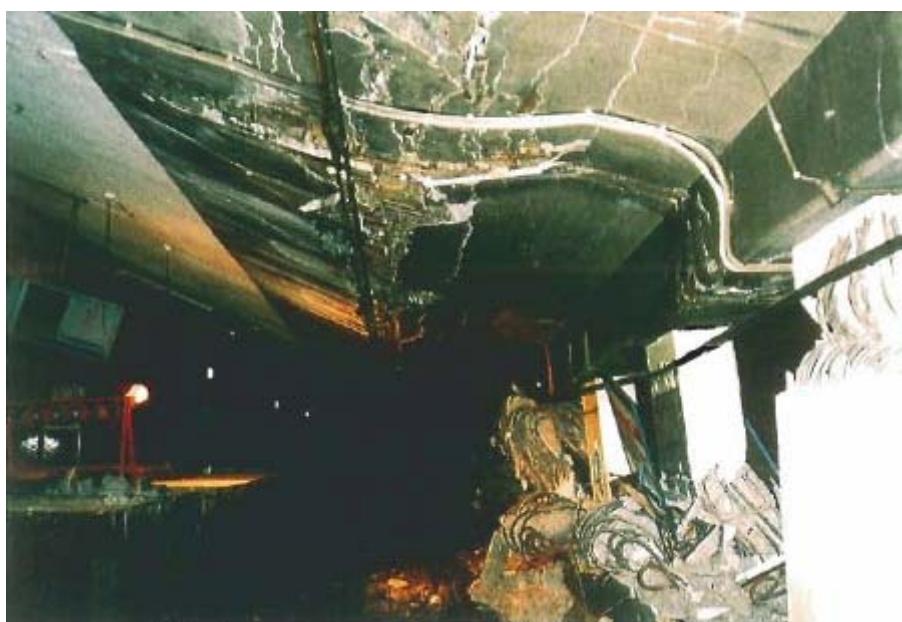
Figure 5 Crushing of the central pillar of Daikai Station of Kobe Express Railway and collapse of the upper floor panel (Source: Architectural Institute of Japan, Picture: Prof. Iwadate)

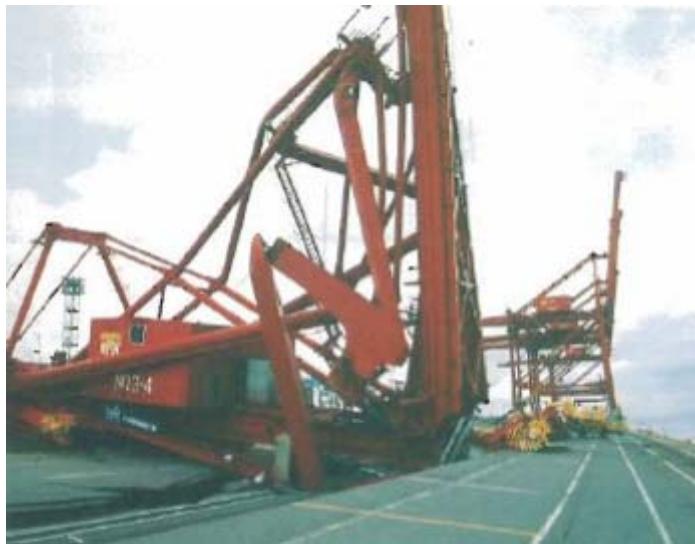
**Figure 6: Collapse of the RC3-4 crane at Rokko Island
(Only one crane totally collapsed.)** (Source: Japan Society of Civil Engineers)

Early in the morning on 17th January 1995, a M7.3 earthquake whose hypocenter was below Akashi Channel occurred and brought great damage to the Hanshin Awaji district. Over 6,400 people died and over 41,500 people were injured, and the monetary amount of the damage is estimated to have been over 9.6 trillion yen. Especially, in the region that is called the "band of the earthquake disaster" (→Figure 1, 2) located on the alluvial plain of the base of Mt. Rokkosan where a seismic intensity of 7 was registered, many old wooden houses with tiled roofs fell down, and many people who were buried under the houses died. The bridge with single pillars of Hanshin Expressway collapsed over a length of 630m (→Figure 3), and the viaduct bridges made of RC rigid frame of the Shinkansen also collapsed (→Figure 4). Part of the structure of the subway was destroyed for the first time in the world (→Figure 5). In the reclaimed land of "Port Island", the cranes in the harbor dipped due to the liquefaction of the ground (→Figure 6).
