## The debris flow in Kanbarasawa

**[December 6<sup>th</sup>, 1996, Otani village, Kitaazumi district, Nagano prefecture]**

**Kunishima Masahiko · Hasegwa Tomoaki (note1)**

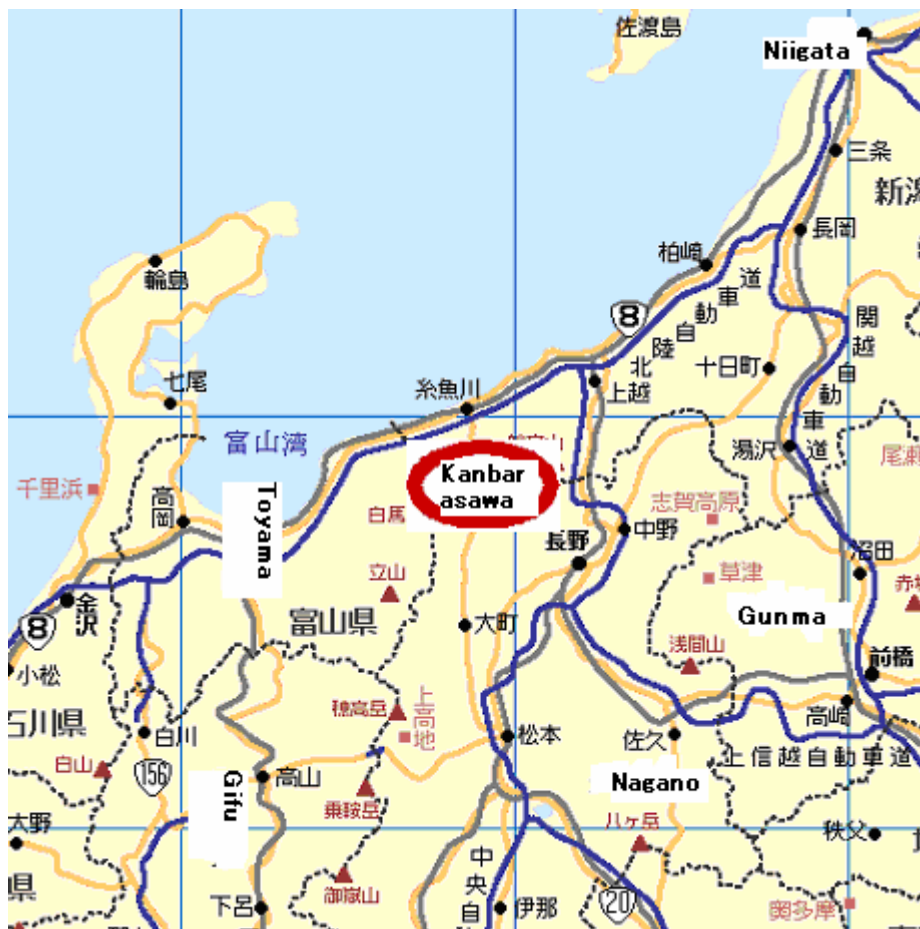
Figure1 The position of Kanbarasawa

The large-scale debris flow arose in Kanbarasawa, Otani village, Nagano Prefecture at around 10:40 a.m. on December 6th, 1996. The destruction at an altitude of around 1300m became a trigger for this debris flow, and it flowed over five waves (or eight waves (when small waves are included)). one of two valley closing constructions which did not have deposited silt right after the concrete cast was completely destroyed and the other was half destroyed by the first wave which was the biggest. After the debris flow passed the 2 check dams downstream with no deposited silt, the check dam under construction and the watercourse construction, it reached the Himekawa River. This debris flow hit the construction sites of disaster related project etc, which Ministry of Construction (now Ministry of Land, Infrastructure and Transport), Forestry Agency and Nagano Prefecture ordered. In this disaster, there were fourteen fatalities, and nine people were injured. The position of Kanbarasawa in Honshu is shown in Figure 1.

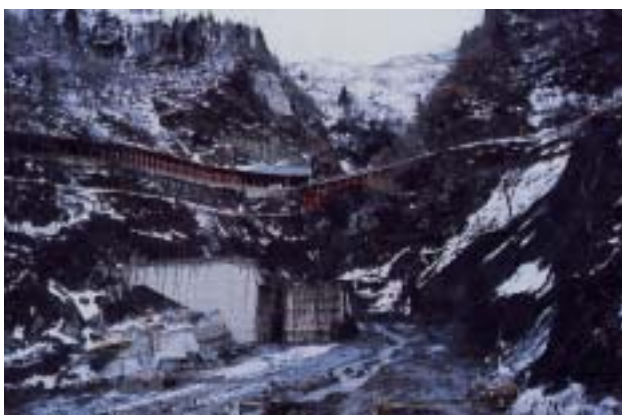
The debris flow arose from the landslide on the right side slope near the 1300m altitude. The 39000m<sup>3</sup> gravel which was destroyed in the upper section destroyed the valley closing constructions of afforestation (one was completely destroyed, one was half destroyed) and it got over 2 check dams, and it became the debris flow which were over 5 waves (or 8 waves (when small waves are included)), and attacked the lower section. It is said that the first wave was a scale of 3m height and 9.1m speed per second. Figure 3 is a photograph of the destruction field.

The primary causes which the debris flow arose are divided into landform condition and geotechnical condition. As a landform condition, the reason was "the extension destruction" (that more and more large-scale destruction occurs as a trigger of the former destruction which occurred

previously) of the slope which became unstable because of the destruction which occurred on July 11<sup>th</sup>, 1995 and that the landslide was the erosion front, the steep slope. As a geotechnical condition, the Kanbarasawa watershed is located in the western edge of Fossa Magna (right on the upper Itoigawa-Shizuoka tectonic line). It is a boundary between weak nature of andesite lava and strong sandstone bed. As a trigger, there was the fact that snowfall and snowmelt flowed and were supplied to the landslide as underground water through the boundary between weak nature of andesite lava in which the water permeability is high and strong sand bed in which the water permeability is low.
