An accident of the fall of the Toki Messe sky bridge

【At about 20:20, August 26th, 2003

Toki messe in Bandaijima, Niigata City, Niigata Prefecture】

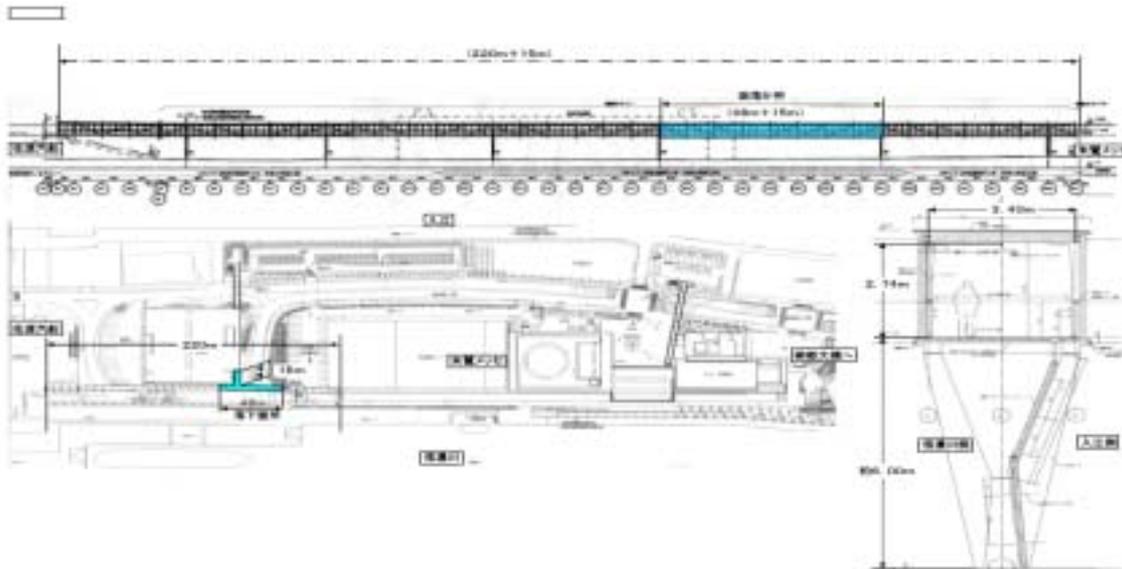
Figure-1 The plan of the fallen place (Source: HP of Room of re-developing Bandai island, Ports and Harbors Bureau promotion section of Niigata Prefecture.)

The Toki Messe opened May 1st, 2003, but only 5 months later, at 20:20 on August 26th, 2003, the sky bridge in the Toki Messe suddenly fell down at a part of the sky bridge between Niigata Convention Center and the multilevel car-parking tower (48m) and at a connection part of the multilevel car-parking tower (15m). The Toki Messe sky bridge connecting Toki Messe and Sado Steamer is 220m. The safety of people was confirmed by using 160t crane about 2 hours after the accident and no one got injured or died in this accident. On November 10th, the governor of Niigata Prefecture decided to pay ¥143,900,000 for running repairs (including the clearance of the accident scene and the installation of the timbering). ¥68,400,000 was added to the cost of recovery by the revised budget in September. The total cost of the measurement became ¥212,300,000. The contract cost of the place was ¥340,345,000. Niigata Prefecture (the owner) required compensation for damage of ¥894,550,000 (total cost) from the traders who undertook design and construction. The first oral pleading was carried out in the Niigata district court on November 26th, 2004.

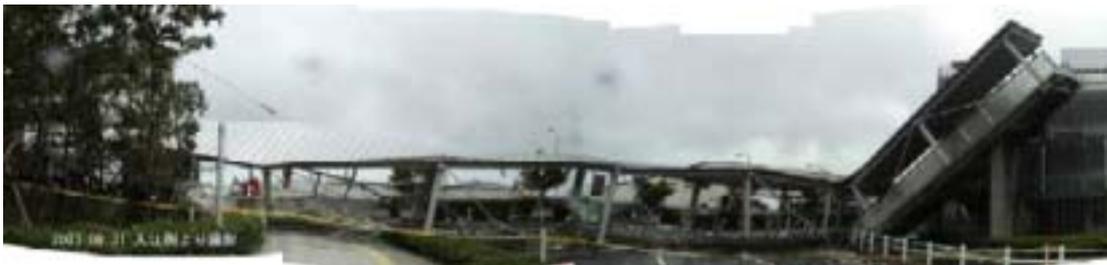
Picture-1 The field right after the accident (Source: HP of Room of re-developing Bandai island, Ports and Harbors Bureau promotion section of Niigata Prefecture.)

At 20:20 on August 26th, 2003, there was a phone call from Sado Kisen Co. to Bandaijima Redevelopment Office, Development Division, Bureau of Port and Airport Development, Niigata Prefectural Government. The information was that there was a part of the sky bridge between Niigata Convention Center and the multilevel car-parking tower had collapsed. No one got injured or died in this accident.

- 1) The failure of the fixing concrete of the diagonal rod.
- 2) The failure or buckling of the chord on the steel frame.
- 3) The flexure fracture of the PC floorboards or the failure of the line of PC steel for pressure bonding.

In addition, according to the structure analysis, if the construction is carried out rightly, it is concluded that the sky bridge would not fall only because of its weight. Therefore, it is not too much to say that the falling accident was brought about by the damage which was made by the first jacking down during the construction. It was estimated that excessive bending cracks were generated near the diagonal rods of PCa floor slab by the effect of large bending stress of the lower chord material PCa (precast concrete), which was generated in 2000(the first jacking down) and in 2002(completion). As the result, this crack developed over time. It is natural to think the falling was caused by the decrease of the effective shear area of concrete in the anchorage zone.

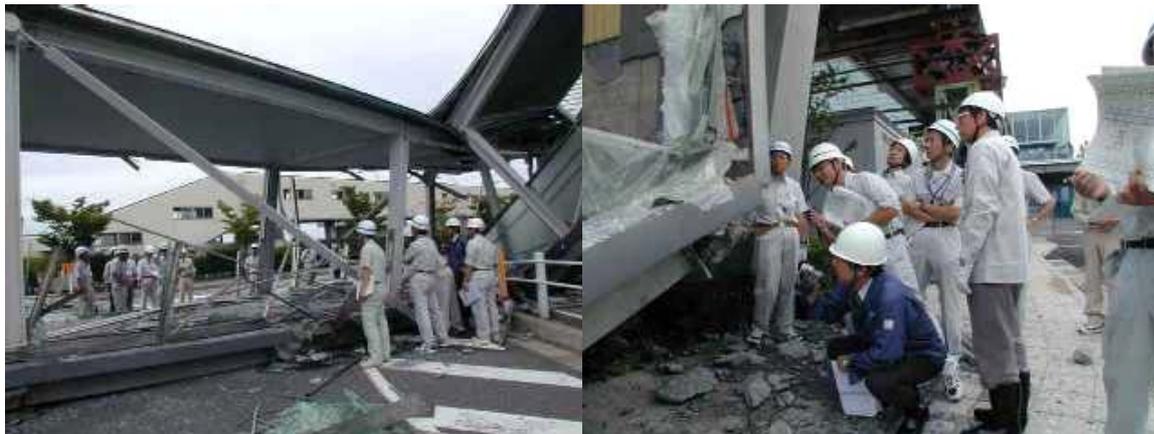
Picture-2 The situation investigation by investigation team (Source: HP of Room of re-developing Bandai island, Ports and Harbors Bureau promotion section of Niigata Prefecture.)

” The Accident Investigation Task • Force” Japan Structural Consultants Association (J S C A) which originally installed was not accepted the request of the accident investigation by Nigata Prefecture, could not get a little information, and could not investigate the condition right after the accident because ” The Toki Messe sky bridge Accident Investigation Group” and “The Toki Messe sky bridge Accident Investigation Committee (Picture-2) ” installed.
