Fukushima Accident Summary(4)

2011-August-02, Ritsuo Yoshioka

3.4 Fukushima-4 Reactor

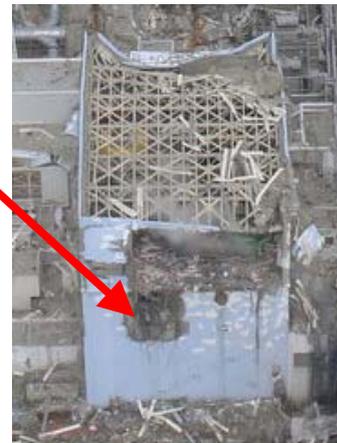
A fire means that some organic material burned. The March 20th photo below shows a square opening on the 4th floor.

The layout drawing shows 2 MG (Motor-Generator) sets inside where the 4th floor broke. These MG sets control the reactor cooling pumps, and transfer torque using fluid oil. We presume that when the hydrogen exploded, leaked oil may have caught on fire due to the high temperature in the spent fuel pool.

Figure Photo of F4 on March 20th.

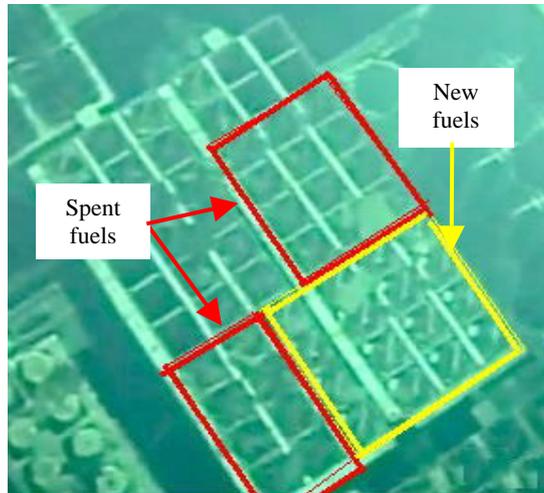
On April 29th, TEPCO showed a photo of the F4 spent fuel pool. It shows that the fuel racks, which separately hold each fuel bundle, were intact. But, we can not see the upper tie-plates and handles of the spent fuels (marked in red). On the other hand, we can see handles clearly for new fuels (marked in yellow). This photo alone cannot tell if the spent fuel bundles are intact or not due to fragments of concrete panels atop the spent fuel.

Figure. F4 spent fuel pool on April 29th
