Brittle Fracture of Turbine Rotor in Nagasaki **October 24, 1970 in Nagasaki-shi, Nagasaki**

Masayuki Nakao (Institute of Engineering Innovation, School of Engineering, the University of Tokyo)

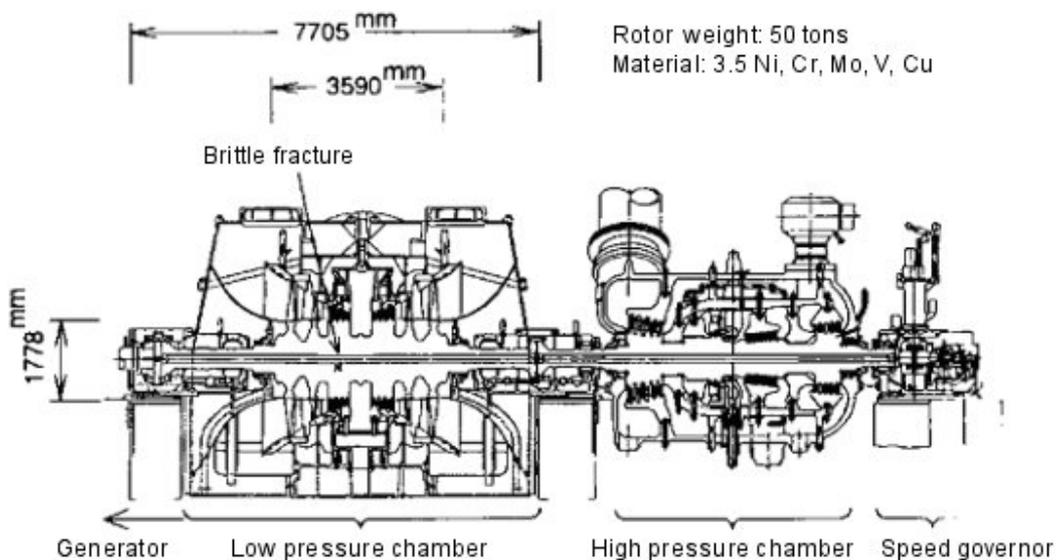
Figure 1. Schematic Diagram of 330,000-Kilowatt Unit [1]

While a traditional turbine had four shafts in three chambers, high pressure with single-shaft, intermediate pressure with single-shaft and low pressure with double-shaft; the new turbine reduced the number of shafts into three, one for the high-intermediate pressure chambers and two in the low pressure chamber as shown in Figure 1.
