Train Fire at Sakuragi-cho

April 24, 1951 at the Sakuragi-cho Station on the Keihin-Tohoku line

Masayuki Nakao (Institute of Engineering Innovation, School of Engineering, The University of Tokyo)

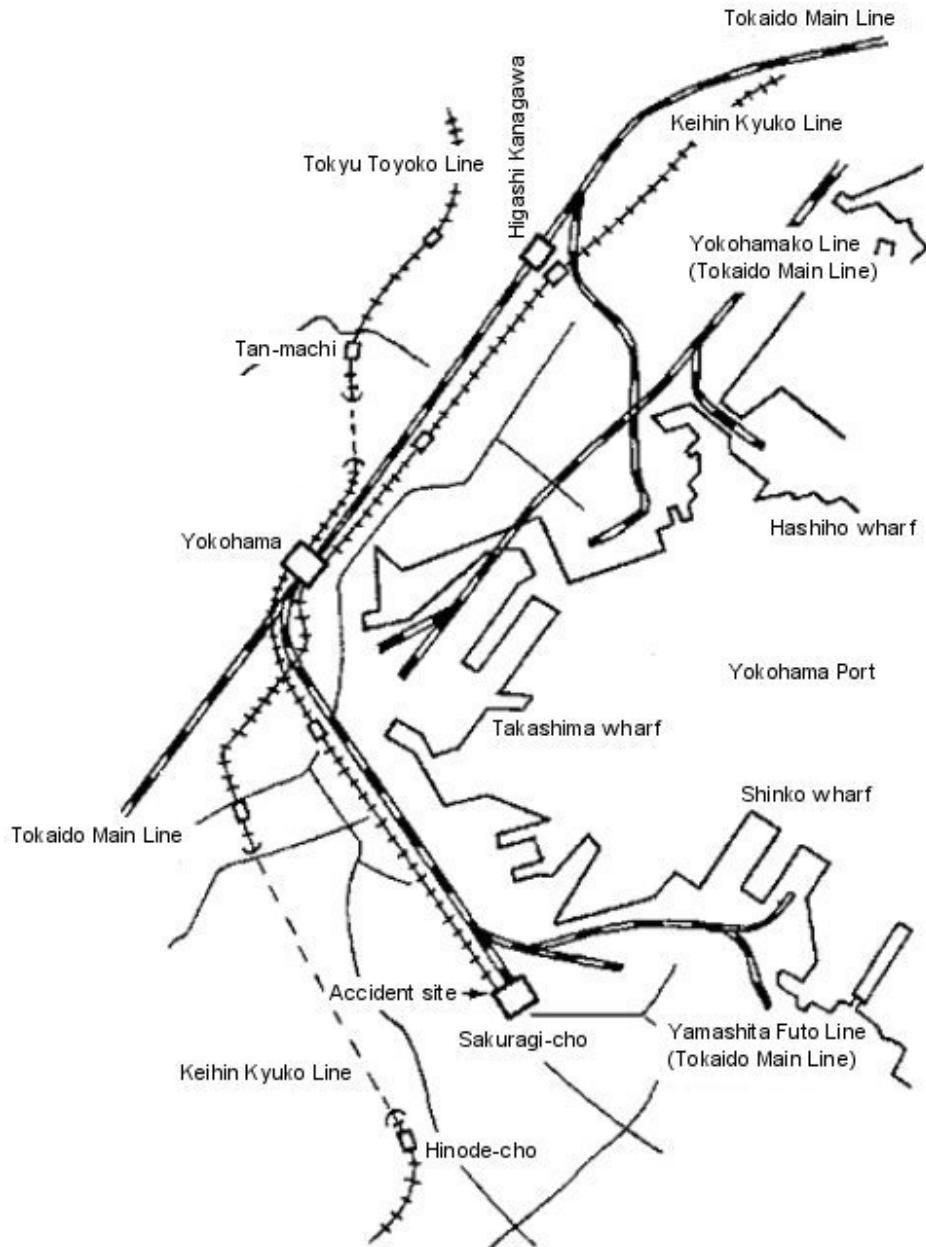
Figure 1. Old Sakuragi-cho Map [2]

Figure 1 shows the map of Sakuragi-cho at the time. Construction crew was replacing insulators of overhead wires at the Sakuragi-cho Station. Around 13:38, one of the construction crew hit the beam with his/her spanner wrench by mistake, cutting a hanging wire at the circulatory shunt. As the result, the contact wire for the inbound line hung down. (Hanging wires support electrical wires. The train's pantograph makes contacts with the contact wire.)
