Train Fire in Hokuriku Tunnel **November 6, 1972 in the Hokuriku Tunnel**

Masayuki Nakao (Institute of Engineering Innovation, School of Engineering, The University of Tokyo)

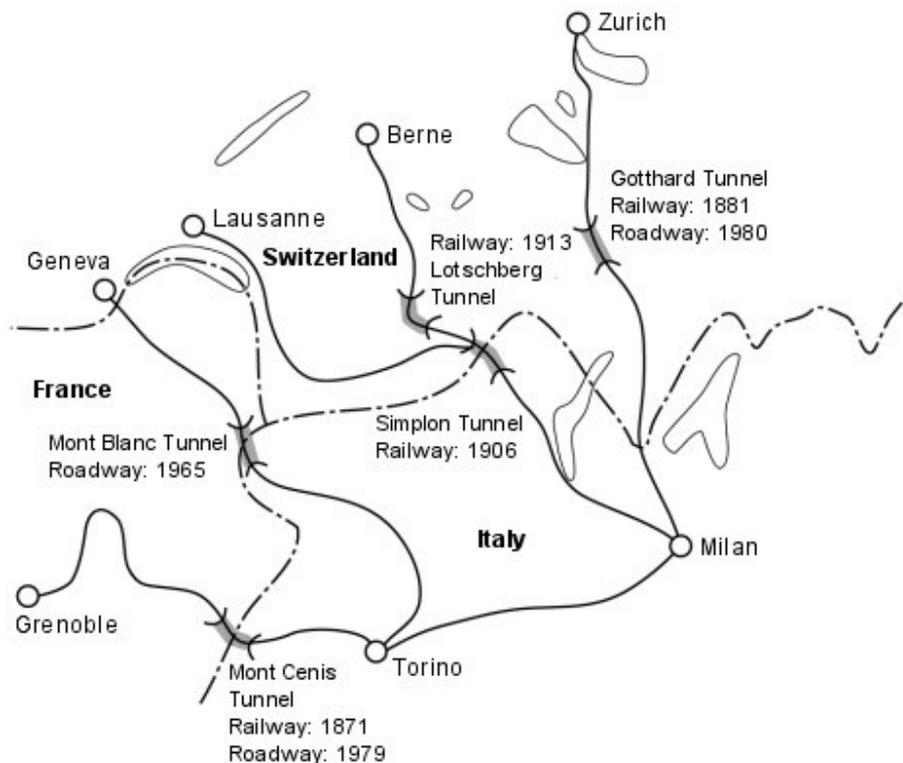
Figure 3. 10 km or Longer Tunnels in the Alps (Road/Rail and the Opened Year)

Due to the difference in atmospheric pressure, many tunnels have air draft from one exit to the other. A fire in such tunnels induces a chimney effect, multiplying the force of the fire. The long road tunnels in the Alps are equipped with air forced ventilation systems that feed and exhaust air forcefully from the exits to reduce air draft. A malfunction in the ventilation system or an operational error will fail to stop the quick spread of fire, as was seen in the 1999 fire in the Mont Blanc Tunnel. In this 1999 fire, while the French company operating the tunnel maximized the air exhaust power immediately after a transport truck caught fire in the tunnel, the Italian company maximized the air feed power for 20 minutes. As the result, 30 vehicles were burned in the accident (Figure 3).
