Explosion of the Space Shuttle Challenger

[January 28, 1986, USA]

by Masayuki Nakao

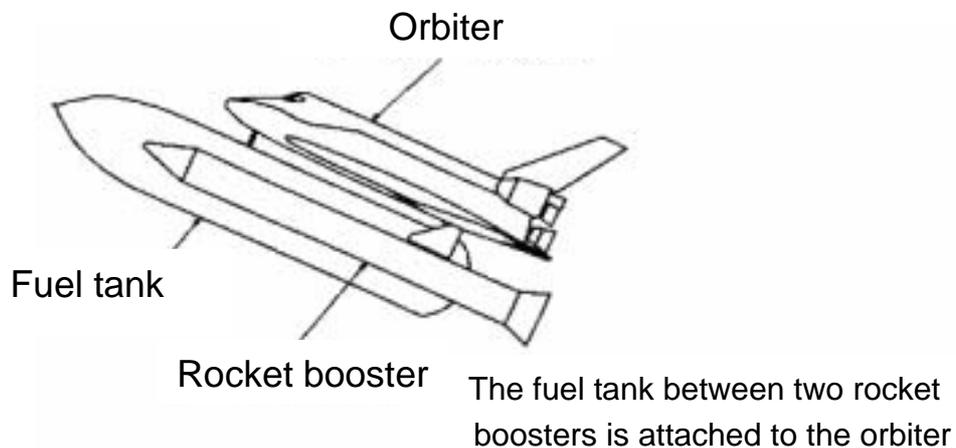
Fig. 1 Overview of the space shuttle [2]

On January 28, 1986, the space shuttle Challenger developed flame on the side of the Solid Rocket Booster shown in Fig. 1 (Photo 1, arrowed) immediately after the launch, and exploded soon after.
