Chernobyl Accident

April 26, 1986 at the Chernobyl nuclear power plant, Pripyat, Ukraine (then part of the Soviet Union)

Masayuki Nakao (Institute of Engineering Innovation, School of Engineering, The University of Tokyo)

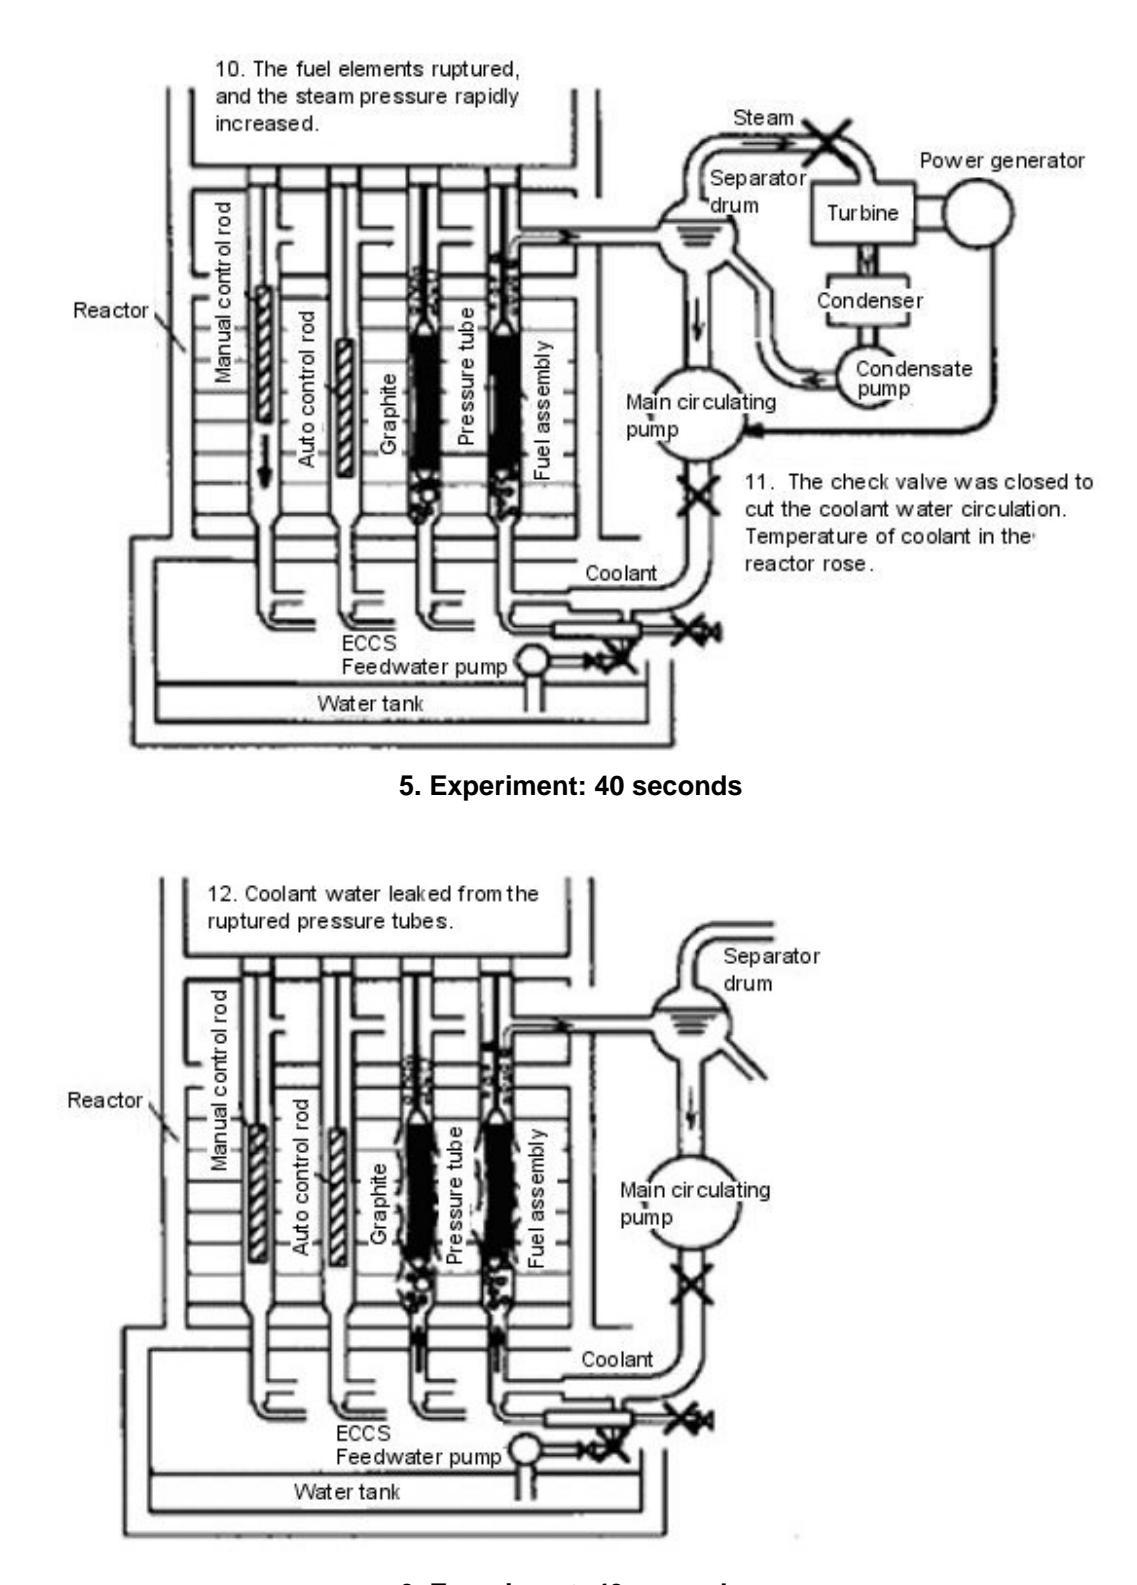
Figure 4. Chernobyl Accident: Sequence of Events 2 [1]

4. Experiment: 36 seconds

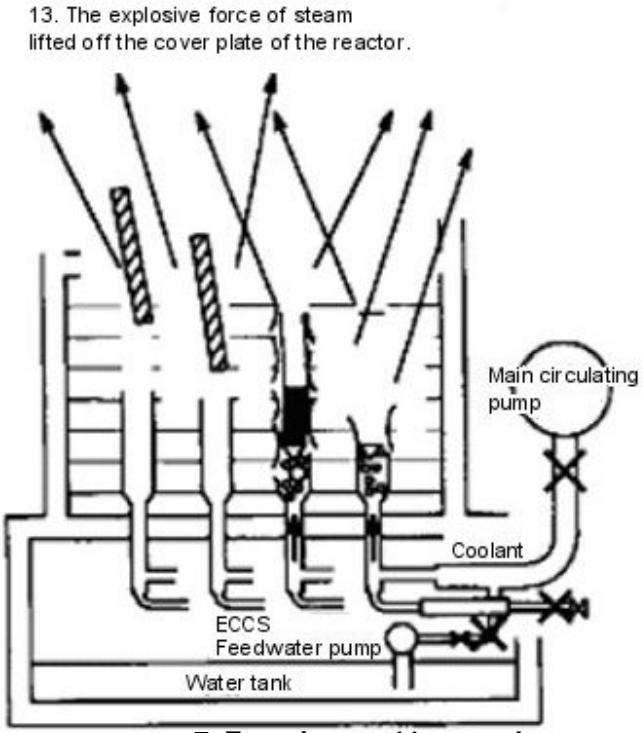
7. Experiment: 44 seconds

14. The second explosion threw out fragments of burning fuel and graphite from the core and sparked a graphite fire.
