Leakage of Sodium Coolant from Secondary Cooling Loop in Prototype Fast Breeder Reactor MONJU

Dec. 8th, 1995, Tsuruga, Fukui pref.

KOBAYASHI, Hideo (Tokyo Institute of Technology)

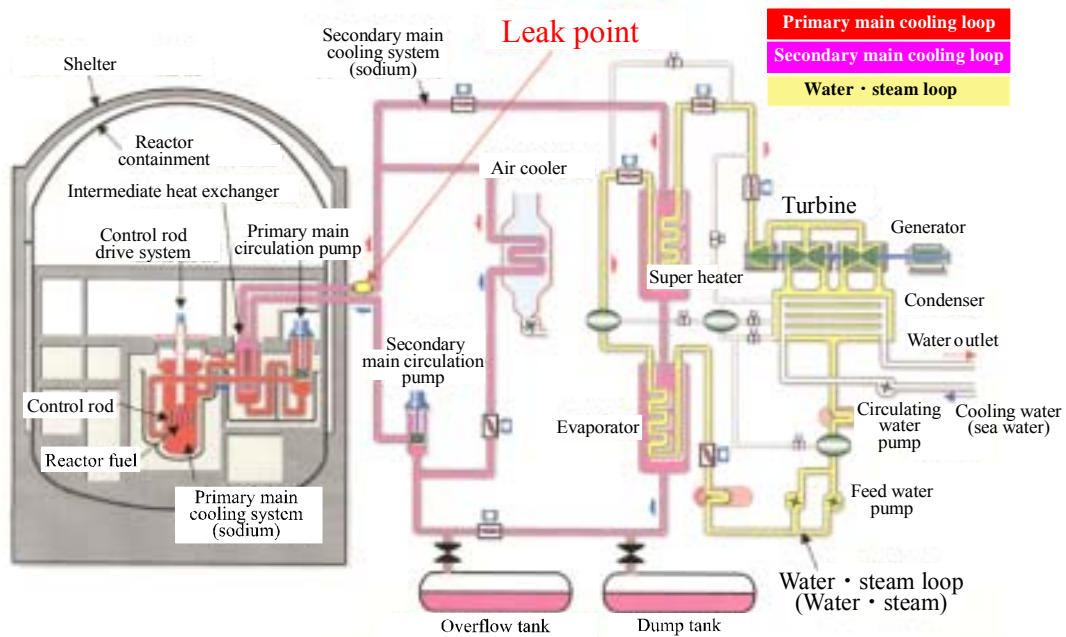
Terminal of the thermometer sensor on the outlet piping of the secondary main cooling loop in the intermediate heat exchanger. The schematic diagram of the equipment, the appearance of the site, and the broken thermometer well together with the route of the leakage are shown in Figures 1, 2 and 3, respectively.

Fig. 1 Schematic diagram of reactor.

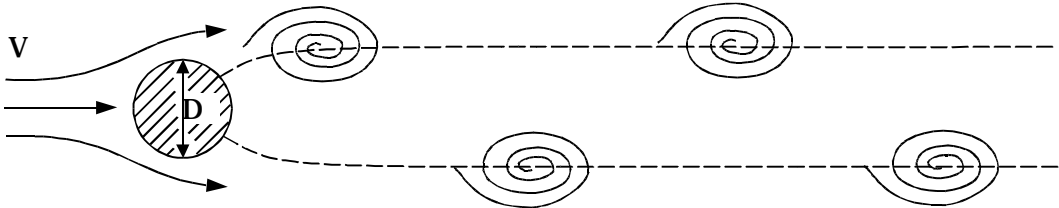
Behind a cylindrical rod, if the first vortex is formed on the right hand side, the second one will be formed on the left, and the next one on the right, and so on, alternating between left and right (Figure 8). The direction of the vortices in the row on the right hand side is the opposite of that on the left. The vortices of the two rows occur at even intervals, but rather than being aligned, the vortices on the left and right are arranged in a zigzag fashion. The reason for why this phenomenon occurs was first elucidated theoretically by Th. von Karman, so that this phenomenon is called Karman's vortex row.

Fig. 8 Karman's vortex row
