Steam Eruption from Secondary System Piping in Nuclear Power Plants

August 9th, 2004, Mihama-cho, Fukui-pref.

KOBAYASHI, Hideo (Tokyo Institute of Technology)

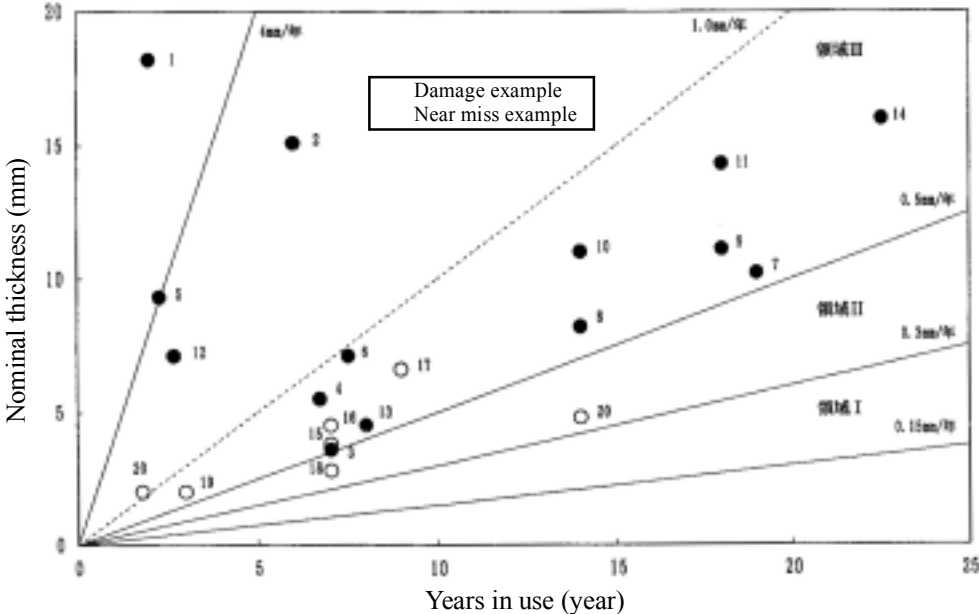
Fig. 4 Erosion/Corrosion Reduction Speed.

Figure 4 shows the results of all 22 erosion and/or corrosion cases. The ordinate indicates the pipe thickness, and the abscissa indicates the duration of service in year. If it is assumed that the localized metal reduction penetrates the entire thickness and the accident occurs, the gradient in Fig. 4 indicates the rate of thickness reduction. The rate of thickness reduction (mm/year) that can cause accidents is in the following range.
