# Capsize of Offshore Oil Drilling Platform

March 27th, 1980, Ekofisk oilfield in the North Sea

KITSUNAI, Yoshio (Japan Crane Association)

KOBAYASHI, Hideo (Tokyo Institute of Technology)

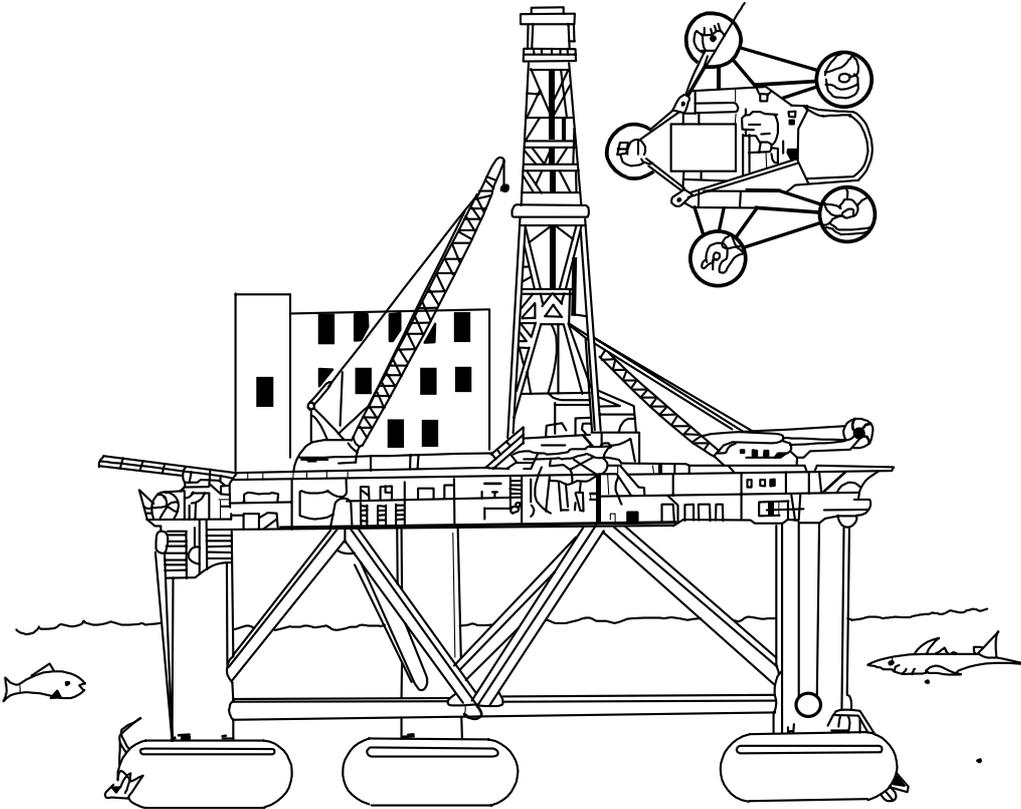
Fig. 1 Alexander L. Kielland.

The offshore oil drilling rig, Alexander L. Kielland, is a semi-submersible platform supported by five columns standing on five 22 meter diameter pontoons (Fig. 1). The dimensions of the platform are 103 x 99 meters in plan and 10,105 tons in weight. A 40 meter high drilling derrick and accommodations for 348 people were installed on the platform. The five 8.5 meter diameter columns on the pontoons were interconnected by a network of horizontal and diagonal bracings. The diameters of the horizontal and diagonal bracings are 2.6 m and 2.2 m, respectively.
