# Leakage of primary coolant at Mihama Unit 2 due to failure of SG tube

February 9th, 1991, Mihama in Fukui Prefecture

## (Summary)

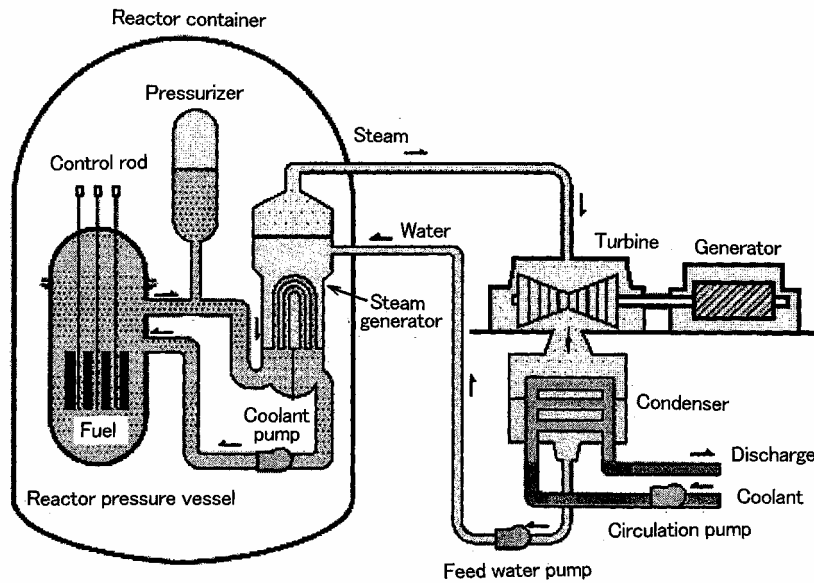
Figure 1 shows a schematic illustration of the pressurized water reactor. Figure 2 shows the steam generator and the location of the failure of the SG tube.

Fig. 1 Schematic illustration of pressurized water reactor.
