Decompression of B-737 of Aloha Airlines by Separation of Upper Fuselage

April 28th, 1988, near Maui Island, Hawaii

KOBAYASHI, Hideo (Yokohama National University) TERADA, Hiroyuki (Japan Aerospace Technology Foundation)

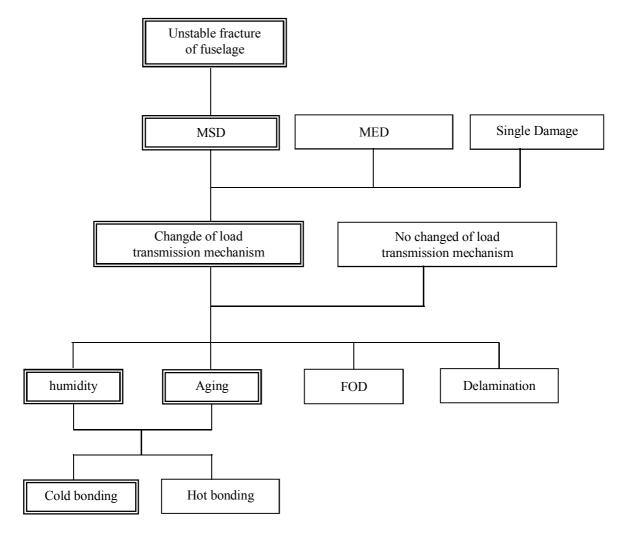
Fig. 4 Fault Tree.

Unstable propagation of m ultiple site cracks induced by corrosion fatigue took place at the fuse lage panel structure. Because the single lap joint had been manufactured using scrim cloth by the cold bonding process, the scrim cloth and adhesives absorbed water and became brittle over the years of operation.

Aloha A irlines neg lected to conduct the perio dical maintenance that was specified by M anuals and Regulations. It was just a matter of time that a crack longer than 100 mm that was easily visible from outside the aircraft would occur that was overlooked by the operator.
