Mid-air Explosion of Comet I over the Mediterranean Sea

Jan. 10th, 1954, Over the Mediterranean Sea (near Rome)

KOBAYASHI, Hideo (Yokohama National University)

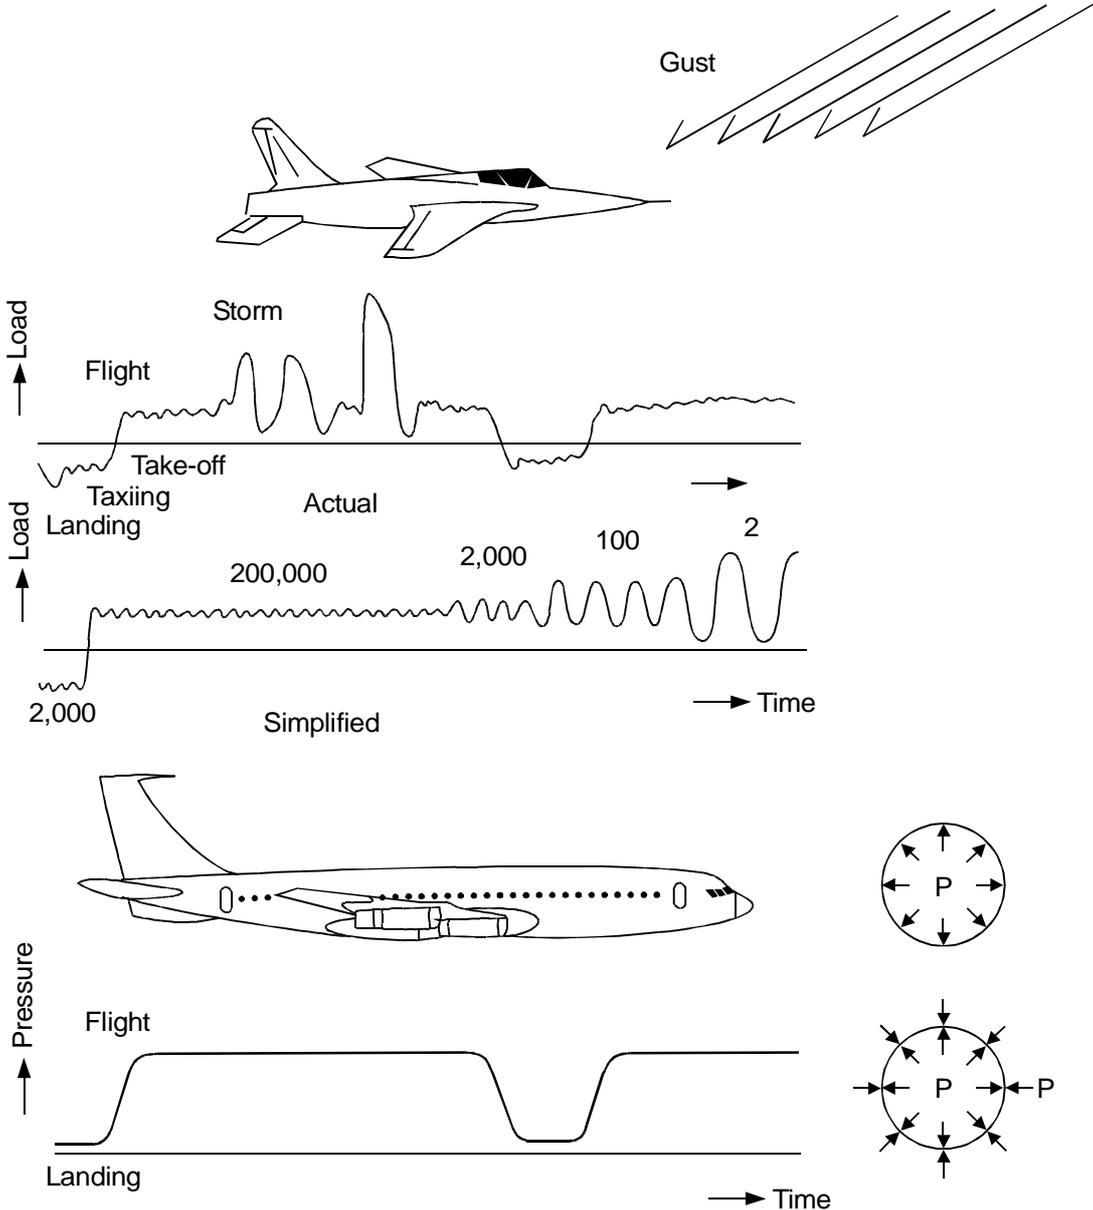
Fig. 2 Typical load applied to transport aircraft.

However, the accident occurred after far fewer flight cycles than this design life. The pressure pattern applied for the fatigue test using the actual fuselage structure is shown in Fig. 1. In the fatigue test, the pressure difference inside and outside of the cabin was assumed to be 0.56 atm. However, in the fatigue test conducted on the ground, a proof pressure load corresponding to 1.12 atm, that is twice that of actual pressure difference, was applied every 1,000 pressure cycles for safety purposes. As a result of this test, the fatigue crack initiation life was determined to be 18,000 pressure cycles.
