Fire during Ethylidenenorbornene Manufacturing
【October 18th, 1973 Kawasaki, Kanagawa, Japan】

Mitsuo Kobayashi (Graduate School of New Frontier Sciences, University of Tokyo)
Masamitsu Tamura (Graduate School of New Frontier Sciences, University of Tokyo)

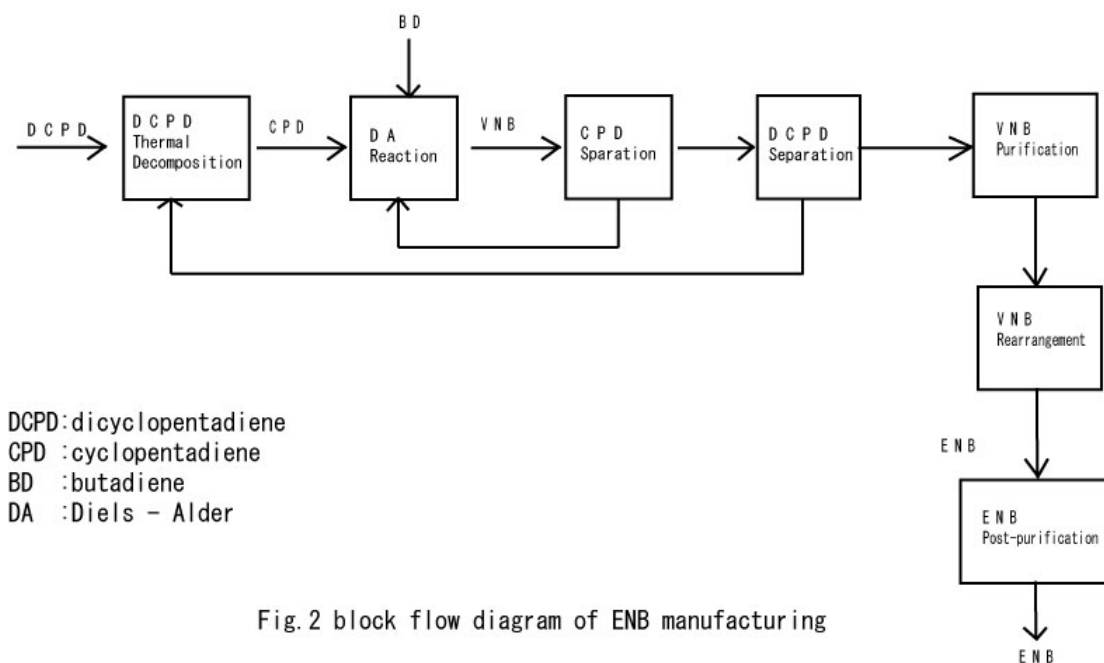
Fig. 2 block flow diagram of ENB manufacturing

On the day of the accident, the DA reactor for the VNB synthesis was stopped due to problems of the CPD separation section. The outline of the process is shown in Fig. 2. Agitation was stopped soon after the supply of raw materials was stopped. The pressure control valve at the reactor outlet was closed manually. The reactor pressure rose after temporarily falling as a result of the supply stop, and then the pressure was released by opening the bypass valve of the control valve. The same operation was repeated. Soon after the operation, the reactor pressure rose suddenly, and the safety valve mounted in the upper part of the reactor operated. A fire was soon occurred in the upper part of the reactor. First a flame spouted out suddenly from the safety valve inlet flange. In addition, a slightly larger flame rose with a small sound in the upper part of the reactor. After few seconds, a large flame suddenly wrapped the reactor. At that moment a slightly larger sound was heard, but it was not recognized as an explosion, because there was no damage to the slate roof or window glass of the nearby building.
