Tachikawa City, the falling accident of the pile driver

【16th March 1991、 Tokyo, Tachikawa City, Akebono town】

Masahiko Kunisima · Koichiro Toyoda (note¹)

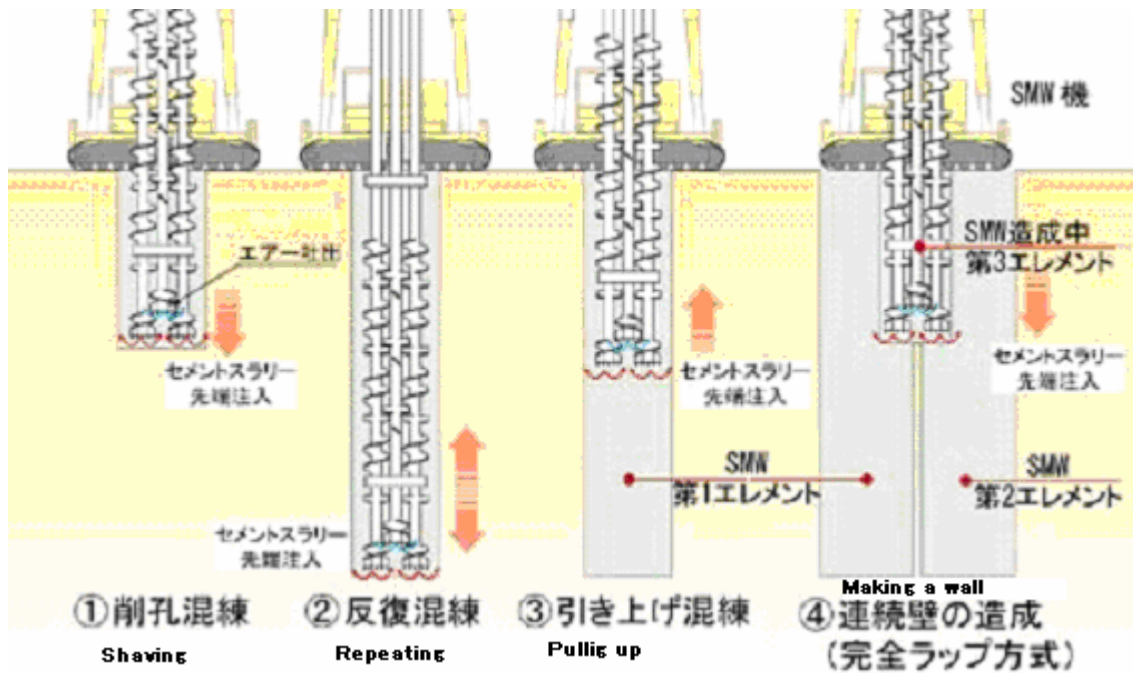
Figure 3. The outline of the SMW method
(Source : Seiko Kogyo home page)

The alarm buzzer of the crane truck informed about the danger from tipping over just before the accident. When the buzzer rang, the safety equipment which stopped the work automatically should have worked. But, on the day, the switch of the safety equipment was cut, and it didn't work. This pile driving method is called "the SMW method" (Soil, Mixing, Wall) and the method is as follows as the pile driver empties the hole, the cement is poured from the tip, and in the cement before the solidifications, the H steel was inserted. (Fig.3)
