## TECHNICAL REPORT: FUKUSHIMA ACCIDENT SUMMARY (AUG. 19, 2011)

**Ritsuo Yoshioka**  
Japan Functional Safety Laboratory  
Yokohama, Japan  
ritsuo.yoshioka@nifty.ne.jp

**Kenji Iino**  
SYDROSE LP  
San Jose, California, USA  
kiino@sydrose.com

The earthquake and tsunami caused unprecedented accidents in six units of Boiling Water Reactors (BWR) in Fukushima Nuclear Power Station 1, operated by The Tokyo Electric Power Company, Incorporated (TEPCO). This report, based on published information, summarizes the causes and processes of these accidents.

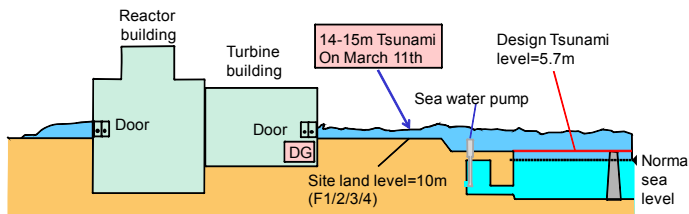
Figure 2 Elevation level of Fukushima facilities [2]

Then, a huge 14-15 meter tsunami attacked the coast at 15:27 followed by a series of tsunami waves until 15:41 on the same day. The tsunami flooded all but one DGs (Figure 2). All DGs were installed in the basement of turbine buildings except one in the reactor building that survived. The reactor buildings are believed to have withstood the tsunami. On the other hand, seismic design level of turbine buildings against earthquakes is the lowest. Why the manufacturers installed the DGs in the basement is unclear. As a hindsight, they had to design correctly. Among all DGs, 3 were air-cooled and one of the air-cooled ones was installed in the reactor building of F6. This was the only DG that survived the tsunami, and it saved F5/6.

At 15:41, all the other DGs were lost, and F1/2/3 had Station Black-Out (SBO, Loss of all AC power). Some of the batteries survived at F2/3/4, however, they were designed for controlling the cooling pumps and not their operation. The core cooling function, therefore, was basically lost for F1/2/3, and the fuel pool cooling function was also lost for F1/2/3/4.

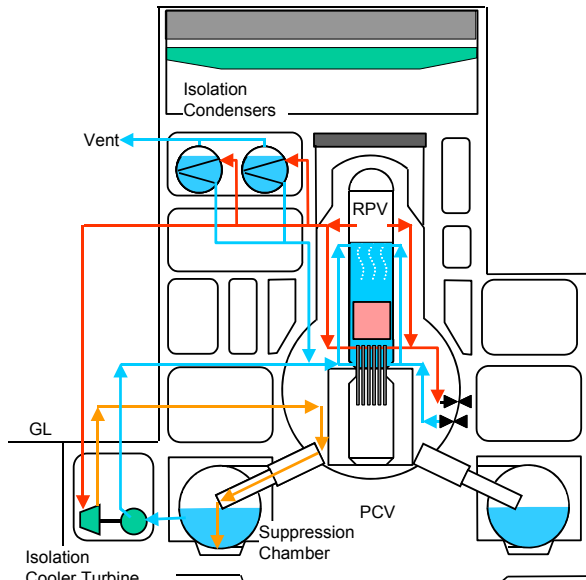
**Figure 5 IC system with F-1**

**March 11, 14:52:** Although all AC power were lost, the Isolation Condenser (IC) started. IC, installed on the 4th floor of the reactor building, does not require electricity for circulating cooling water (Figure 5). How long the IC worked remains unknown. Its designed running time was 8 hours, however, batteries in the basement of the turbine building for controlling IC were also hit by the tsunami, and our guess is that TEPCO operators repeatedly turned the IC on and off several times for several hours.

This core cooling function with intermittent operation of IC was insufficient, and the fuel temperature went up to start fuel failure.

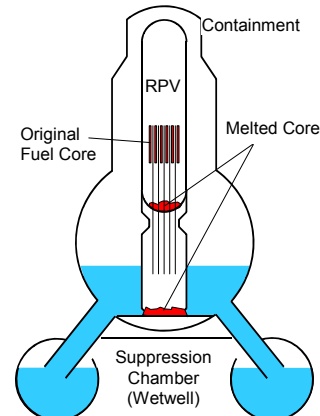
**Figure 8 Fuel melt-down status[7]**

New York Times, in its April 6th issue [7], reported information from NRC. The article with the figure described that fuel fell down to the bottom of RPV in the form of fragments and particles of fuel pellet (Figure 8). Since the bottom of RPV was broken, fuel fell further down to the bottom of PCV. We believe that this is the current situation with F1/2/3. Water level within PCV in the figure is our estimate.

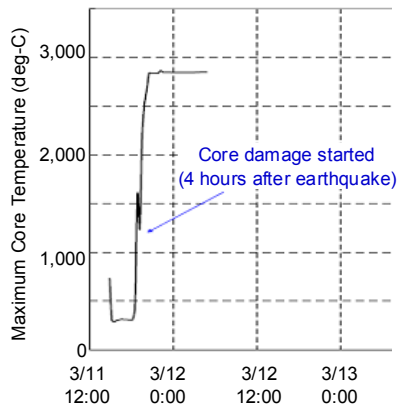
**Figure 9 F1 max. fuel temperature [8]**

2 month later, TEPCO issued a report of calculation results. If IC did not work, 100% of the fuel pellets would have reached 2,800deg.-C during the night of March 11th, and all fuel would have dropped to the bottom of RPV. The melted core then broke the PCV. This is a real “Melt-down”. Meanwhile, TEPCO says that F1 shows some positive pressure values in RPV and PCV, and this means the hole is not big. This is a mystery, and no one has explained the phenomenon yet. We presume that there was some contribution of IC, as well as some cooling by the water at the bottom of RPV, and that is why there is no big hole at the bottom of RPV.

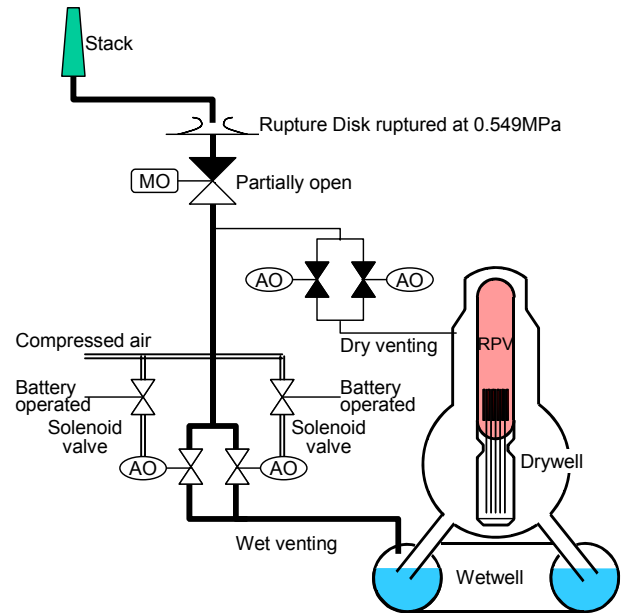
**Figure 10 F1 vent route [9]**

TEPCO had to open 2 valves to vent after the PCV pressure reached the rupture disk set-point. One of the valves was motor-operated (MO), and the other air-operated (AO). It took TEPCO as long as 9 hours to start the venting due to difficulty in opening these 2 valves from loss of electricity and high-radiation in the area. There were 2 routes for venting, but TEPCO basically applied venting from the wetwell. This so called wet-venting traps most radio-active material in the wetwell water and largely reduces release of radio-activity.

In any case, the time-chart shows that PCV-venting became available after the fuel was already half-melted. So, PCV-venting could not have saved the PCV integrity.

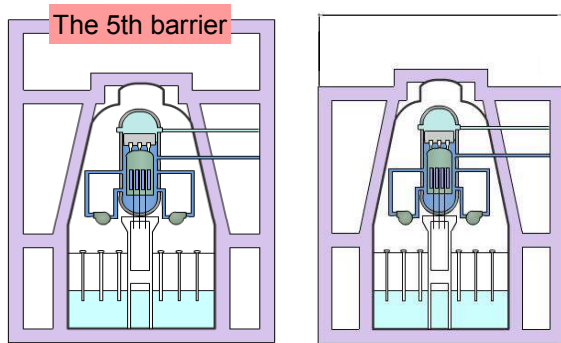
**Figure 13 Actual Thickness of the 5th Wall**

As we explained above, the walls and roof of the top floor were designed thin. The left-side illustration in Figure 13 was shown in a Government web site, where it said that the reactor building wall is 2 meter thick, and acts as the 5th barrier. This explanation was misleading and the page was deleted from the website after the accident. The illustration should have been like the one on the right side in Figure 13.

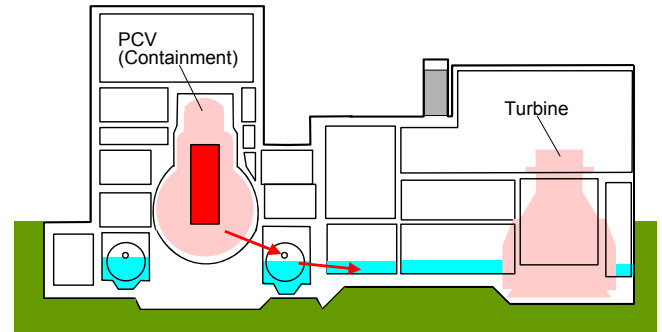
Figure 15 Water path

These results also suggest that water in the RPV went to the PCV, and then to the basement of the reactor building. Penetration holes between reactor building and turbine building would allow the water to reach the basement of the turbine building, as Figure 15 shows.

Nuclear fuel material such as Uranium or Plutonium has not been found in the above water, however, since fuel fragments fell to the damaged PCV with probable holes, they could go out with water. TEPCO is now operating the water circulation system to prevent sea contamination.

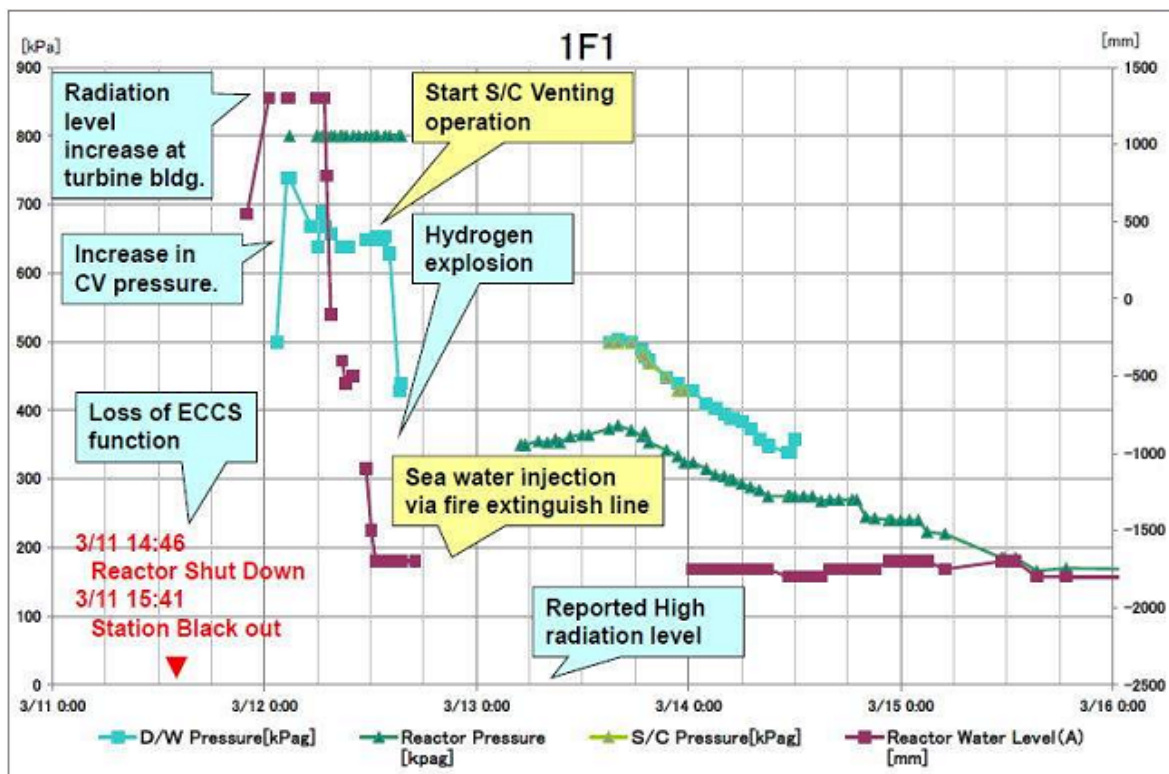
Figure 16 Trend Data of F1 up to March 15 [4]

Figure 16 shows the event chart with pressure and water level of F1 for the first several days.

We conclude that F1 is in “half melt-down” status, i.e., fuel pellets reached 1,400deg.-C or higher, but less than 2,800deg.-C. Hot fuel fell to the RPV bottom, broke holes there to fall further to the bottom of PCV. PCV is also damaged by hot fuel.

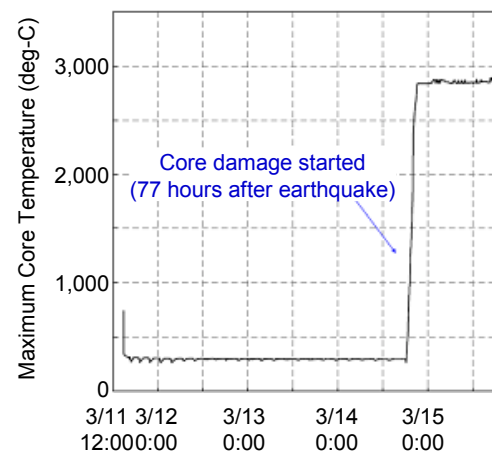
Figure 19 F2 max. fuel temperature [8]

2 months later, TEPCO issued a report of calculation results. After RCIC had stopped, about 50% of the fuel pellets reached 2,800deg.-C during the night of March 14th, and dropped to the bottom of RPV.

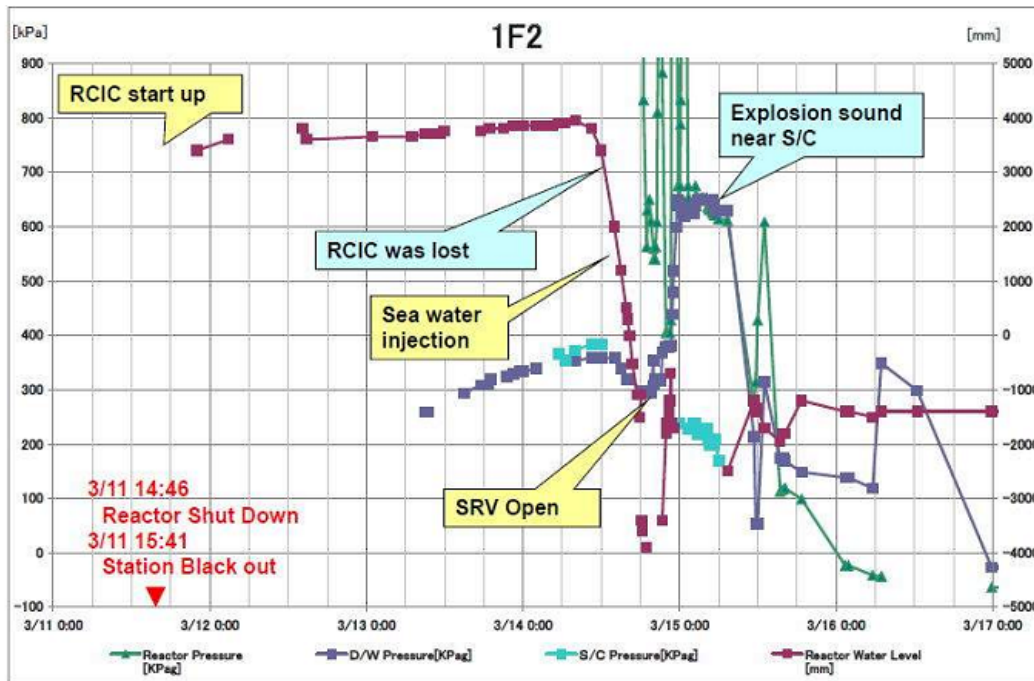
**Figure 21 Trend Data of Unit 2 up to March 17 [4]**

Figure 21 shows the event chart with pressure and water level of F2 for the first several days.

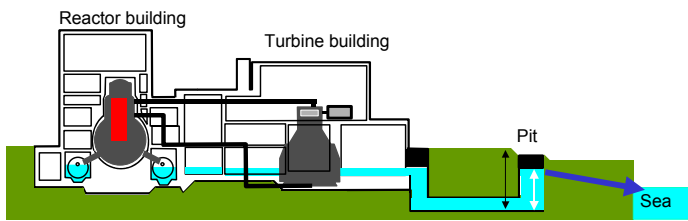
**Figure 22** Water path to the “Pit”

**April 2:** Very high radiation (400mSv/h) was observed at a location 2-meters away from the “Pit” of F2. The pit is the exit of the turbine building water to the sea. When F2 was shut-down on March 11th, we estimated that there was radio-activity of  $4.2 \times 10^{18}$  Bq of Iodine-131 in the whole core. This Iodine went to the suppression chamber, and went out to the basement of the turbine building, because PCV was already broken. This high value means that water in the Pit had almost the same radiation level as the water in the core.

TEPCO also announced that Iodine-131 was measured at the sea in front of F2, and its value was as high as 5.40-million Bq/cc. Since the basements of the buildings were not watertight, some amount of leakage is likely. This means that sea contamination had begun. TEPCO is now installing barriers to the sea and the leakage is decreasing.

Nuclear fuel material such as Uranium or Plutonium has not been found in the above water, but we guess since RPV and PCV were broken, such material could go out with water. Also, underground of these buildings may already be contaminated.

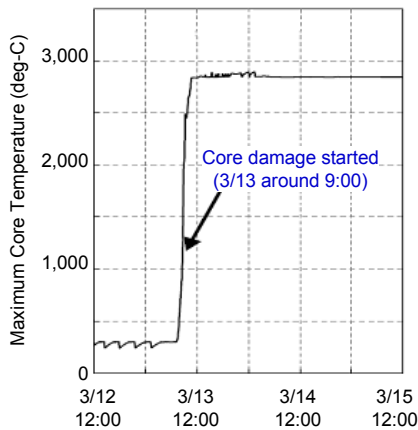
**Figure 23 F3 Max, fuel temperature [8]**

2 months later, TEPCO issued a report of calculation results. After HPCI had stopped, about 50% to 100% of the fuel pellets reached 2,800deg.-C in the morning of March 13th, and dropped to the bottom of RPV.

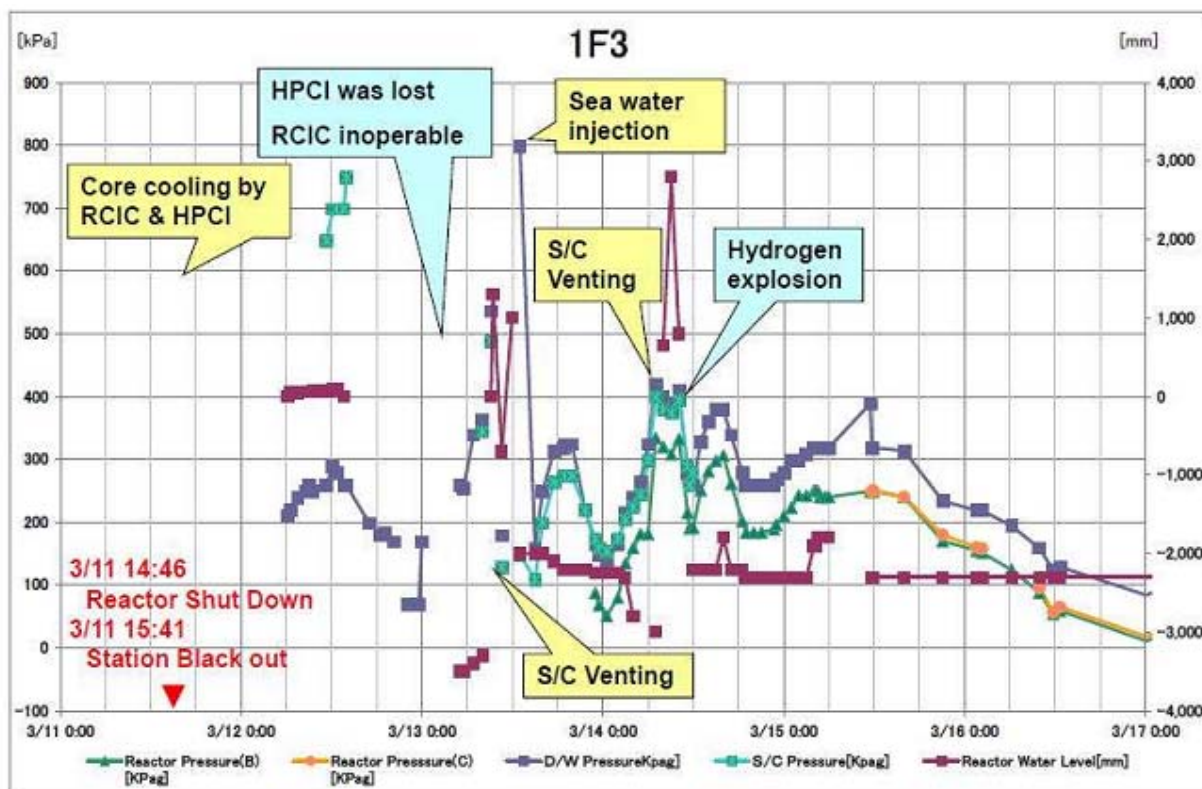
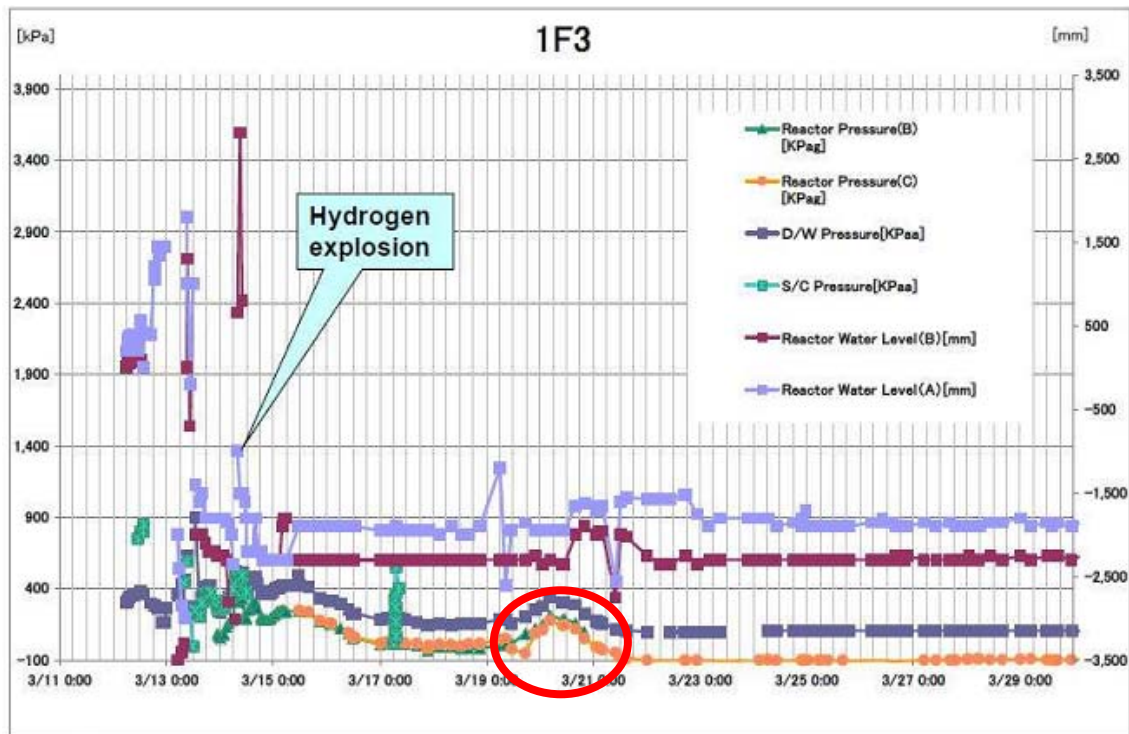
Figure 28 and 29 show event charts with pressure and water levels of F3 for the first several days. Figure 30 shows detail trend of the RPV and drywell pressure in the red circle in Figure 29.

Both RPV and PCV are likely to have kept their integrities, or at least, there were no big holes in RPV/PCV until March 19th, because both pressure values were low but positive. On March 20th, however, we can see pressure spikes both in RPV and PCV, followed by decrease to zero pressure on March 21st. This increase and decrease in pressure suggest that a hole once closed and then opened.

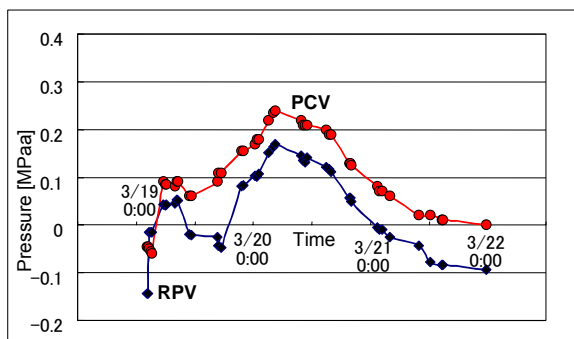
Figure 30 Pressure in RPV and PCV on F3

Our guess is that disintegrated fuel dropped and clogged up the small holes on March 20th to raise the pressure in RPV/PCV, then the holes grew larger on March 21st. Since these phenomena advanced slowly, we do not believe there was a re-criticality accident or any kind of explosion. The fact is that the PCV integrity was completely broken on March 21st.

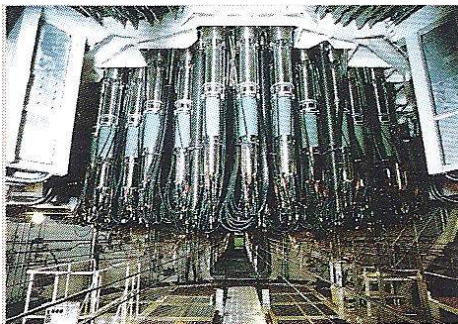
**Figure 33 Bottom of ABWR RPV [15]**

We presume that radio-active material went out at this time with the smoke. Black smoke is an indication of carbon from organic material such as cable insulators. There are many cables under the bottom of RPV for the control rod drive mechanisms and neutron detectors (Figure 33). As we explained in 3.1.1, hot fuel broke the instrument tubes and fell down to the RPV bottom. They probably burned the cables at this time.

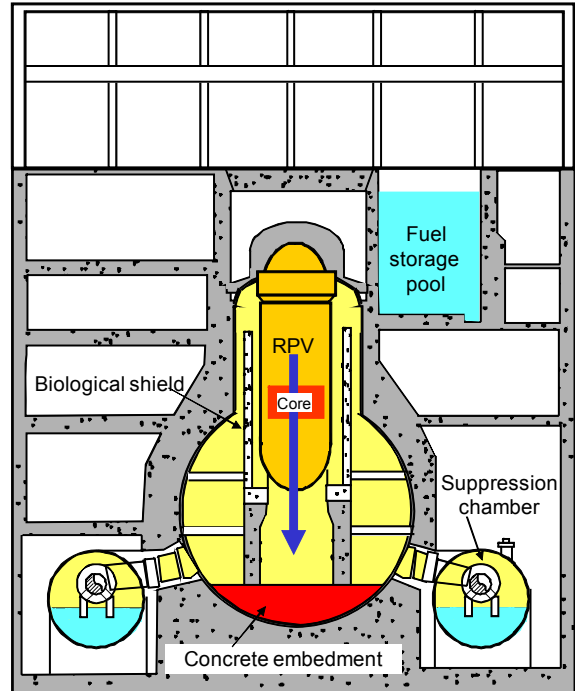
**Figure 34 MARK-I PCV [16]**  
( PCV concrete floor is shown red)

The French national laboratory suggested that “core-concrete chemical reaction” was responsible for the black smoke. Of course, hot fuel fell down on the concrete floor of the PCV, as Figure 34 shows, however, a Japanese national laboratory says that Japanese plants do not use concrete with carbon, and this reaction will not occur. So, it is more probable that this black smoke was caused by fire of the cables when hot fuel fell on them.

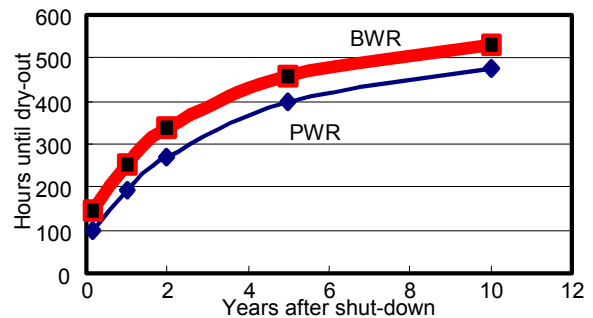
Figure 37 Hours to dry-out with different cooling time [22]

There are many risks associated with the spent fuel pool, but they are not well known in Japan. A US-NRC document [22] describes the number of hours allowed after loss of pool cooling. Figure 37 shows that a BWR spent fuel will start to dry-out in a week if it has been loaded with spent fuel from shut-down 2 months earlier. Once dry-out starts, fuel is cooled only by air, but inefficient air-cooling will let the melt-down process start within 5-hours, as Figure 38 shows.

Based on the former conservative analysis, we had to assume that the melt-down process was initiated in the F4 spent fuel pool on May 15th, and the fuel reached 1,200deg.-C to generate hydrogen gas. Of course, in the latter optimistic case, spent fuel might be intact.

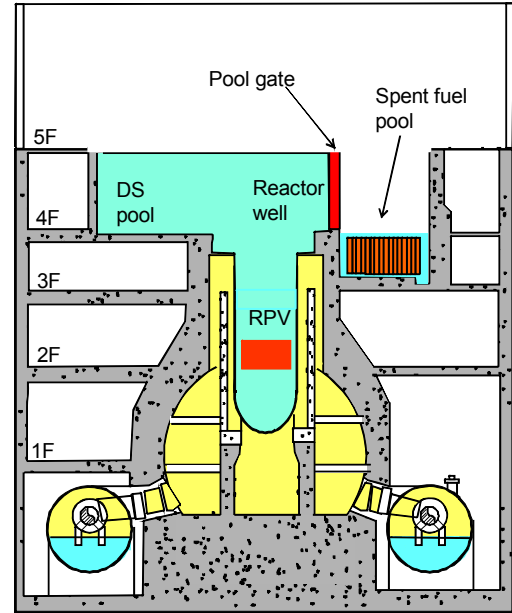
**Figure 41 Water inventory of F4 before explosion [16]**  
(Water level assumed by the authors)

Since all fuel bundles in the core had been moved to the spent fuel pool, the pool gate was closed as Figure 41 shows. When the pool water level dropped and hydrogen exploded, this pool gate was possibly damaged to allow water from the Dryer-Separator (DS) pool and reactor well to fall into the spent fuel pool. About 2,000tons of water could have been moved to the spent fuel pool, just enough to keep the spent fuel cooled for several more days.
